Cross River Rail Project

Monthly Environmental Report

April 2022

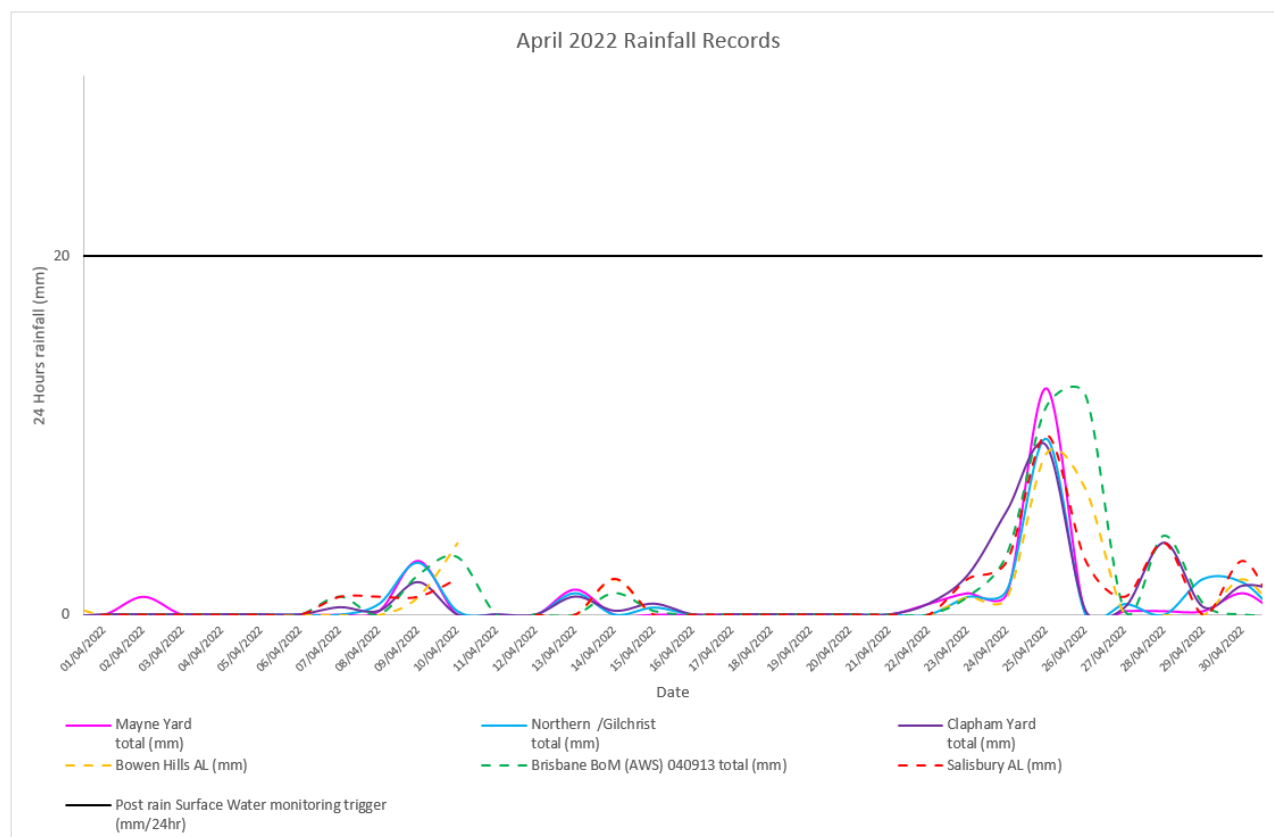
Figure 4: April 2022 Rainfall Records

Post rainfall monitoring is triggered typically following any rainfall event exceeding 20 to 25 mm over 24 hours, however, storm events during the high-risk period of the year (November to March) of lesser amounts but of a higher intensity may cause run-off which would also trigger post-rain monitoring consistent with the C-EMP.
