# Cross River Rail Project

## Monthly Environmental Report

August 2020

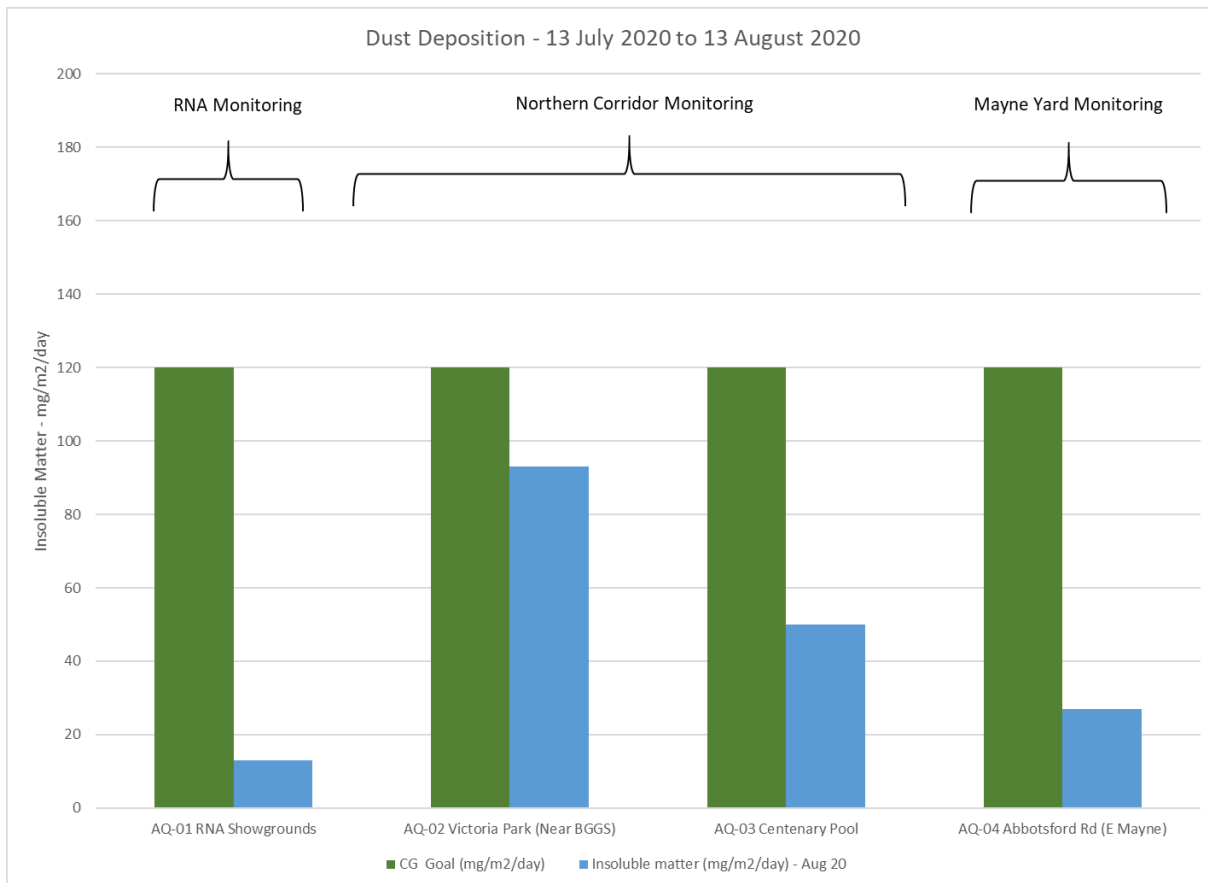
Figure 4: Air Quality Monitoring (Deposited Dust) – 13 July – 13 August 2020 Results

The dust deposition gauges result for the reporting period are detailed below and complied with Condition 13(b) of the CGCR.

CGCR Goal (mg/m <sup>2</sup> /day)	AQ-01 Results - RNA Showgrounds (mg/m <sup>2</sup> /day)	AQ-02 Results - BGGS (mg/m <sup>2</sup> /day)	AQ-03 Centenary Pool (mg/m <sup>2</sup> /day)	AQ-04 Abbotsford Rd (E Mayne) (mg/m <sup>2</sup> /day)
120	13	93	50	27
Total Rainfall during Period	14mm	16mm	16mm	14mm

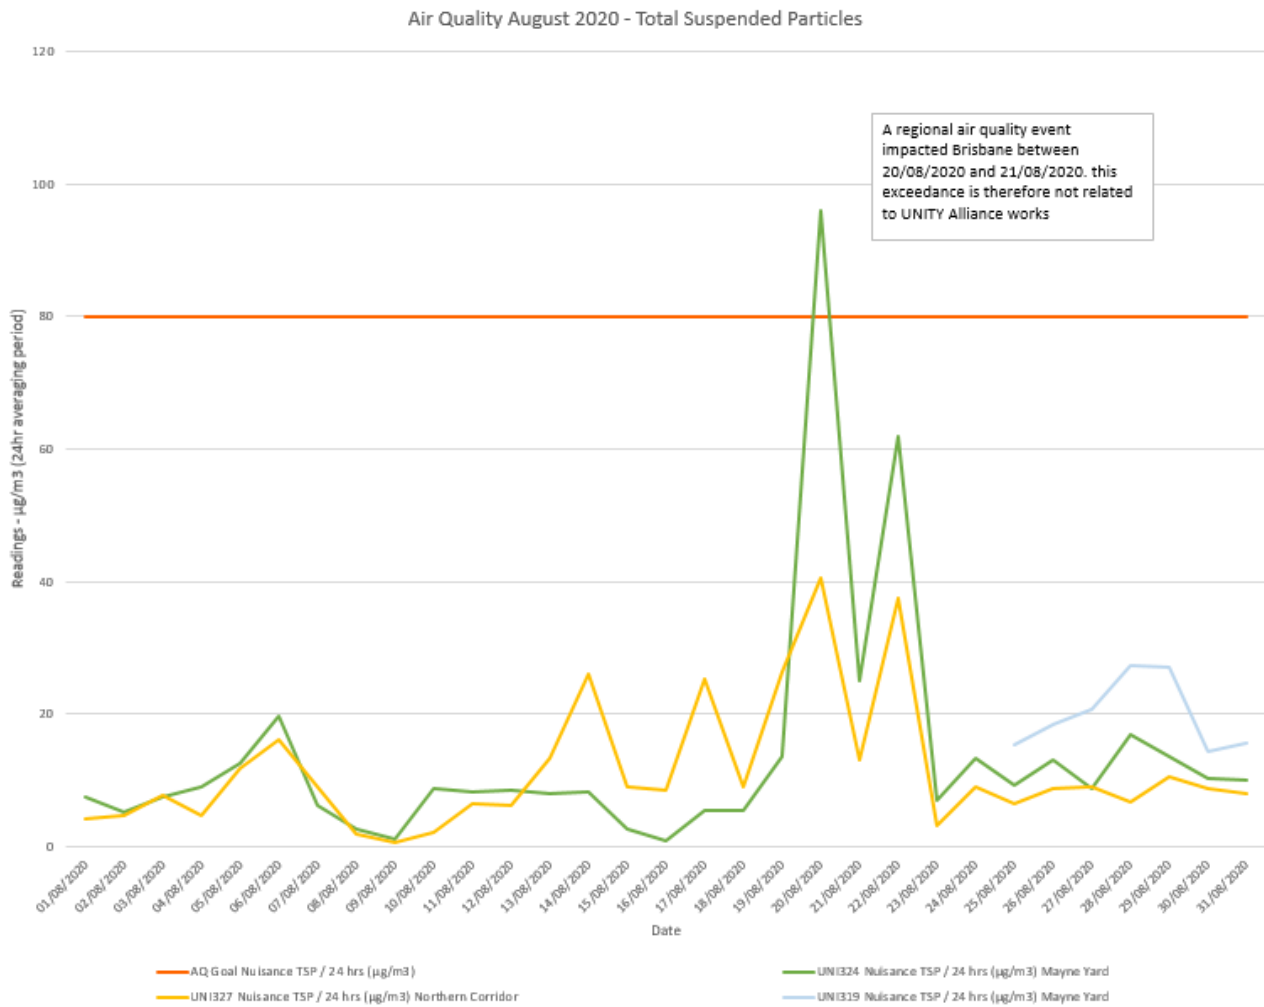
Figure 5: Air Quality Monitoring (TSP) - August 2020 Results

PM<sub>10</sub> is one of the indicators for which the Coordinator General has imposed a goal of 50 µg/m<sup>3</sup> (over an averaging period of 24 hours) the project must aim to achieve under Imposed Condition 13(a).

TSP is one of the indicators for which the Coordinator General has imposed a goal of 80 µg/m<sup>3</sup> (over an averaging period of 24 hours) the project must aim to achieve under Imposed Condition 13(a).

These stations have been set up on site as per AS/NZS 3850 1.1 following consultation with UNITY Air Quality Professionals.

All particulate monitoring results did not exceed the relevant air quality goals specified by imposed condition 13, excluding the 20<sup>th</sup> of August 2020. On this date (and extending to the 23<sup>rd</sup> of August) a regional air quality event occurred, with poor air quality experienced across South East Queensland. These exceedances were regionally based and therefore not associated with UNITY works. This is further explored in section 3.2.5 below. The RIS scope of works is achieving the outcomes set out by the CGCR and OEMP.

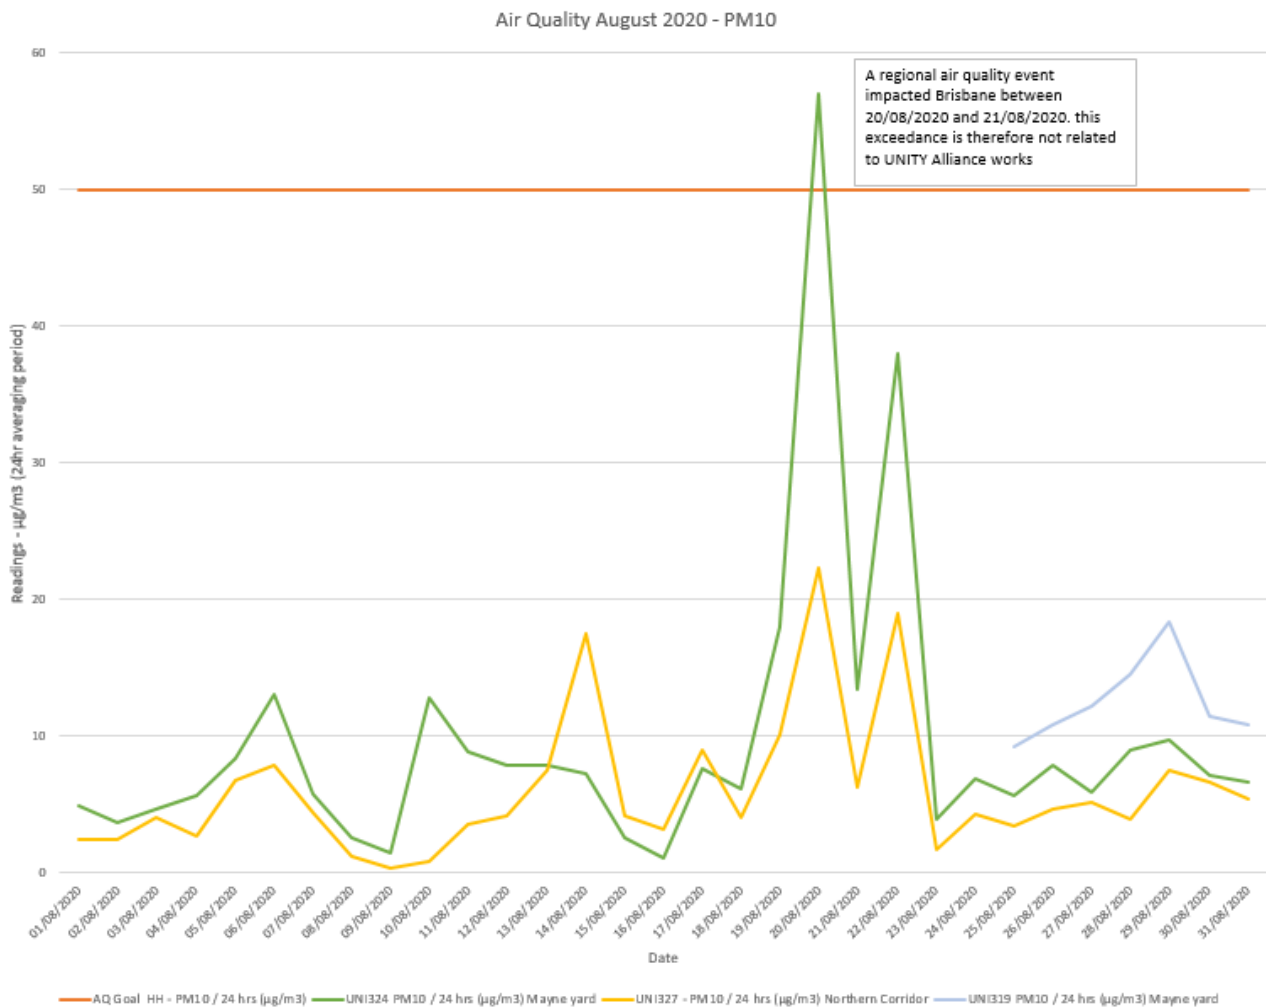
Figure 6: Air Quality Monitoring (PM10) - August 2020 Results

For the four days in question, the daily running average for PM10 was classified as very poor by the Department of Environment and Science. This was significantly higher than the rest of the month. Significant spikes were observed at our stations with significant spikes on both the 20<sup>th</sup> and 22<sup>nd</sup> of August.

Due to the consistency of poor air quality results in the area, it has been concluded that UNITY works were not the cause of the measured exceedances at Mayne Yard station and the decreased air quality at the Victoria Park Station.

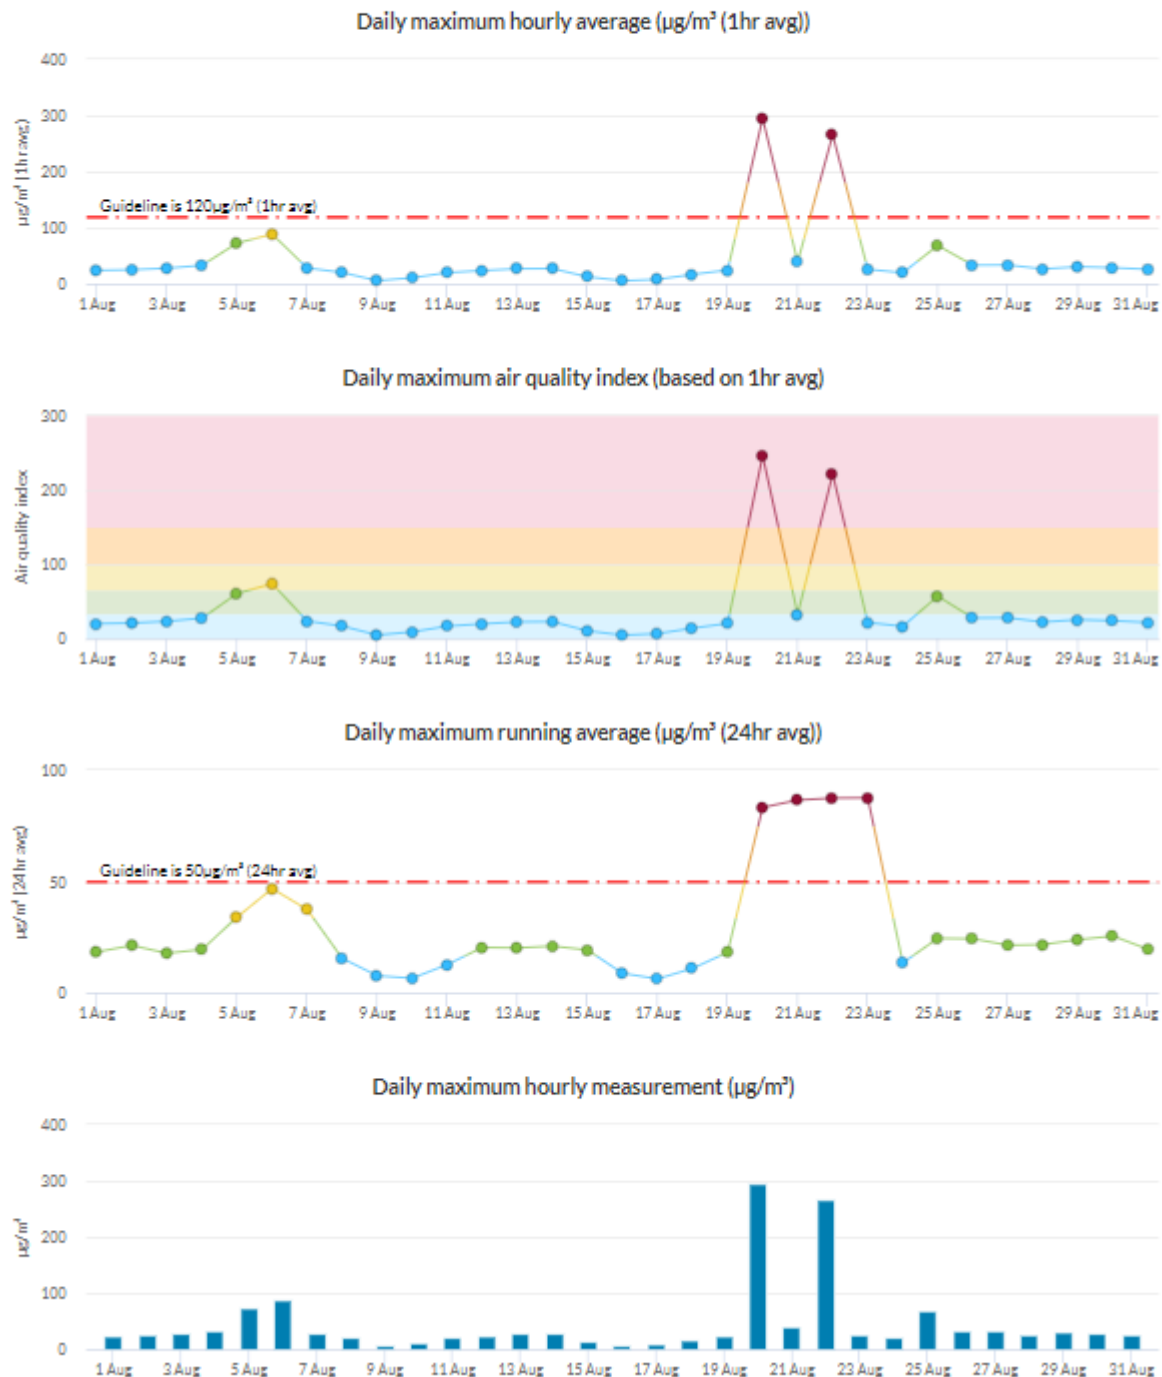
Figure 7: Woolloongabba – DES Station - PM<sub>10</sub> graph for August 2020 (reproduction from the DES website accessed 14 August 2020)

The guideline for Particle PM<sub>10</sub> is 120µg/m<sup>3</sup> (1hr avg) and 50µg/m<sup>3</sup> (24hr avg).

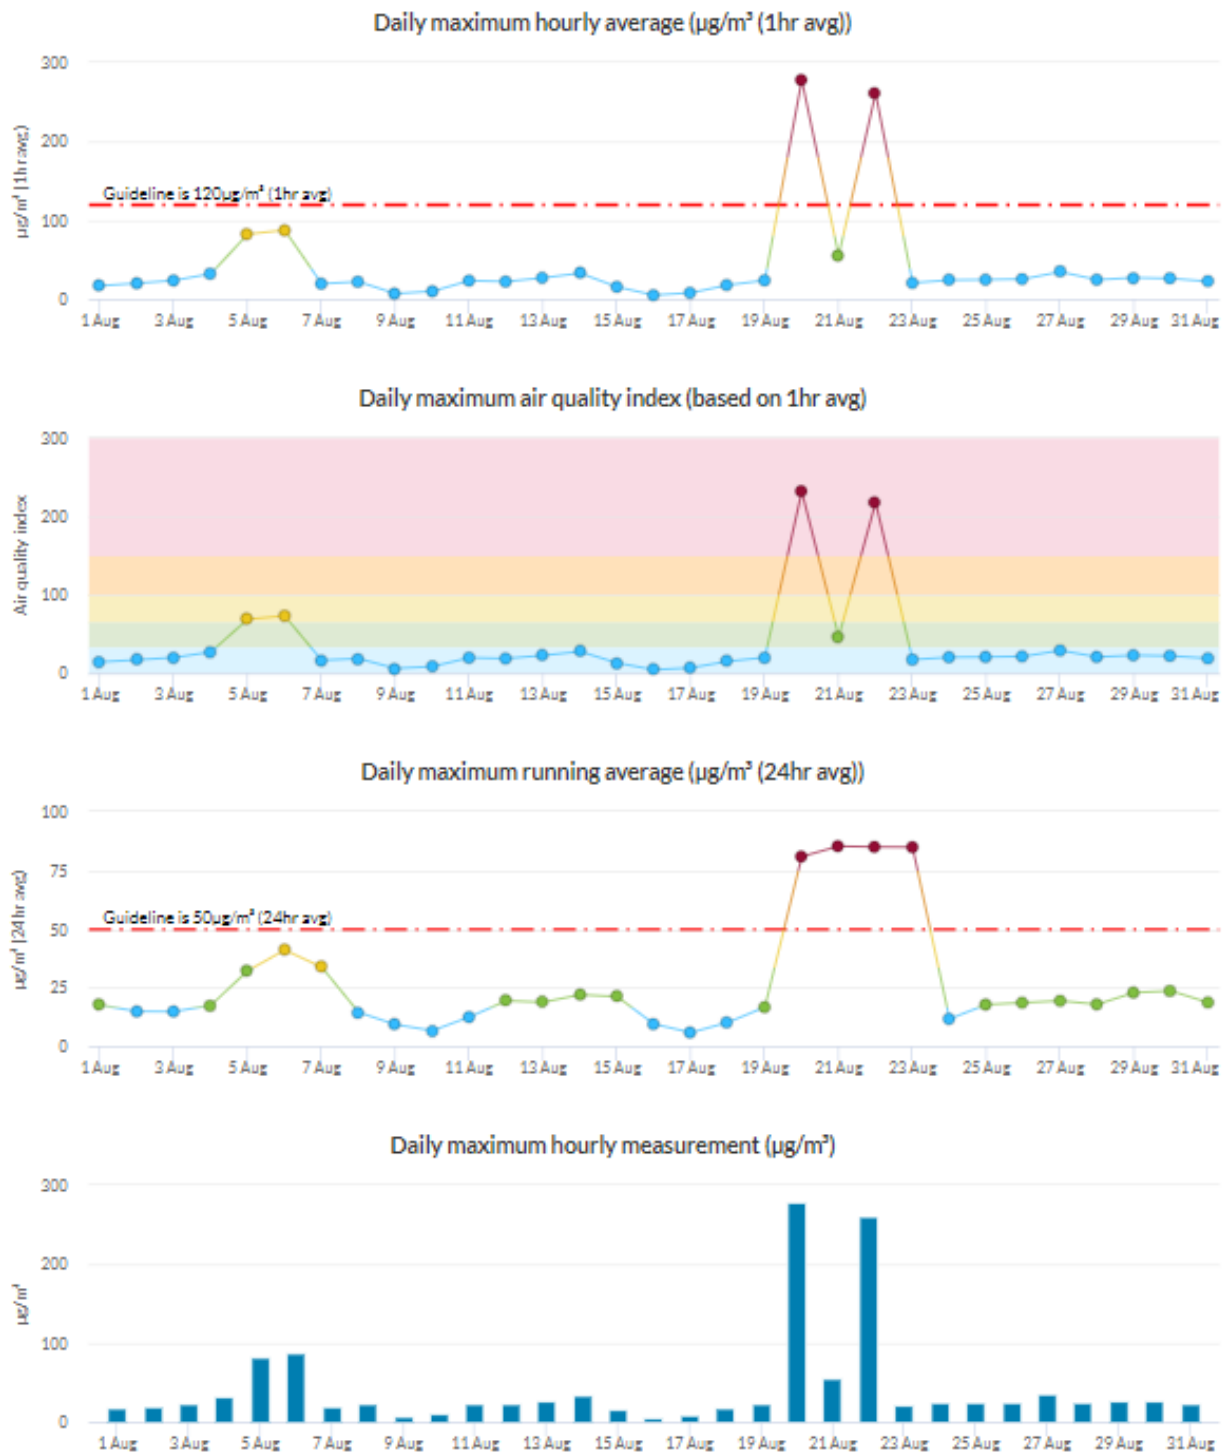
Figure 8: Brisbane – DES Station - PM<sub>10</sub> graph for August 2020 (reproduction from the DES website accessed 14 August 2020)

The guideline for Particle PM<sub>10</sub> is 120µg/m<sup>3</sup> (1hr avg) and 50µg/m<sup>3</sup> (24hr avg).

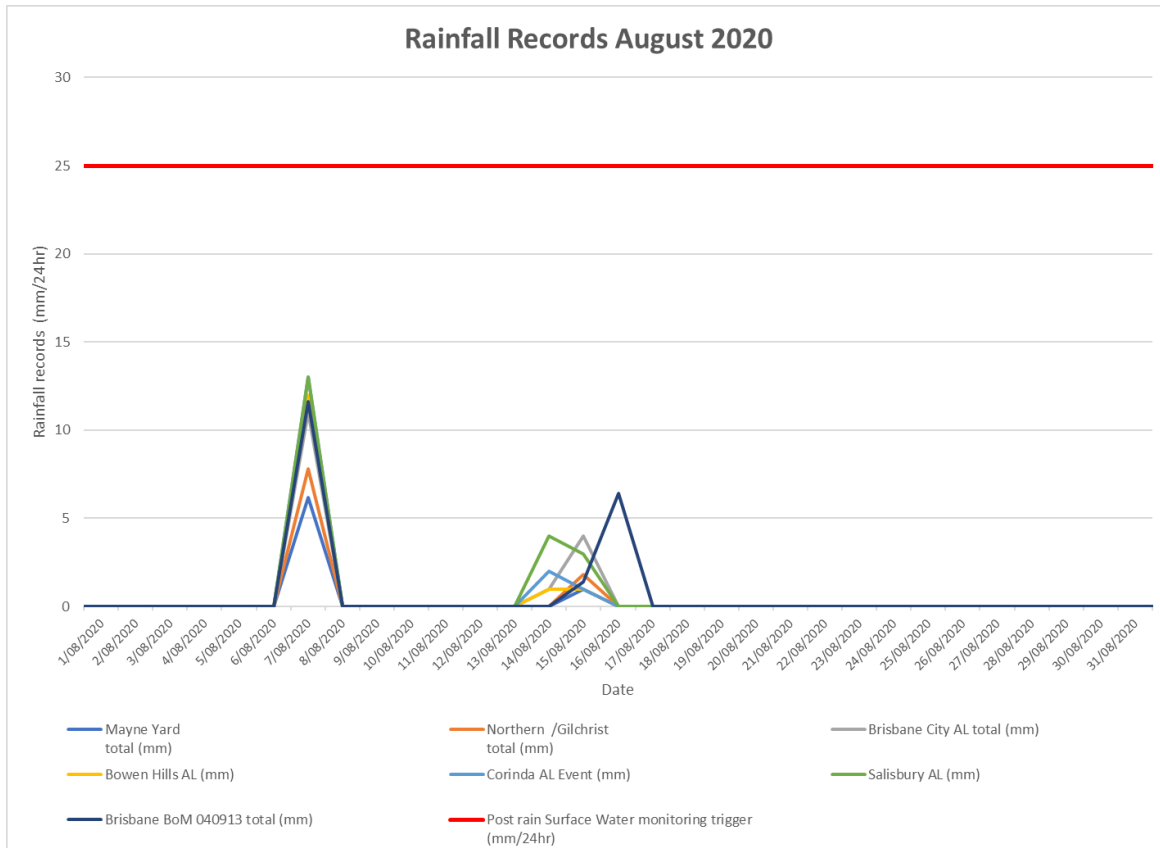
Figure 9: Rainfall – August 2020 Results

Water Quality monitoring to demonstrate compliance with Condition 15b and Condition 18 was triggered on 07 August due a rainfall event resulting in run-off being generated from the active sites. Surface water monitoring undertaken on 08 August.

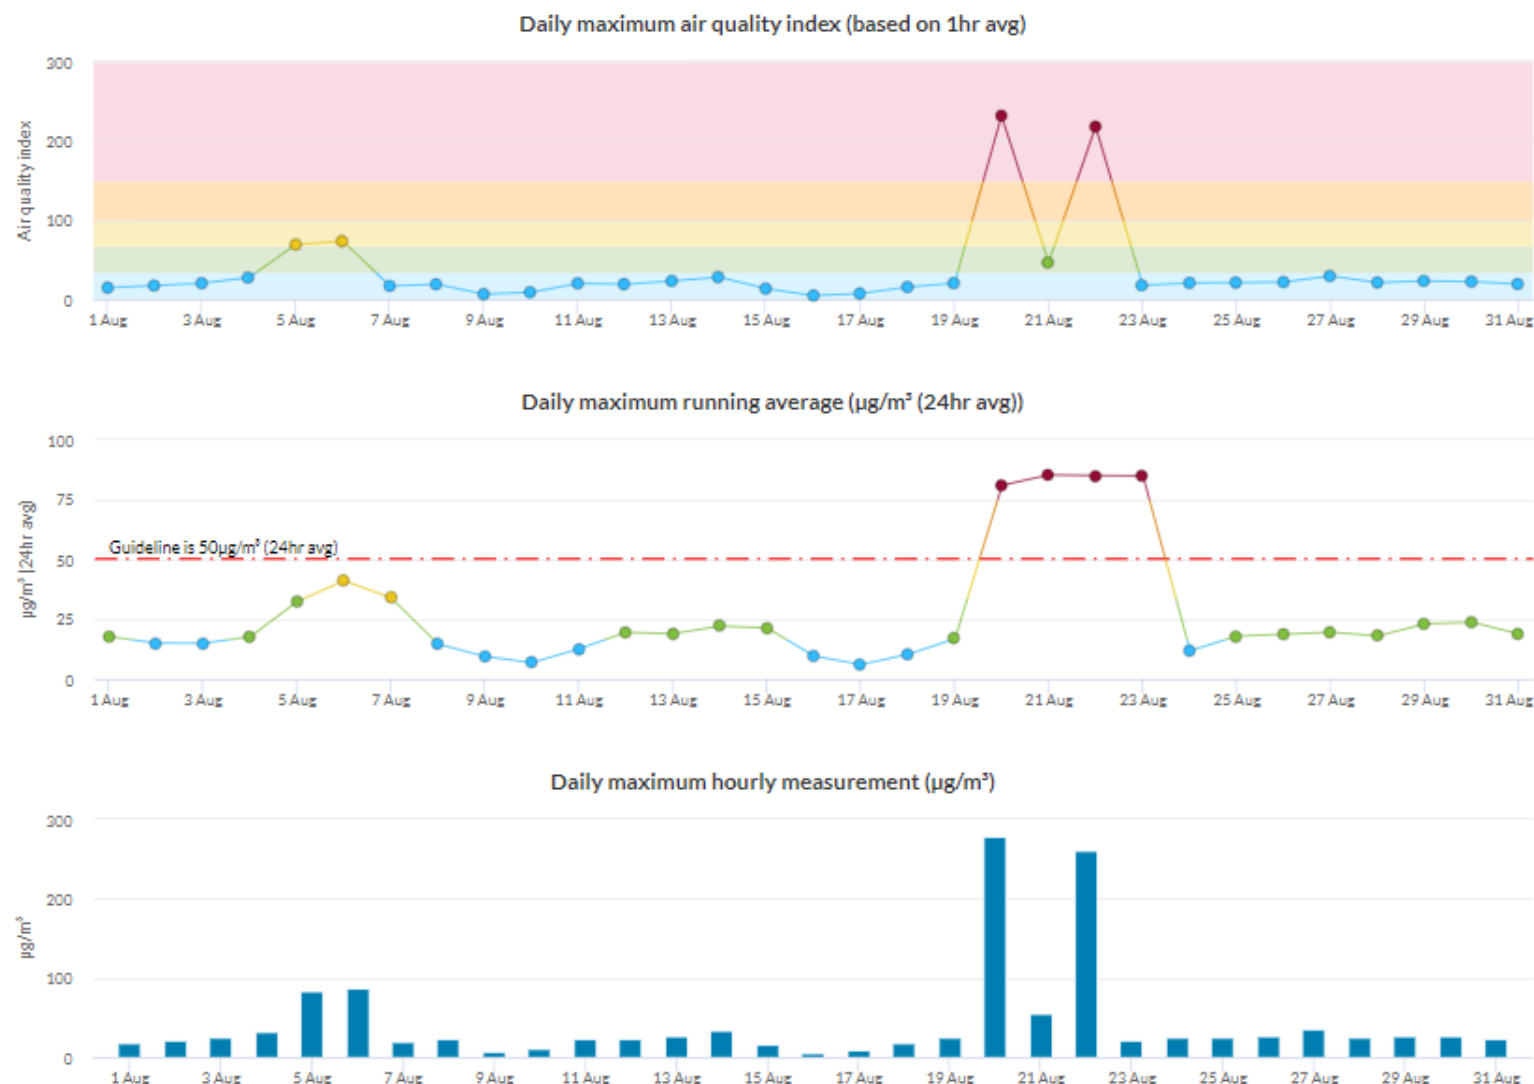
Figure 1: Brisbane CBD – DES Station - PM10 graph for August 2020 (reproduction from the DES website accessed September 2020)

During 4<sup>th</sup> to 6<sup>th</sup>, and 19<sup>th</sup> to the 24<sup>th</sup> of August 2020, South East Queensland experienced poor regional air quality. The regional ambient air quality levels were influenced by external events outside of CBGU's control (e.g. hazard reduction butrning, high wind, and dust storms). On 20<sup>th</sup> August 2020, the Department of Environment and Science issued an air quality alert stating that that South East Queensland and South West Queensland was experiencing elevated health action levels.
