Cross River Rail Project

Monthly Environmental Report

December 2019

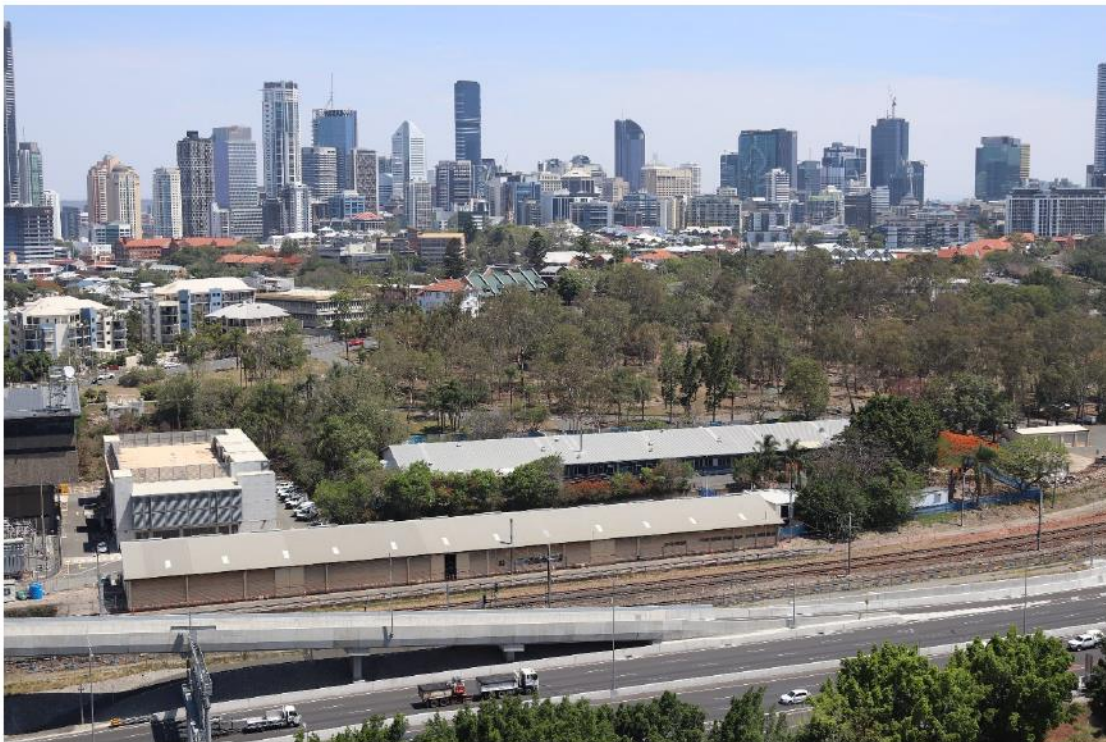
Plate 1: View from time lapse camera installed on the top of the QIMR Berghofer Medical Research Institute building 300 Herston Road, Herston

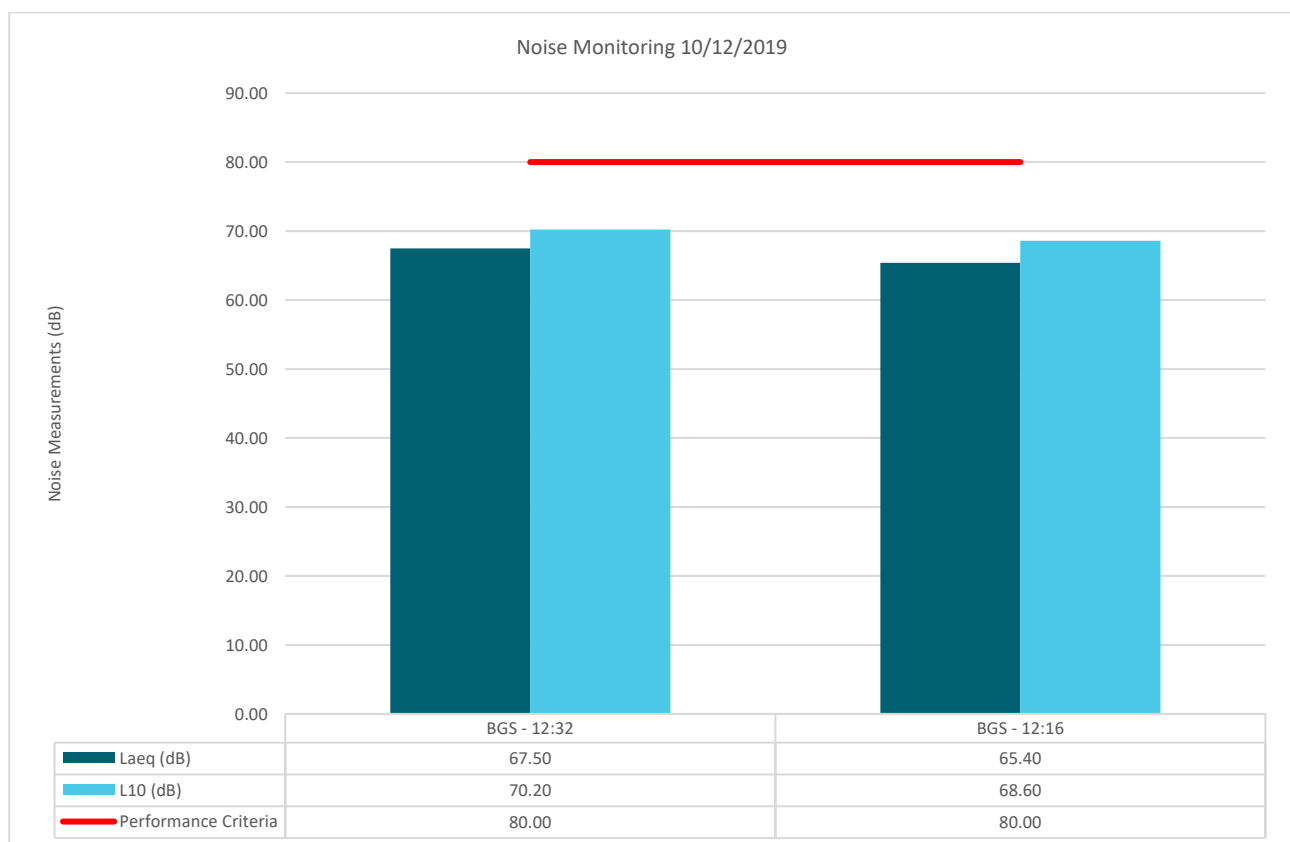
4.1.1 Noise monitoring Results

Attended Noise Monitoring validated the predictive model that the Performance Criteria would not be exceeded by the Relevant Project Works.

Attended Noise monitoring was undertaken on 10 December 2019 during geotechnical investigation near Brisbane Girls Grammar School.

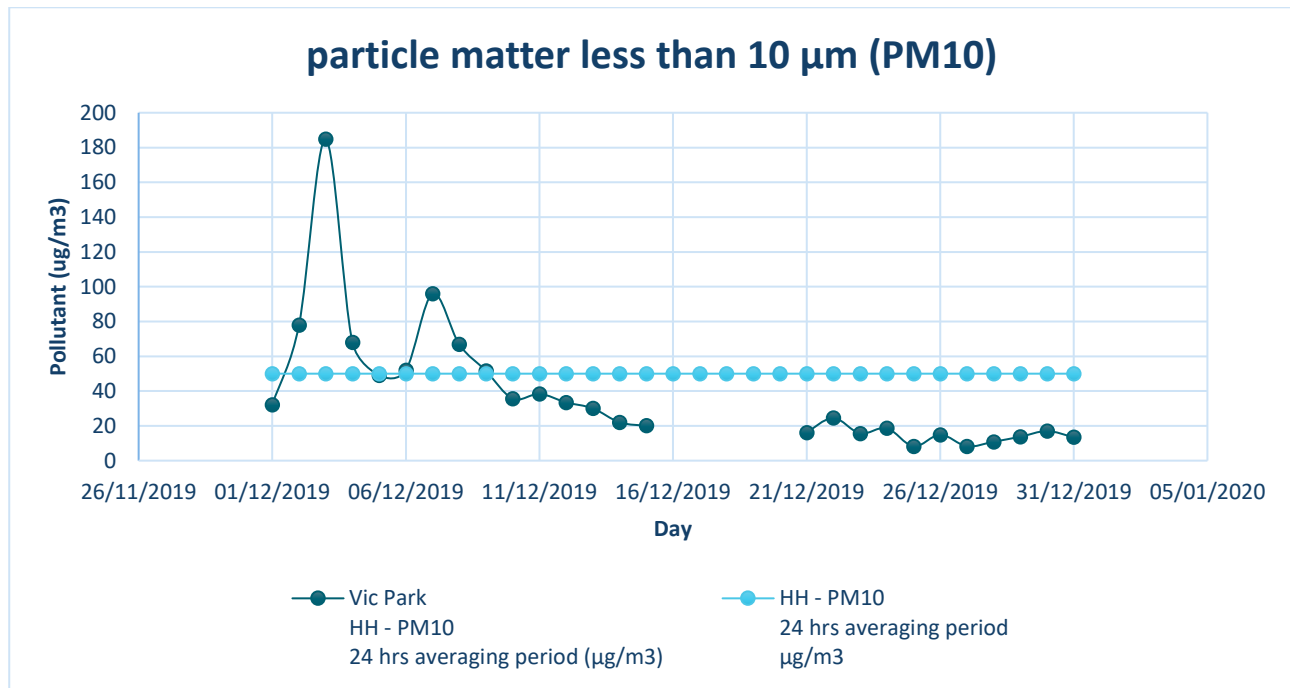
Figure 1: Transurban QLD Legacy Way (Spring Hill) - PM10 graph for December 2019 (reproduction from the online data accessed 16 December 2019 and 20 January 2020)

PM₁₀ is one of the indicator for with the Coordinator General has imposed a goal of 50 µg/m³ (over an averaging period of 24 hours) the project must aim to achieve under Condition 13(a) of the CGCR.

At the time this report is being written, validated air quality data for the month of December for the Legacy Way tunnel is not available.

The below graph has been prepared using available online data from the Legacy Way website. The data used on this webpage is collected by third parties using equipment which is not controlled by Transurban Queensland and as such may be subject to faults or errors by third parties, external weather or environmental events, or server access issues. (<https://brisbanenetwork.linkt.com.au/sustainability/legacy-way-air-quality-information/?type=external&date=2019-12-21#graphs>).

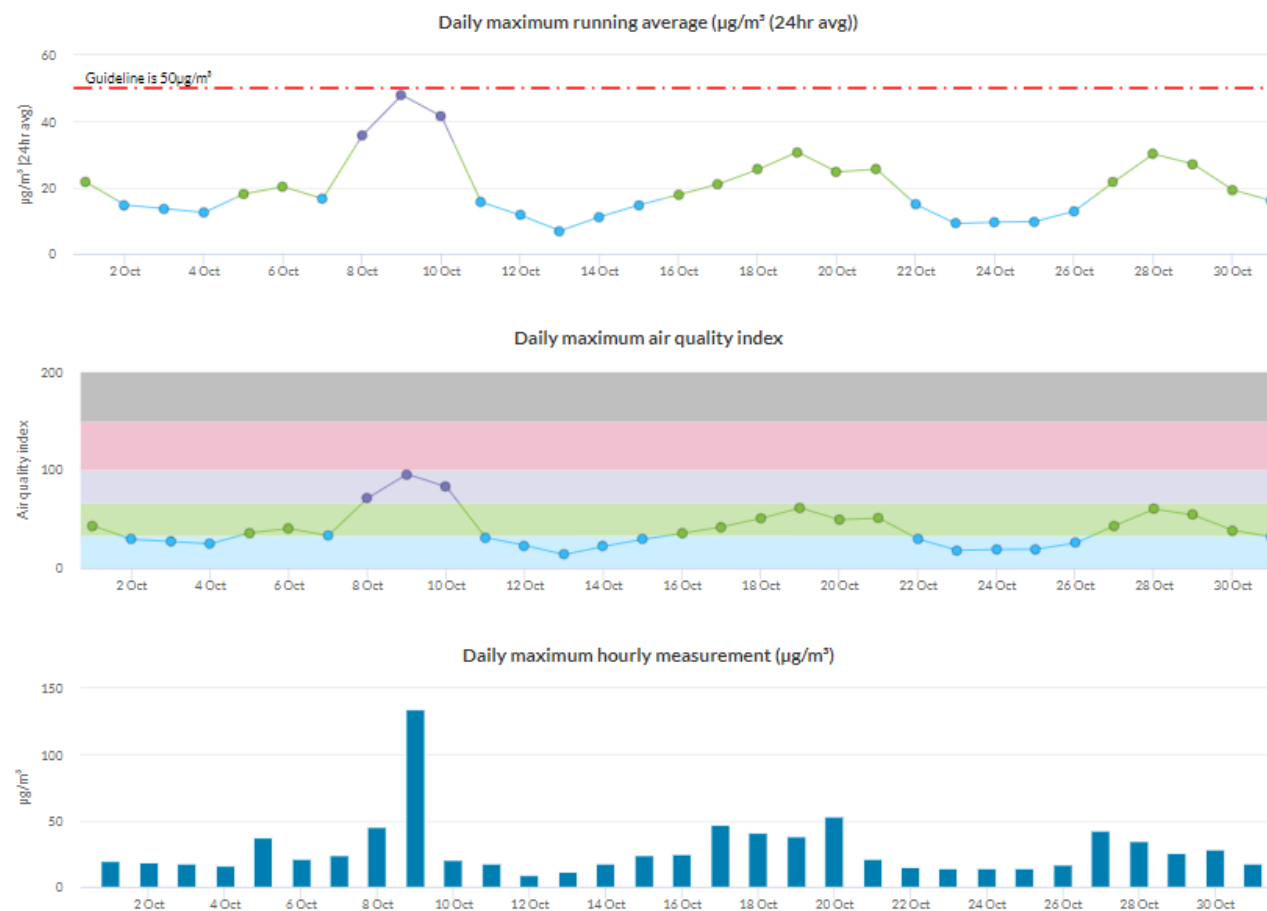
The guideline for Particle PM₁₀ is 50 µg/m³ (24hr avg).

Figure 1: Brisbane CBD – DES Station - PM₁₀ graph for October 2019 (reproduction from the DES website accessed January 2020)

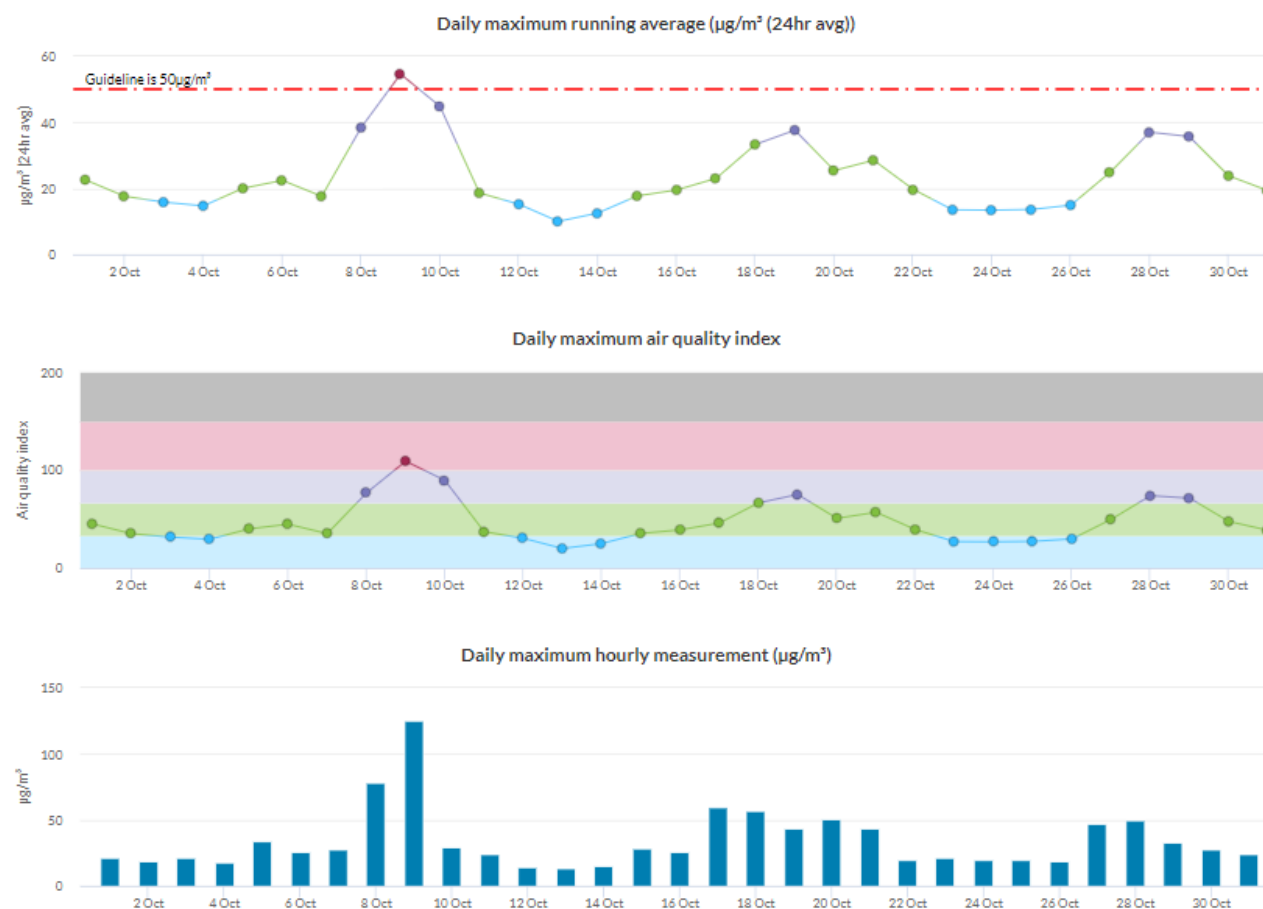
The guideline for Particle PM₁₀ is 50 µg/m³ (24hr avg).

Figure 2: South Brisbane – DES Station - PM₁₀ graph for October 2019 (reproduction from the DES website accessed January 2020)

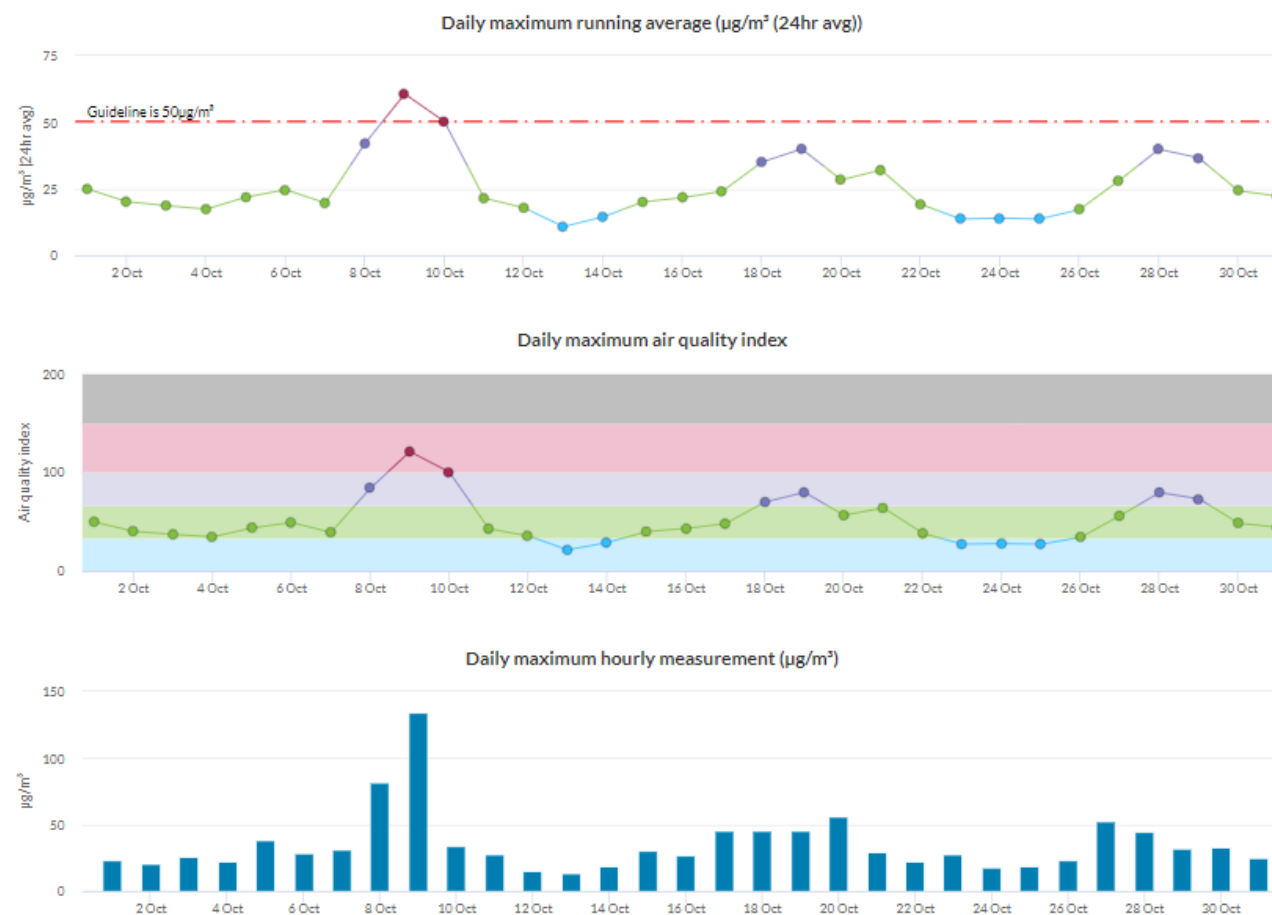
The guideline for Particle PM₁₀ is 50 µg/m³ (24hr avg).

Figure 3: Woolloongabba – DES Station - PM₁₀ graph for October 2019 (reproduction from the DES website accessed January 2020)

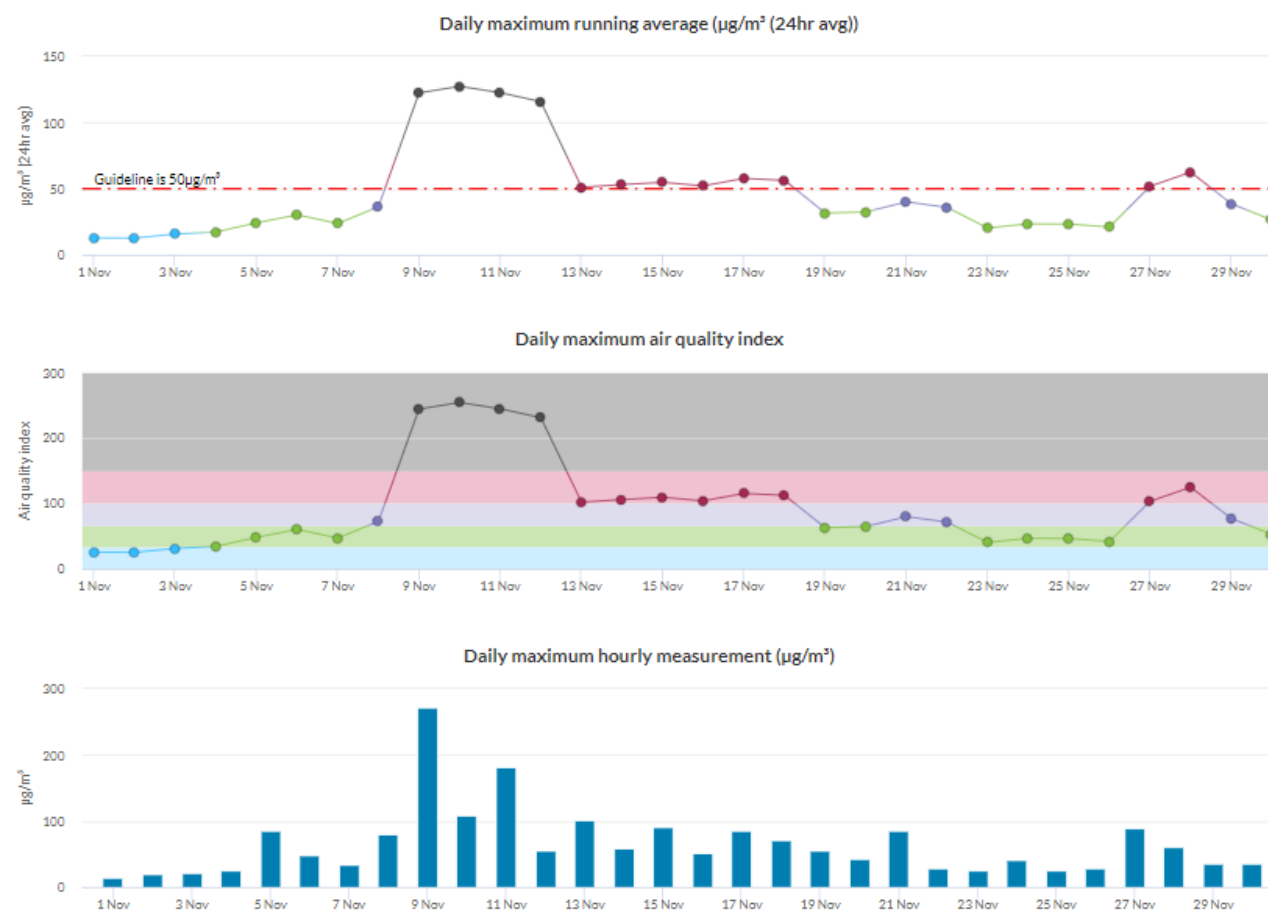
The guideline for Particle PM₁₀ is 50µg/m³ (24hr avg).

Figure 4: Brisbane CBD – DES Station - PM₁₀ graph for November 2019 (reproduction from the DES website accessed January 2020)

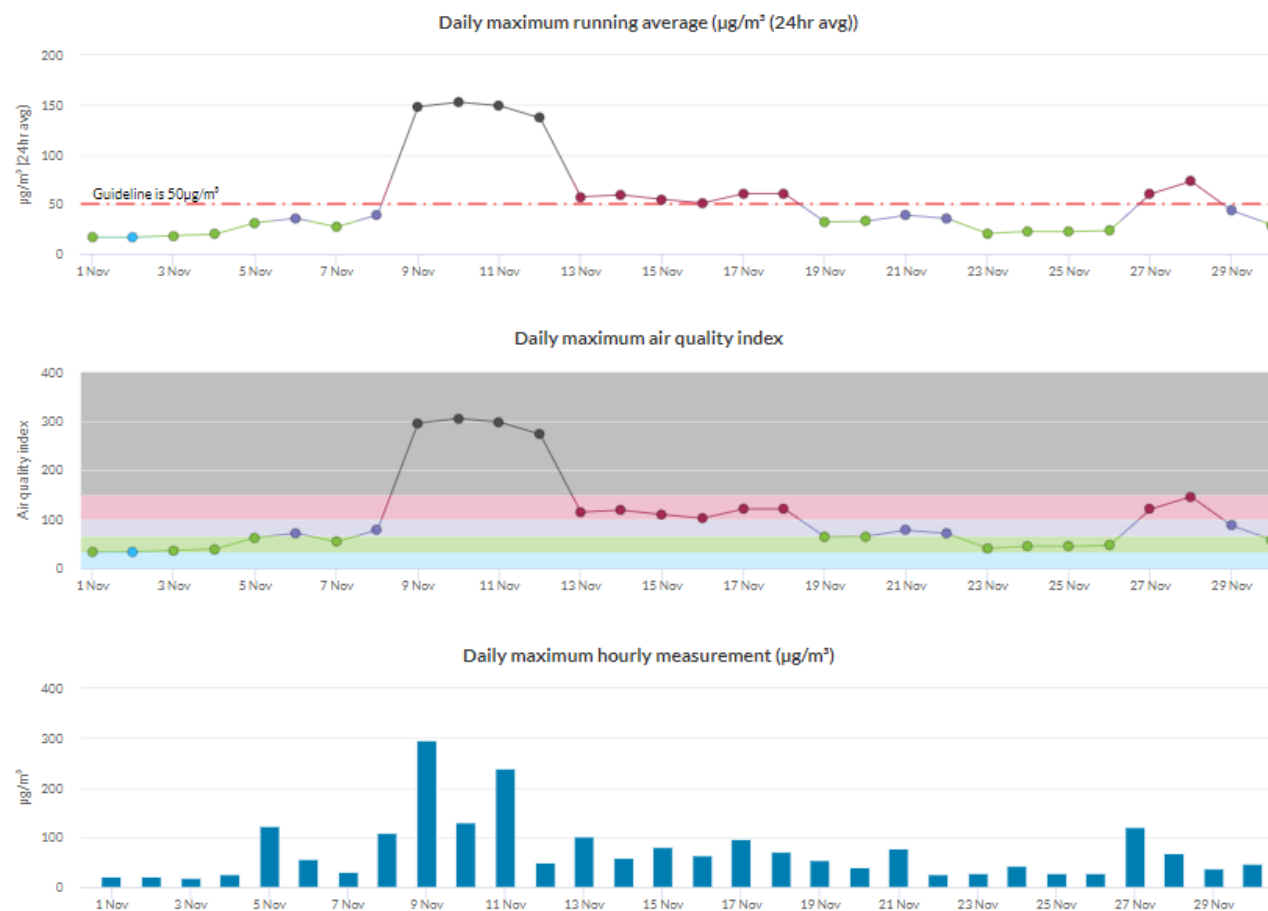
The guideline for Particle PM₁₀ is 50µg/m³ (24hr avg).

Figure 5: South Brisbane – DES Station - PM10 graph for November 2019 (reproduction from the DES website accessed January 2020)

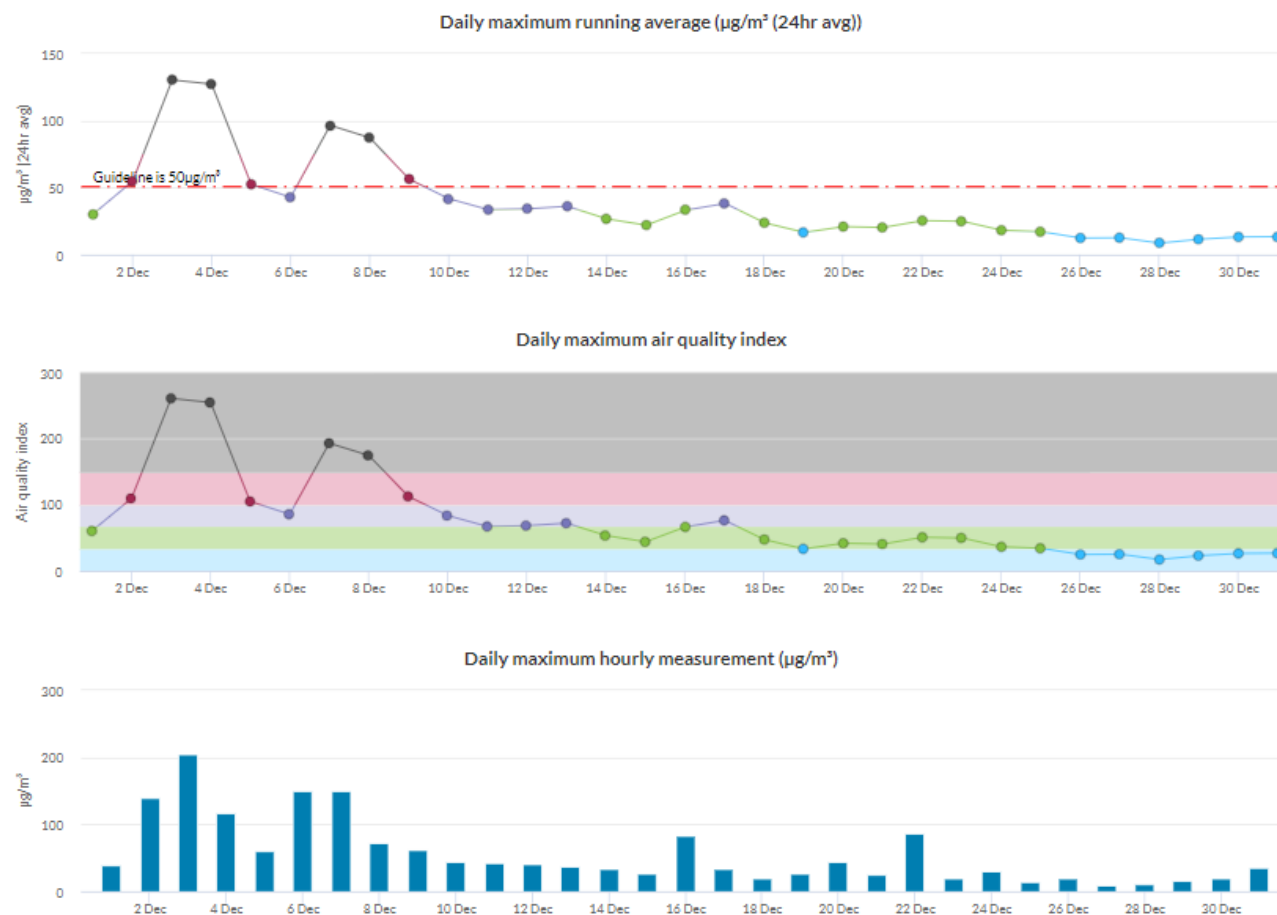
The guideline for Particle PM₁₀ is 50µg/m³ (24hr avg).

Figure 7: Brisbane CBD – DES Station - PM₁₀ graph for December 2019 (reproduction from the DES website accessed January 2020)

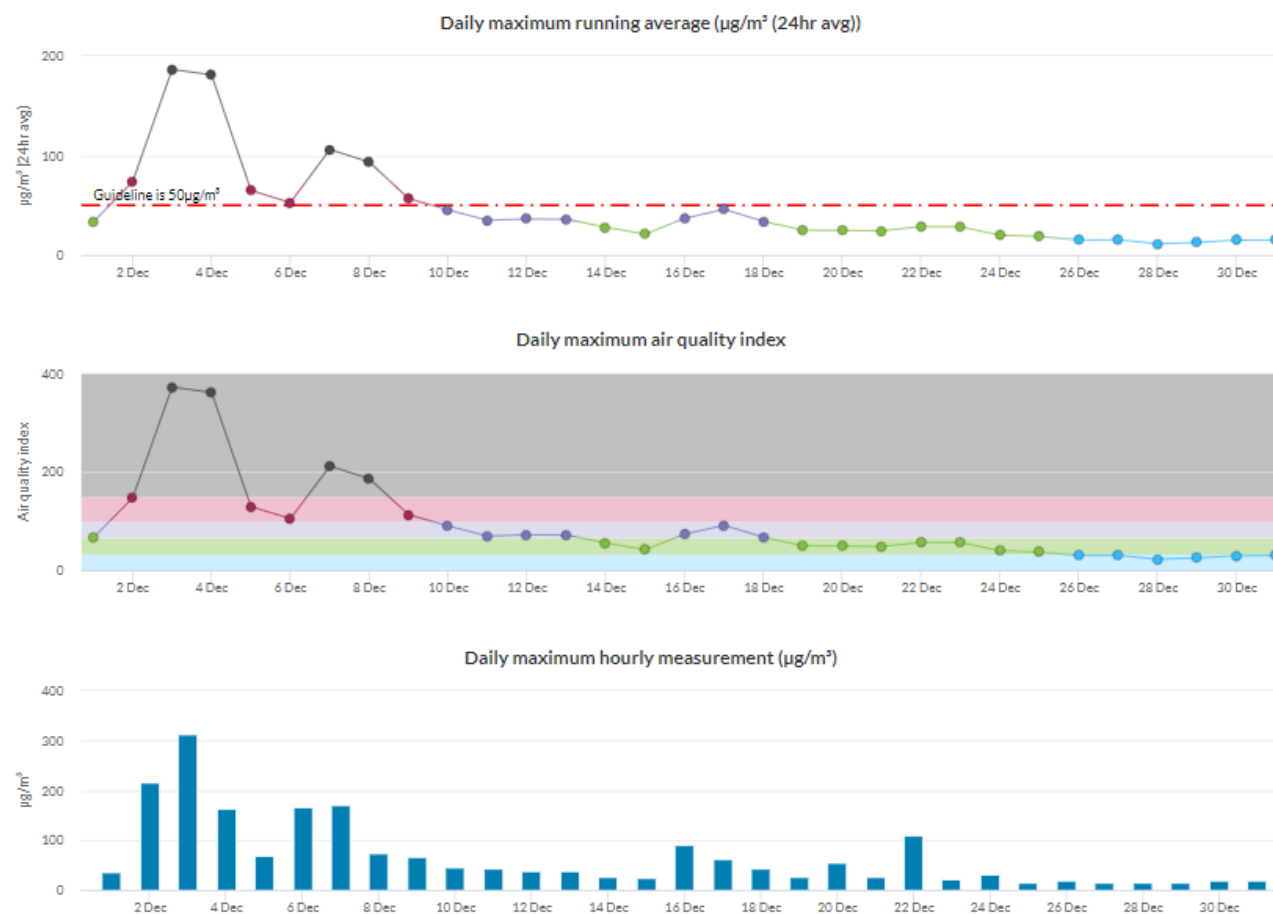
The guideline for Particle PM₁₀ is 50µg/m³ (24hr avg).

Figure 8: South Brisbane – DES Station - PM₁₀ graph for December 2019 (reproduction from the DES website accessed January 2020)

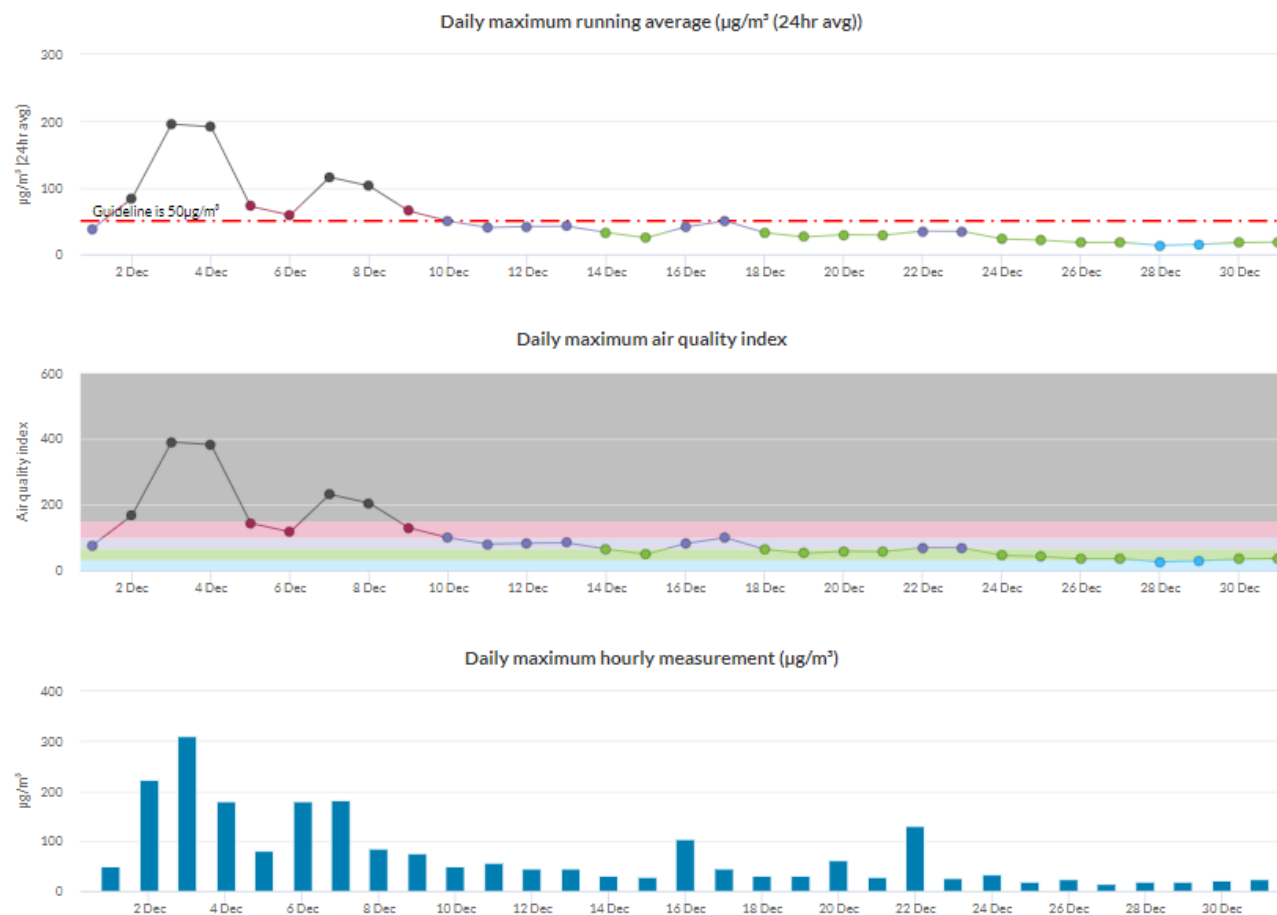
The guideline for Particle PM₁₀ is 50µg/m³ (24hr avg).

Figure 9: Woolloongabba – DES Station - PM10 graph for December 2019 (reproduction from the DES website accessed January 2020)
