# Cross River Rail Project

## Monthly Environmental Report

December 2020

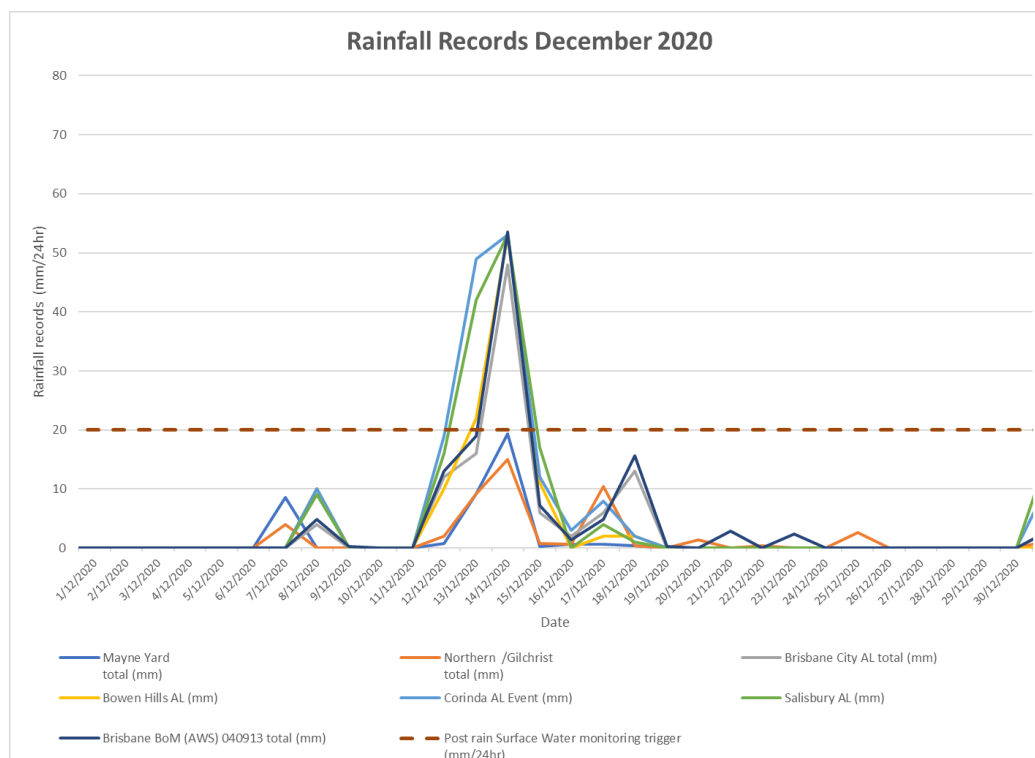
Figure 4: Rainfall – December 2020 Results

Post rainfall monitoring is triggered typically following any rainfall event exceeding 20 to 25 mm over 24 hours, however storm events during the high-risk period of the year (November to March) of lesser amounts but higher intensity may cause run-off which would also trigger post rain monitoring consistent with the C-EMP.
