# Cross River Rail Project

## Monthly Environmental Report

December 2022

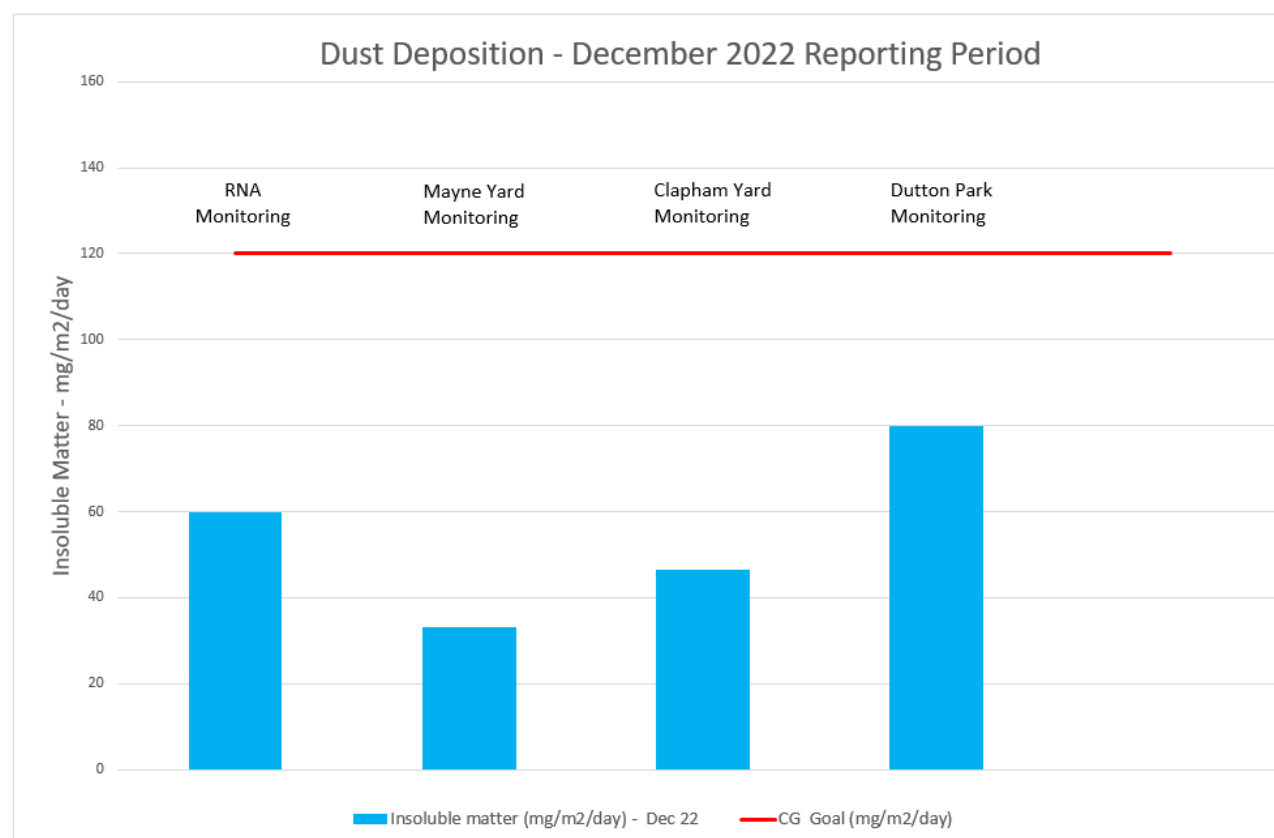
Figure 1 Air Quality Monitoring (Deposited Dust) Results

Table 7 Dust deposition gauge results for the reporting period

At the Southern Portal worksite, the Southern dust deposition gauge was damaged during sampling and no valid data was recorded. The gauge was fixed for the following reporting period. Dust deposition results are detailed in **Appendix A** (Table 7 and Figure 1) and **Appendix B** (Table 4.2).

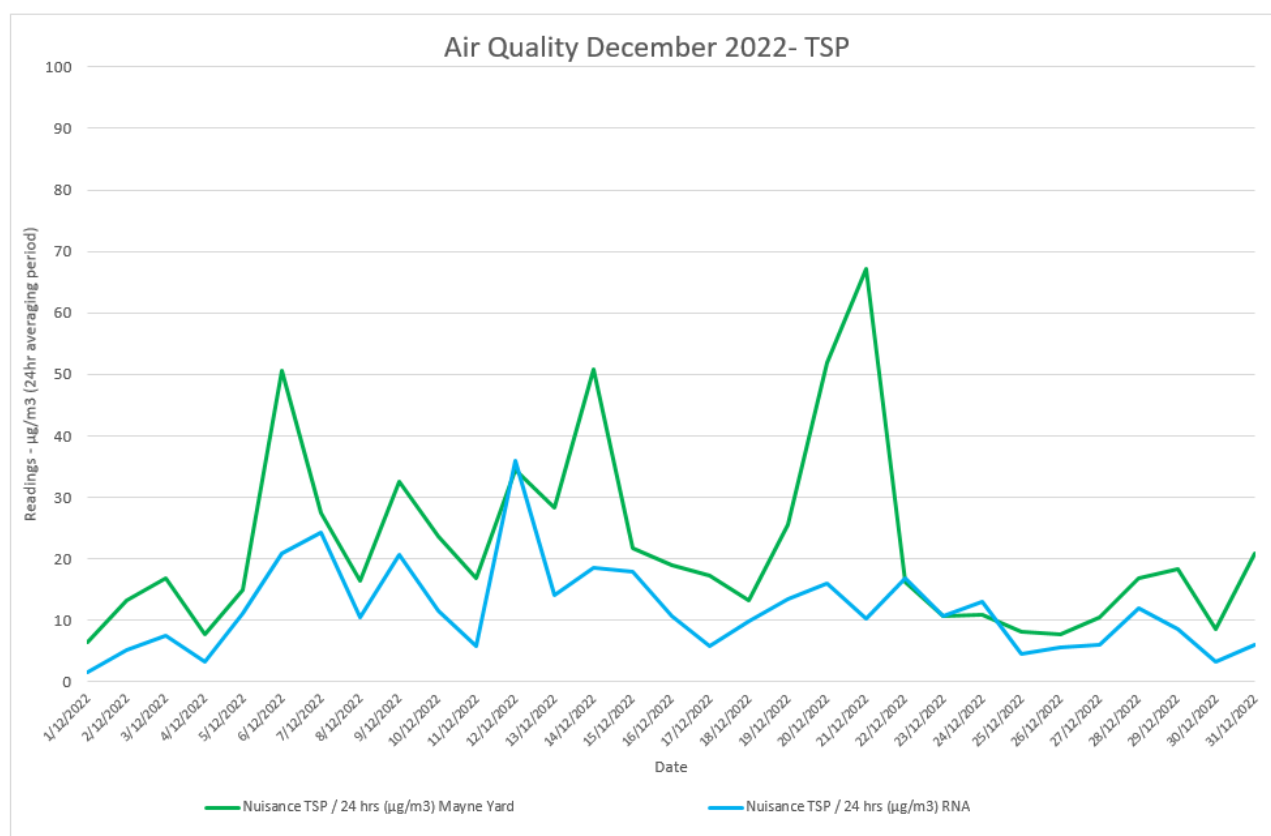
Figure 2 Air Quality Monitoring (TSP) Results

The Clapham Yard DMP experienced data recording failure from 7 December 2022 onwards. As a result, there is no data for this period for Clapham Yard during the reporting period.

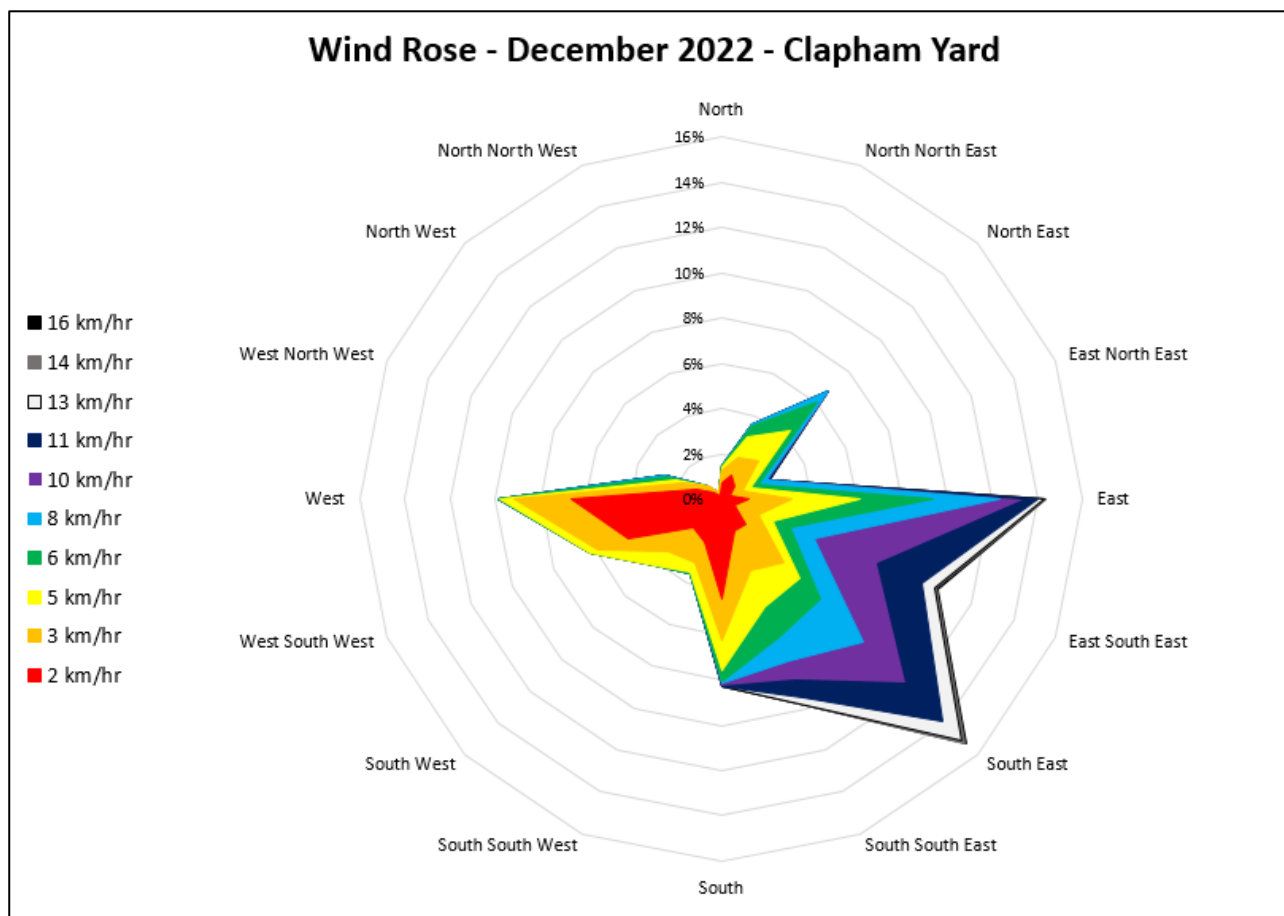
Figure 4 Clapham Yard December 2022 Wind Rose

As shown on the wind rose below (refer Figure 4), the predominant winds were south-easterly. Meaning any potential dust generated from UNITY works would have travelled west away from the sensitive residential receivers located on Ipswich Road.

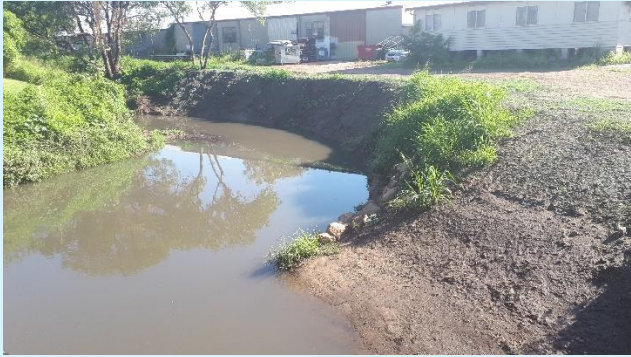
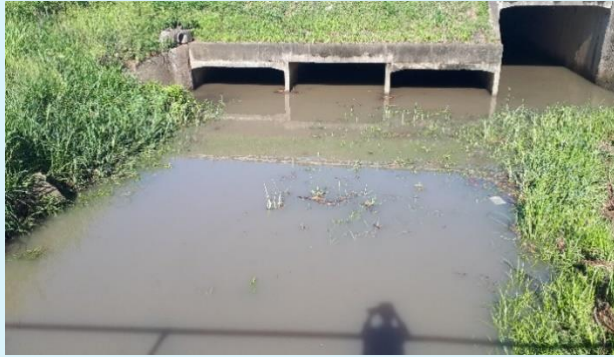
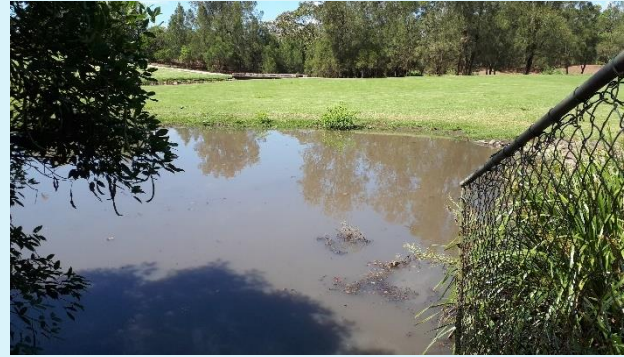
There is evidence that vegetation clearing completed by Brisbane City Council (BCC) and a private landowner adjacent to Moolabin Creek, have significantly contributed to the increased sedimentation within the waterway.

BCC clearing was observed on 24 October 2022 during post rainfall monitoring (refer to Figure 5). The creek bank has not re-established since the clearing event (refer to Figure 6), and this would have contributed to increased sedimentation upstream of UNITY Works.

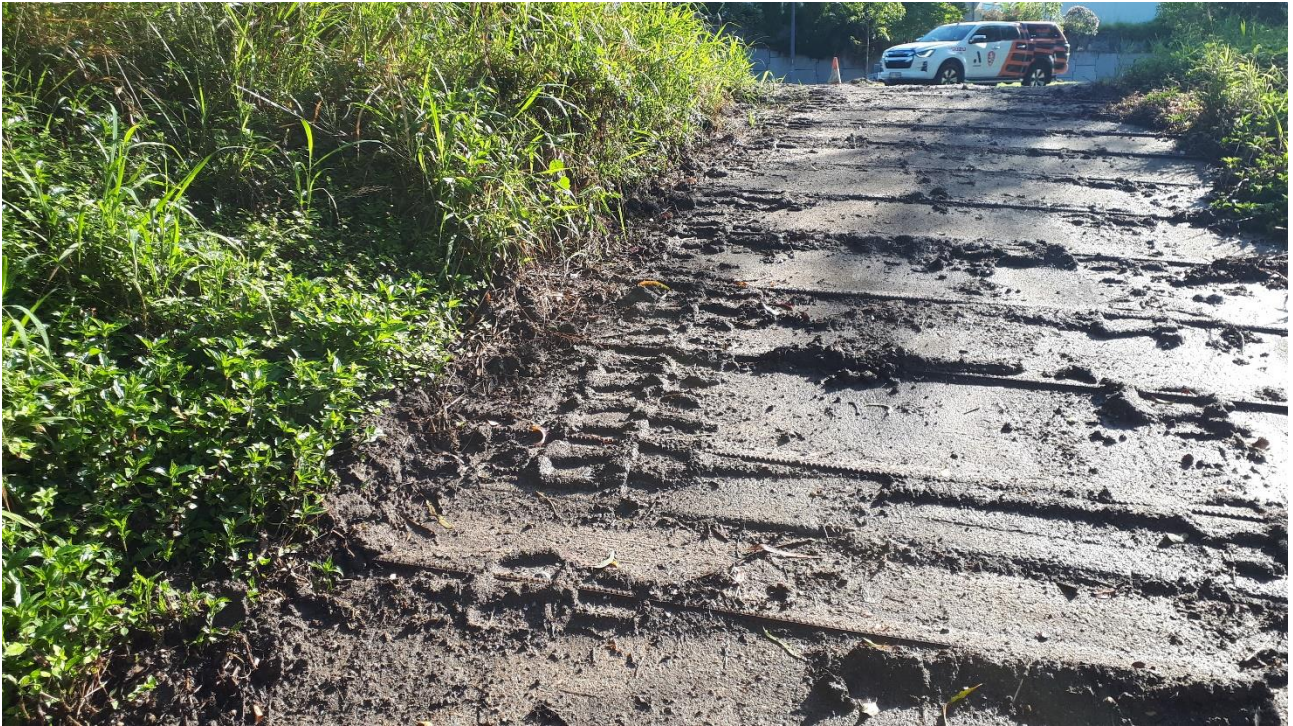
*Figure 8 Excavator Track Mark from Recent BCC Clearing*

This was done in place of quantitative monitoring as there was evidence Brisbane City Council had recently undertaken vegetation removal within the creek (refer to excavator track mark in Figure 8). Therefore, UNITY would not be able to determine if our worksites had solely attributed to any water quality changes within the creek. The inspection at Rocklea Station confirmed no discharges had occurred during or after the rainfall event.

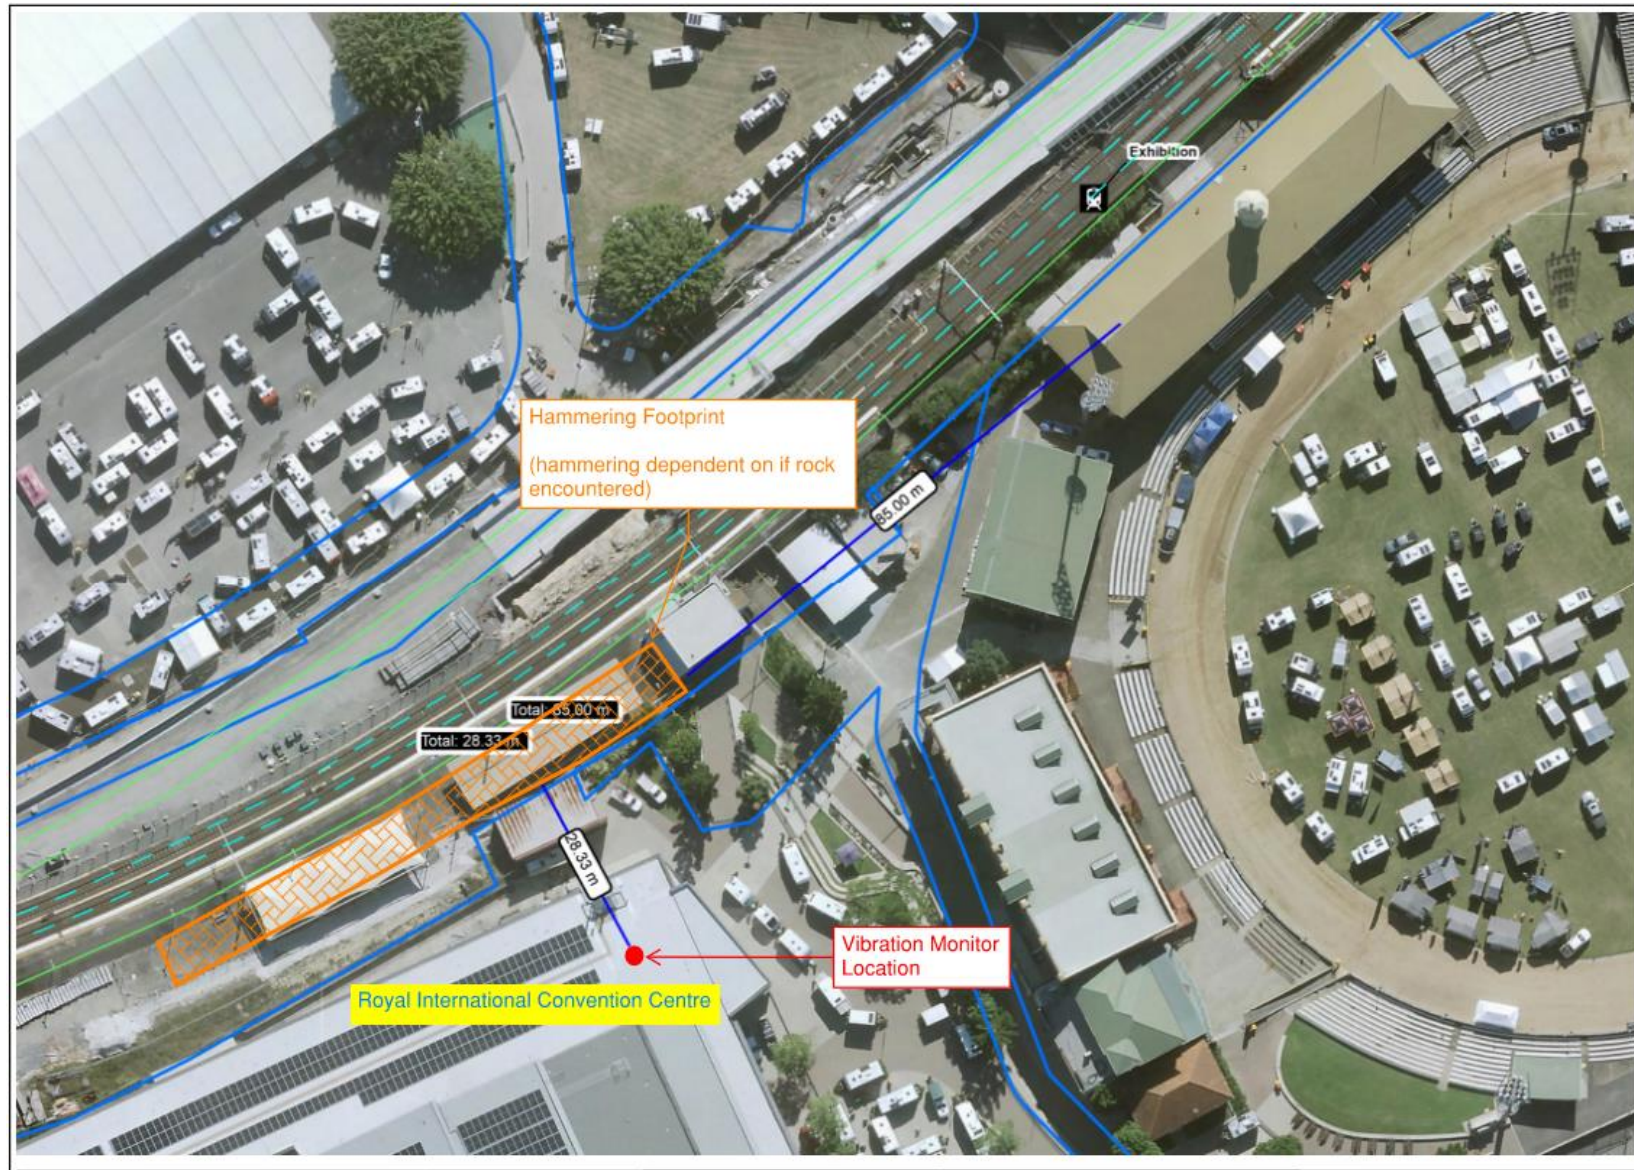
Figure 20 RNA December 2022 Vibration Monitoring

In the Northern Area, vibration monitoring continued at RNA during the use of a 7.5T hydraulic hammer in close proximity to the Royal International Convention Centre. The results were well below the vibration goal and are detailed in **Appendix A** (Table 5).

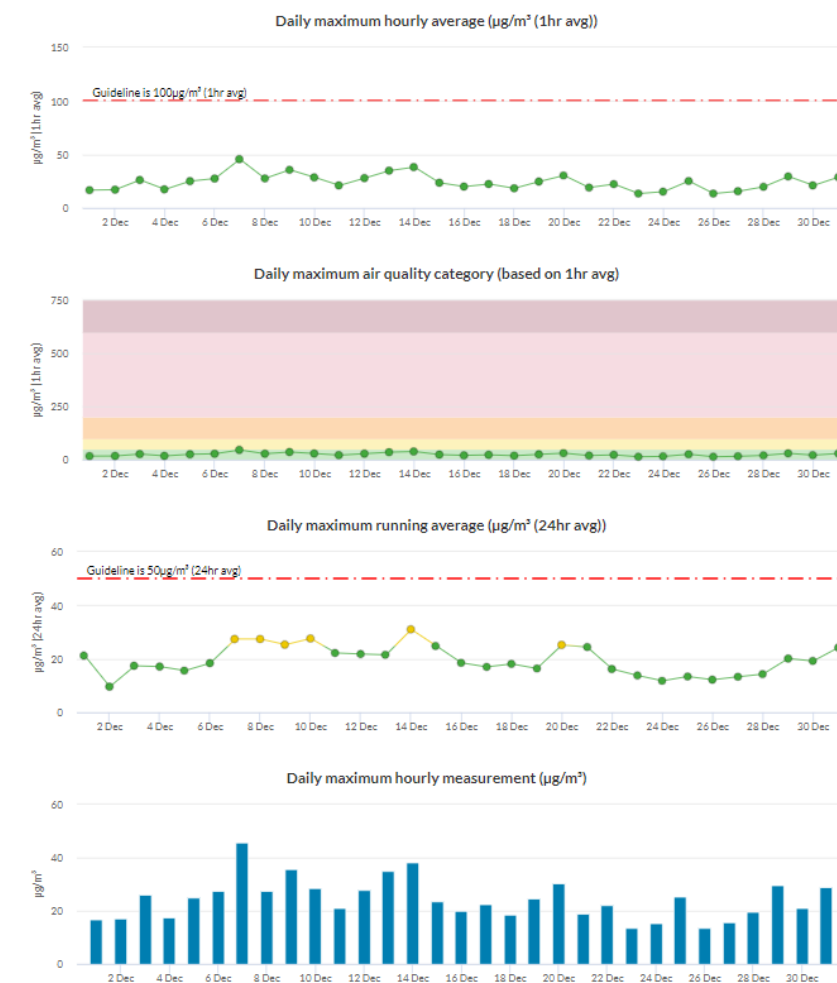
Figure 1: Brisbane CBD – DES Station - PM10 graph for December 2022 (reproduction from the DES website).

The guideline for Particle PM<sub>10</sub> is 100µg/m<sup>3</sup> (1hr avg) and 50µg/m<sup>3</sup> (24hr avg).

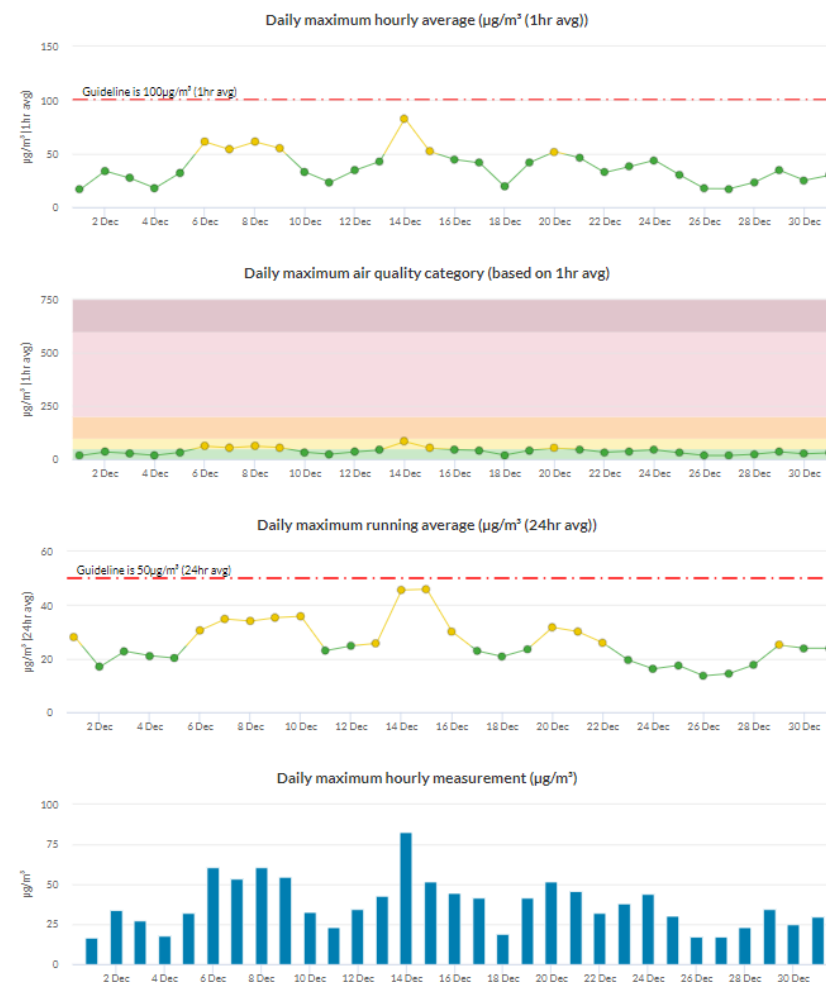
Figure 3: Woolloongabba – DES Station - PM10 graph for December 2022 (reproduction from the DES website).

The guideline for Particle PM<sub>10</sub> is 100µg/m<sup>3</sup> (1hr avg) and 50µg/m<sup>3</sup> (24hr avg).
