Cross River Rail Project

Monthly Environmental Report

July 2020

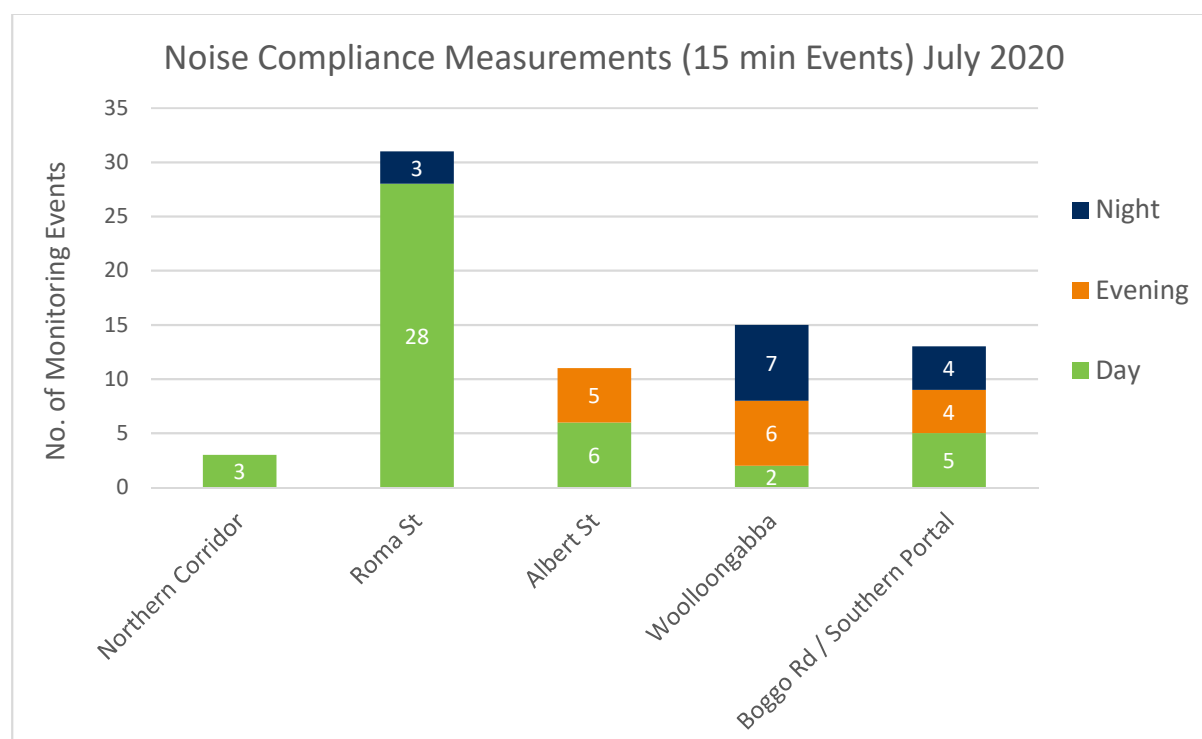
In the Central area, noise monitoring was undertaken on 70 occasions during the month as summarised in the graph below and detailed in **Appendix B**. Where internal monitoring was not possible for the contractors, they have undertaken external monitoring at nominated locations. The contractors noise consultants have then used suitable façade attenuation corrections, considering receiver property type, to determine compliance against the project's noise goals and to provide further calibration of the completed modelled predictions. The contractors have reported that the project noise requirements have been met during this reporting month. A breakdown of the monitoring events across the project by time of day and location is shown below.

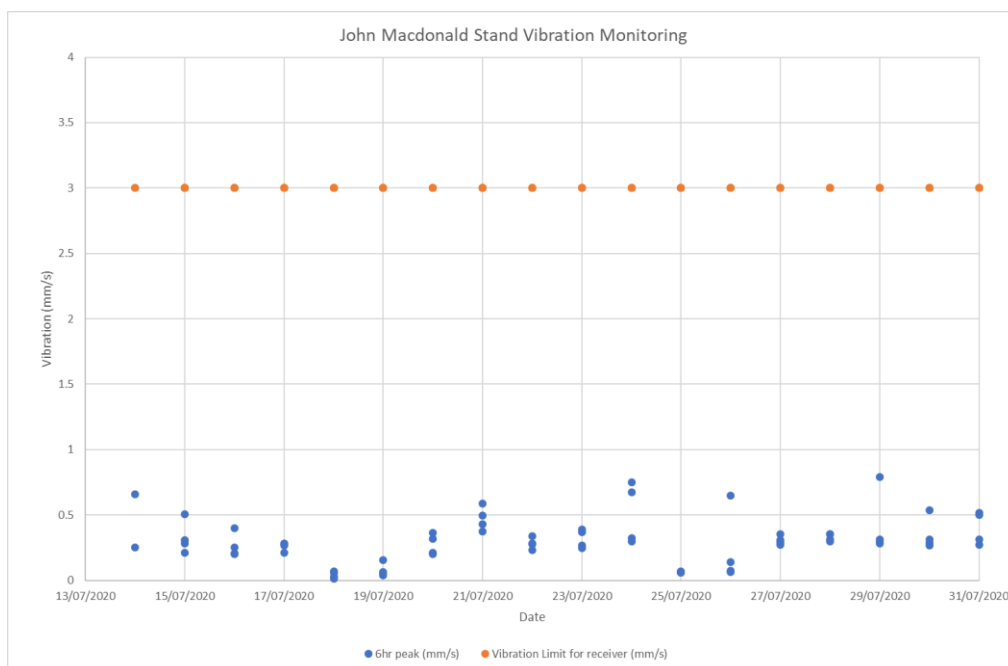
Figure 2: Vibration Monitoring – John MacDonald Stand

Monitoring of both the John MacDonald Stand and RNA members stand was taken as close as possible to the buildings (refer Attachment 3). The measured vibration results were lower than the predicted vibration limits specified in the Property Damage Sub Plan.

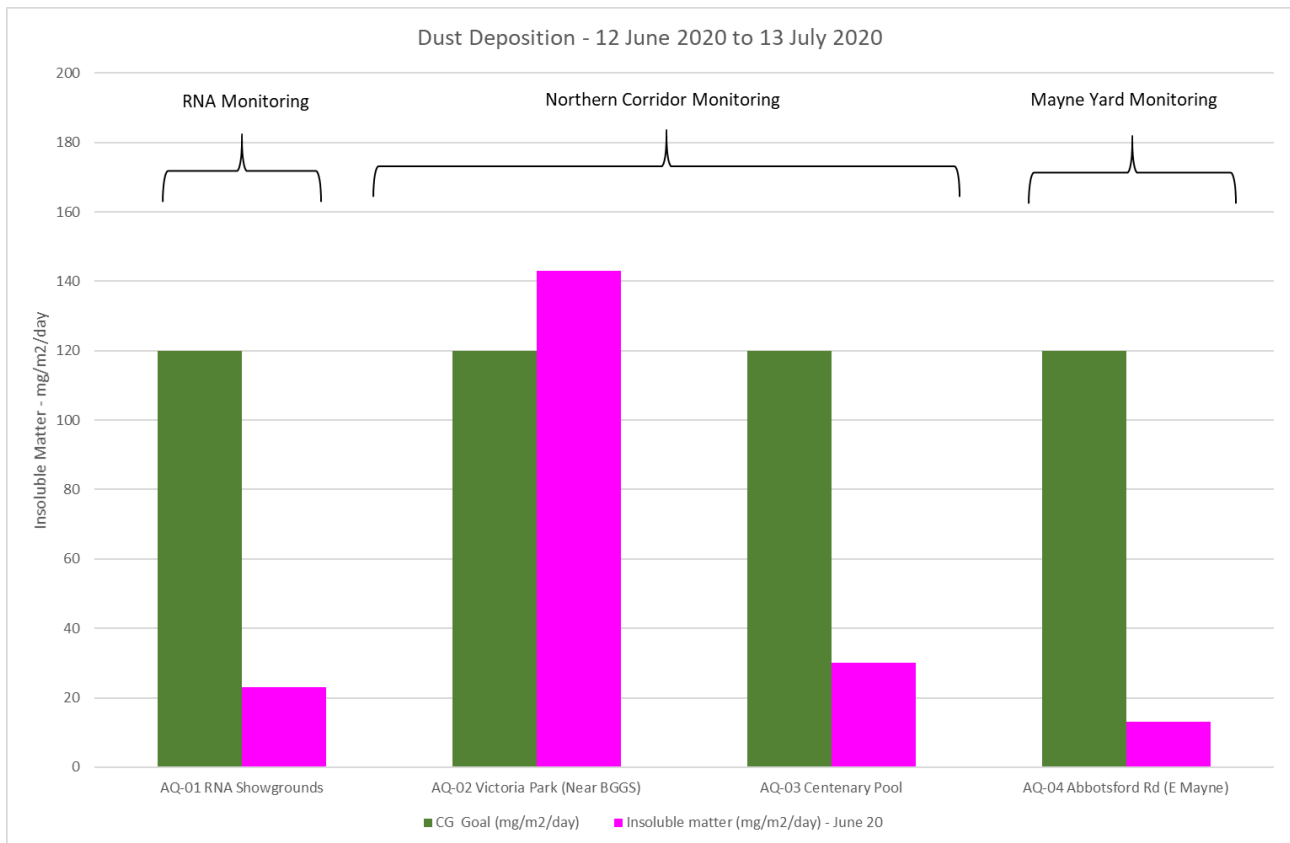
Figure 4: Air Quality Monitoring (Deposited Dust) –12 June – 13 July 2020 Results

The dust deposition gauges result for the reporting period are detailed below and complied with Condition 13(b) of the CGCR.

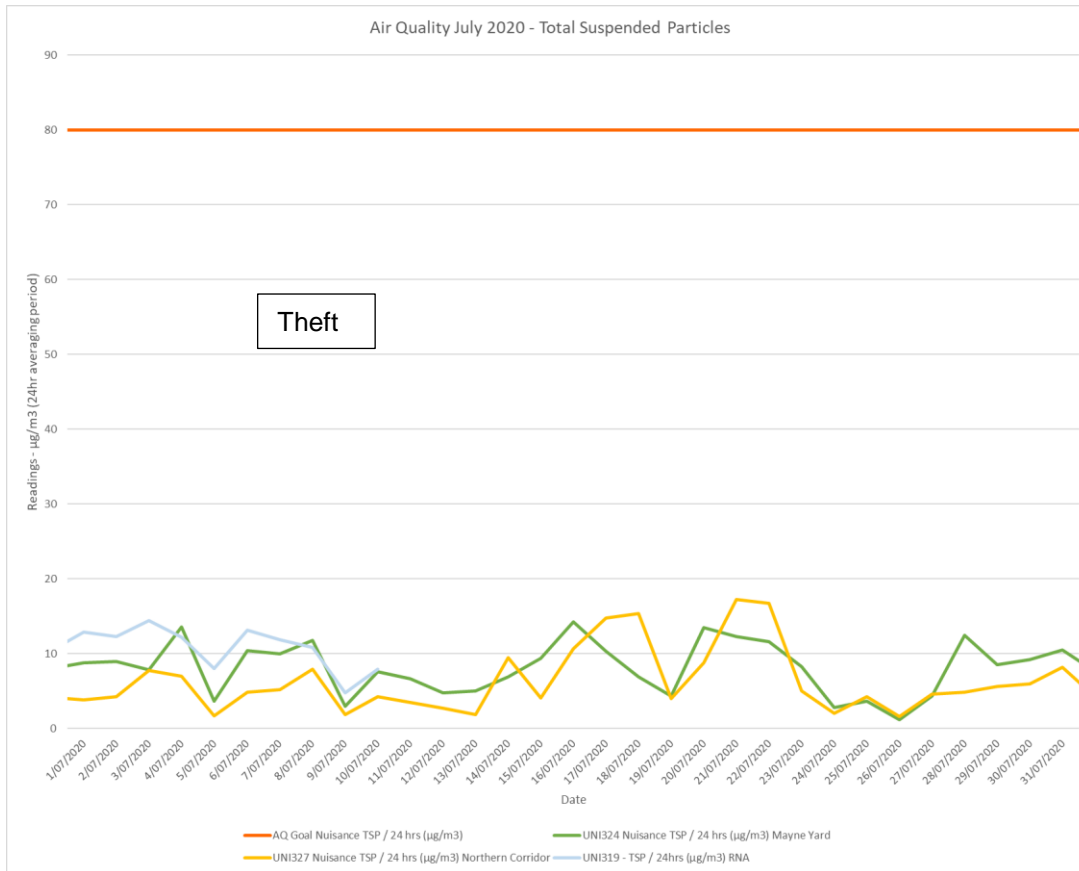
Figure 5: Air Quality Monitoring (TSP) - July 2020 Results

TSP is one of the indicators for which the Coordinator General has imposed a goal of 80 $\mu\text{g}/\text{m}^3$ (over an averaging period of 24 hours) the project must aim to achieve under Imposed Condition 13(a).

These stations have been set up on site as per AS/NZS 3850 1.1 following consultation with UNITY Air Quality Professionals.

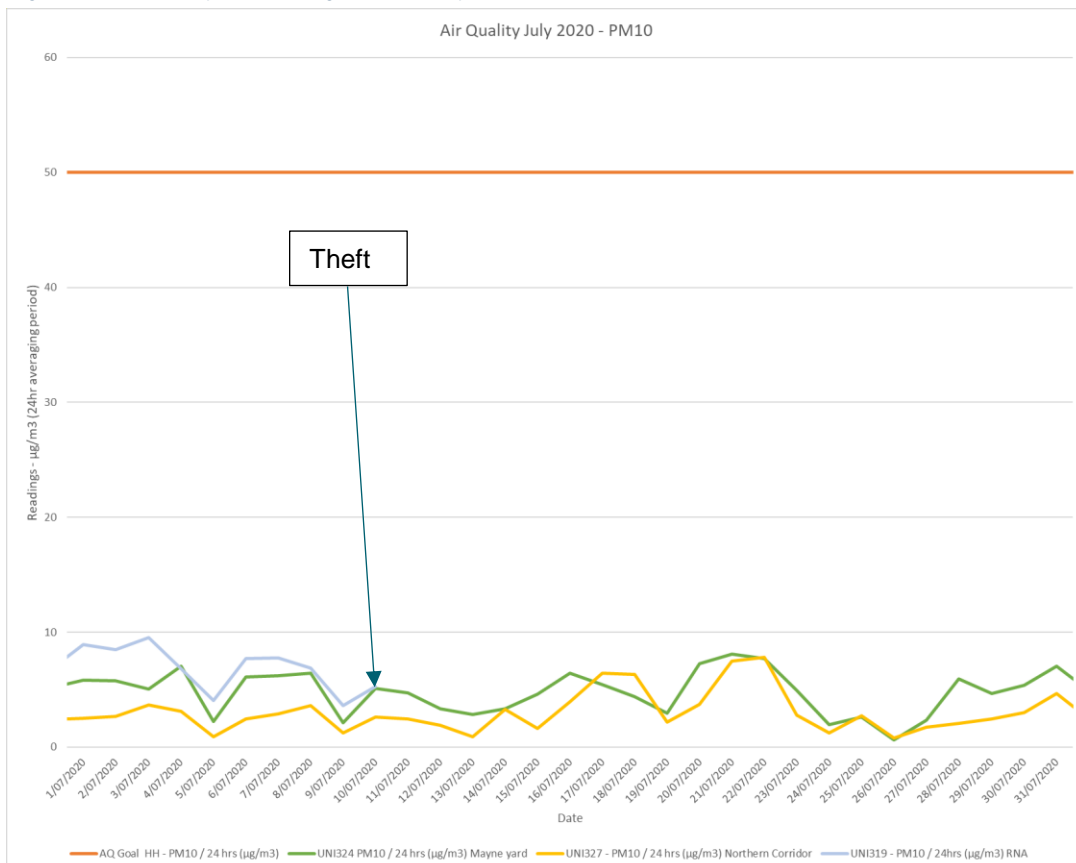
Figure 6: Air Quality Monitoring (PM10) - July 2020 Results

PM₁₀ is one of the indicators for which the Coordinator General has imposed a goal of 50 $\mu\text{g}/\text{m}^3$ (over an averaging period of 24 hours) the project must aim to achieve under Imposed Condition 13(a).

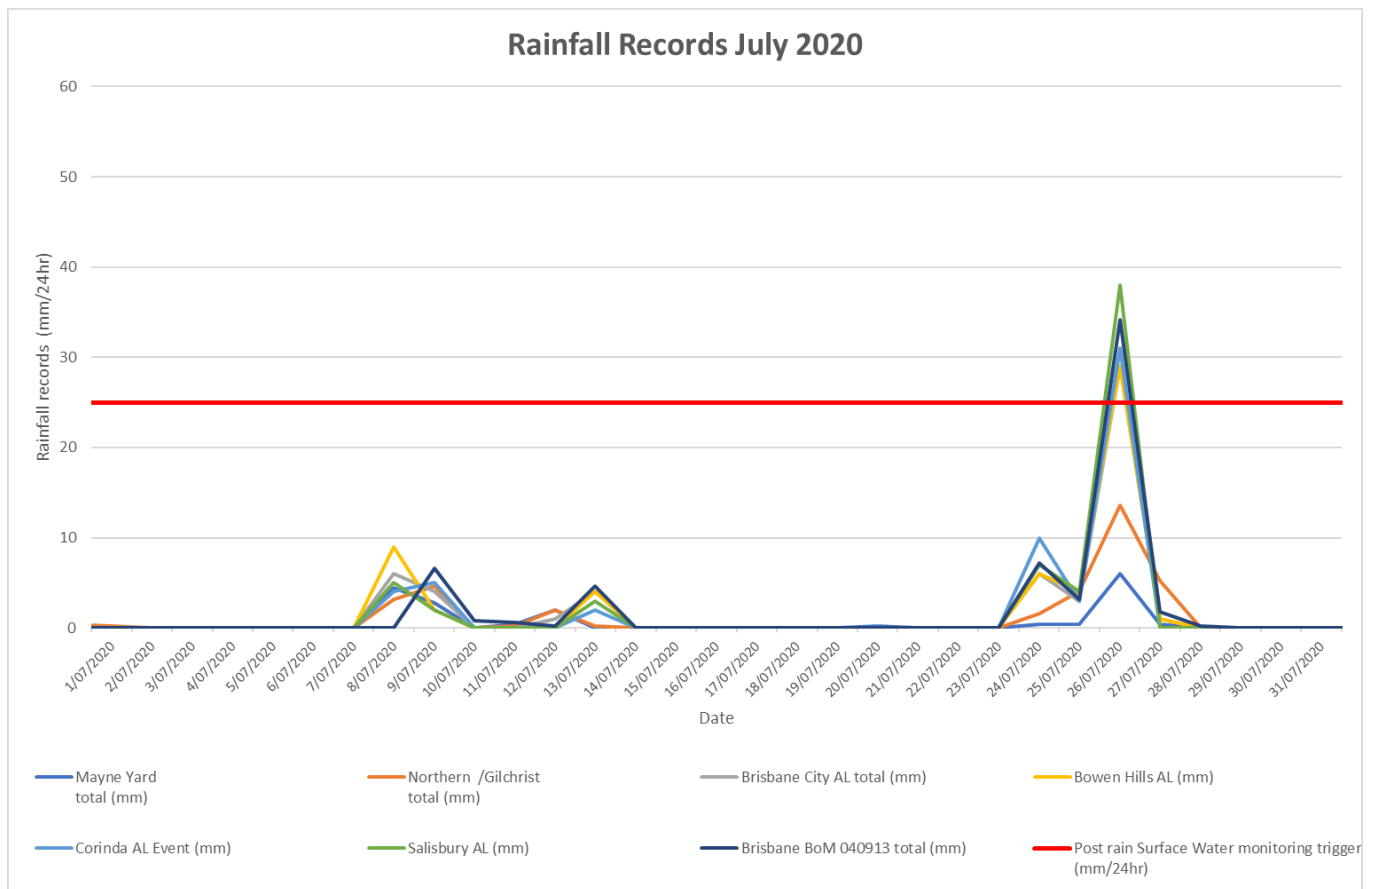
Figure 7: Rainfall - June 2020 Results

Water Quality monitoring to demonstrate compliance with Condition 18 was triggered on the weekend of the 25th-26th July with post-rainfall sampling undertaken on the 27th July.

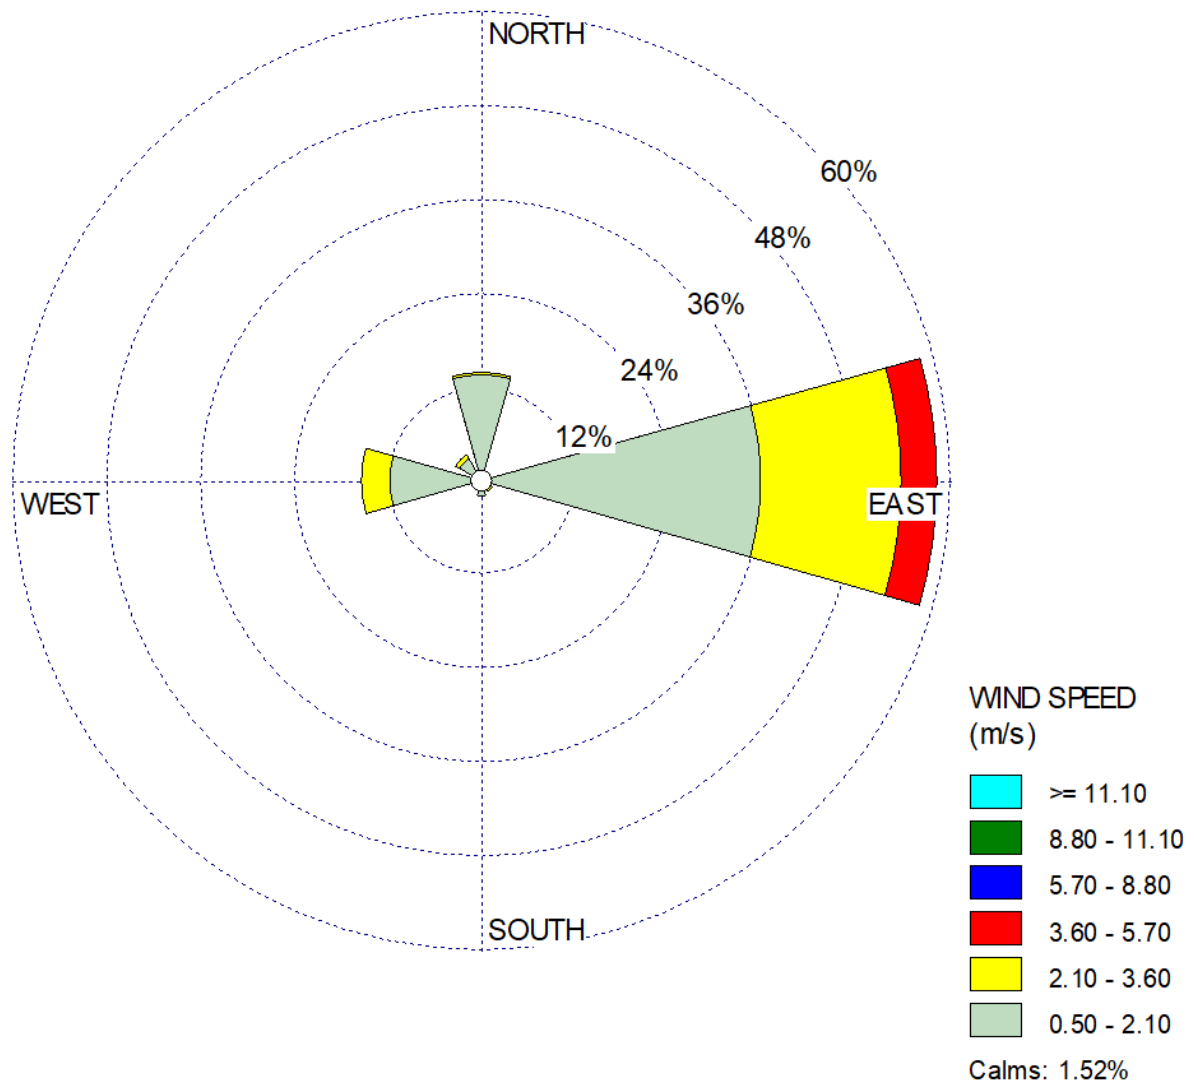
Plate 1: Prevalent Wind Conditions during monitoring period – Construction hours

- The prevalent wind conditions between 12 June and 13 July 2020 are presented in Plate 1 and 2 and summarised in Figure 3.

What can be determined from the measured results and the supporting data is that it is very likely Unity Works would not have caused the exceedance alone.

It is very likely that there are other dust sources in the area that contributed enough dust to AQ-02 to cause to the exceedance.

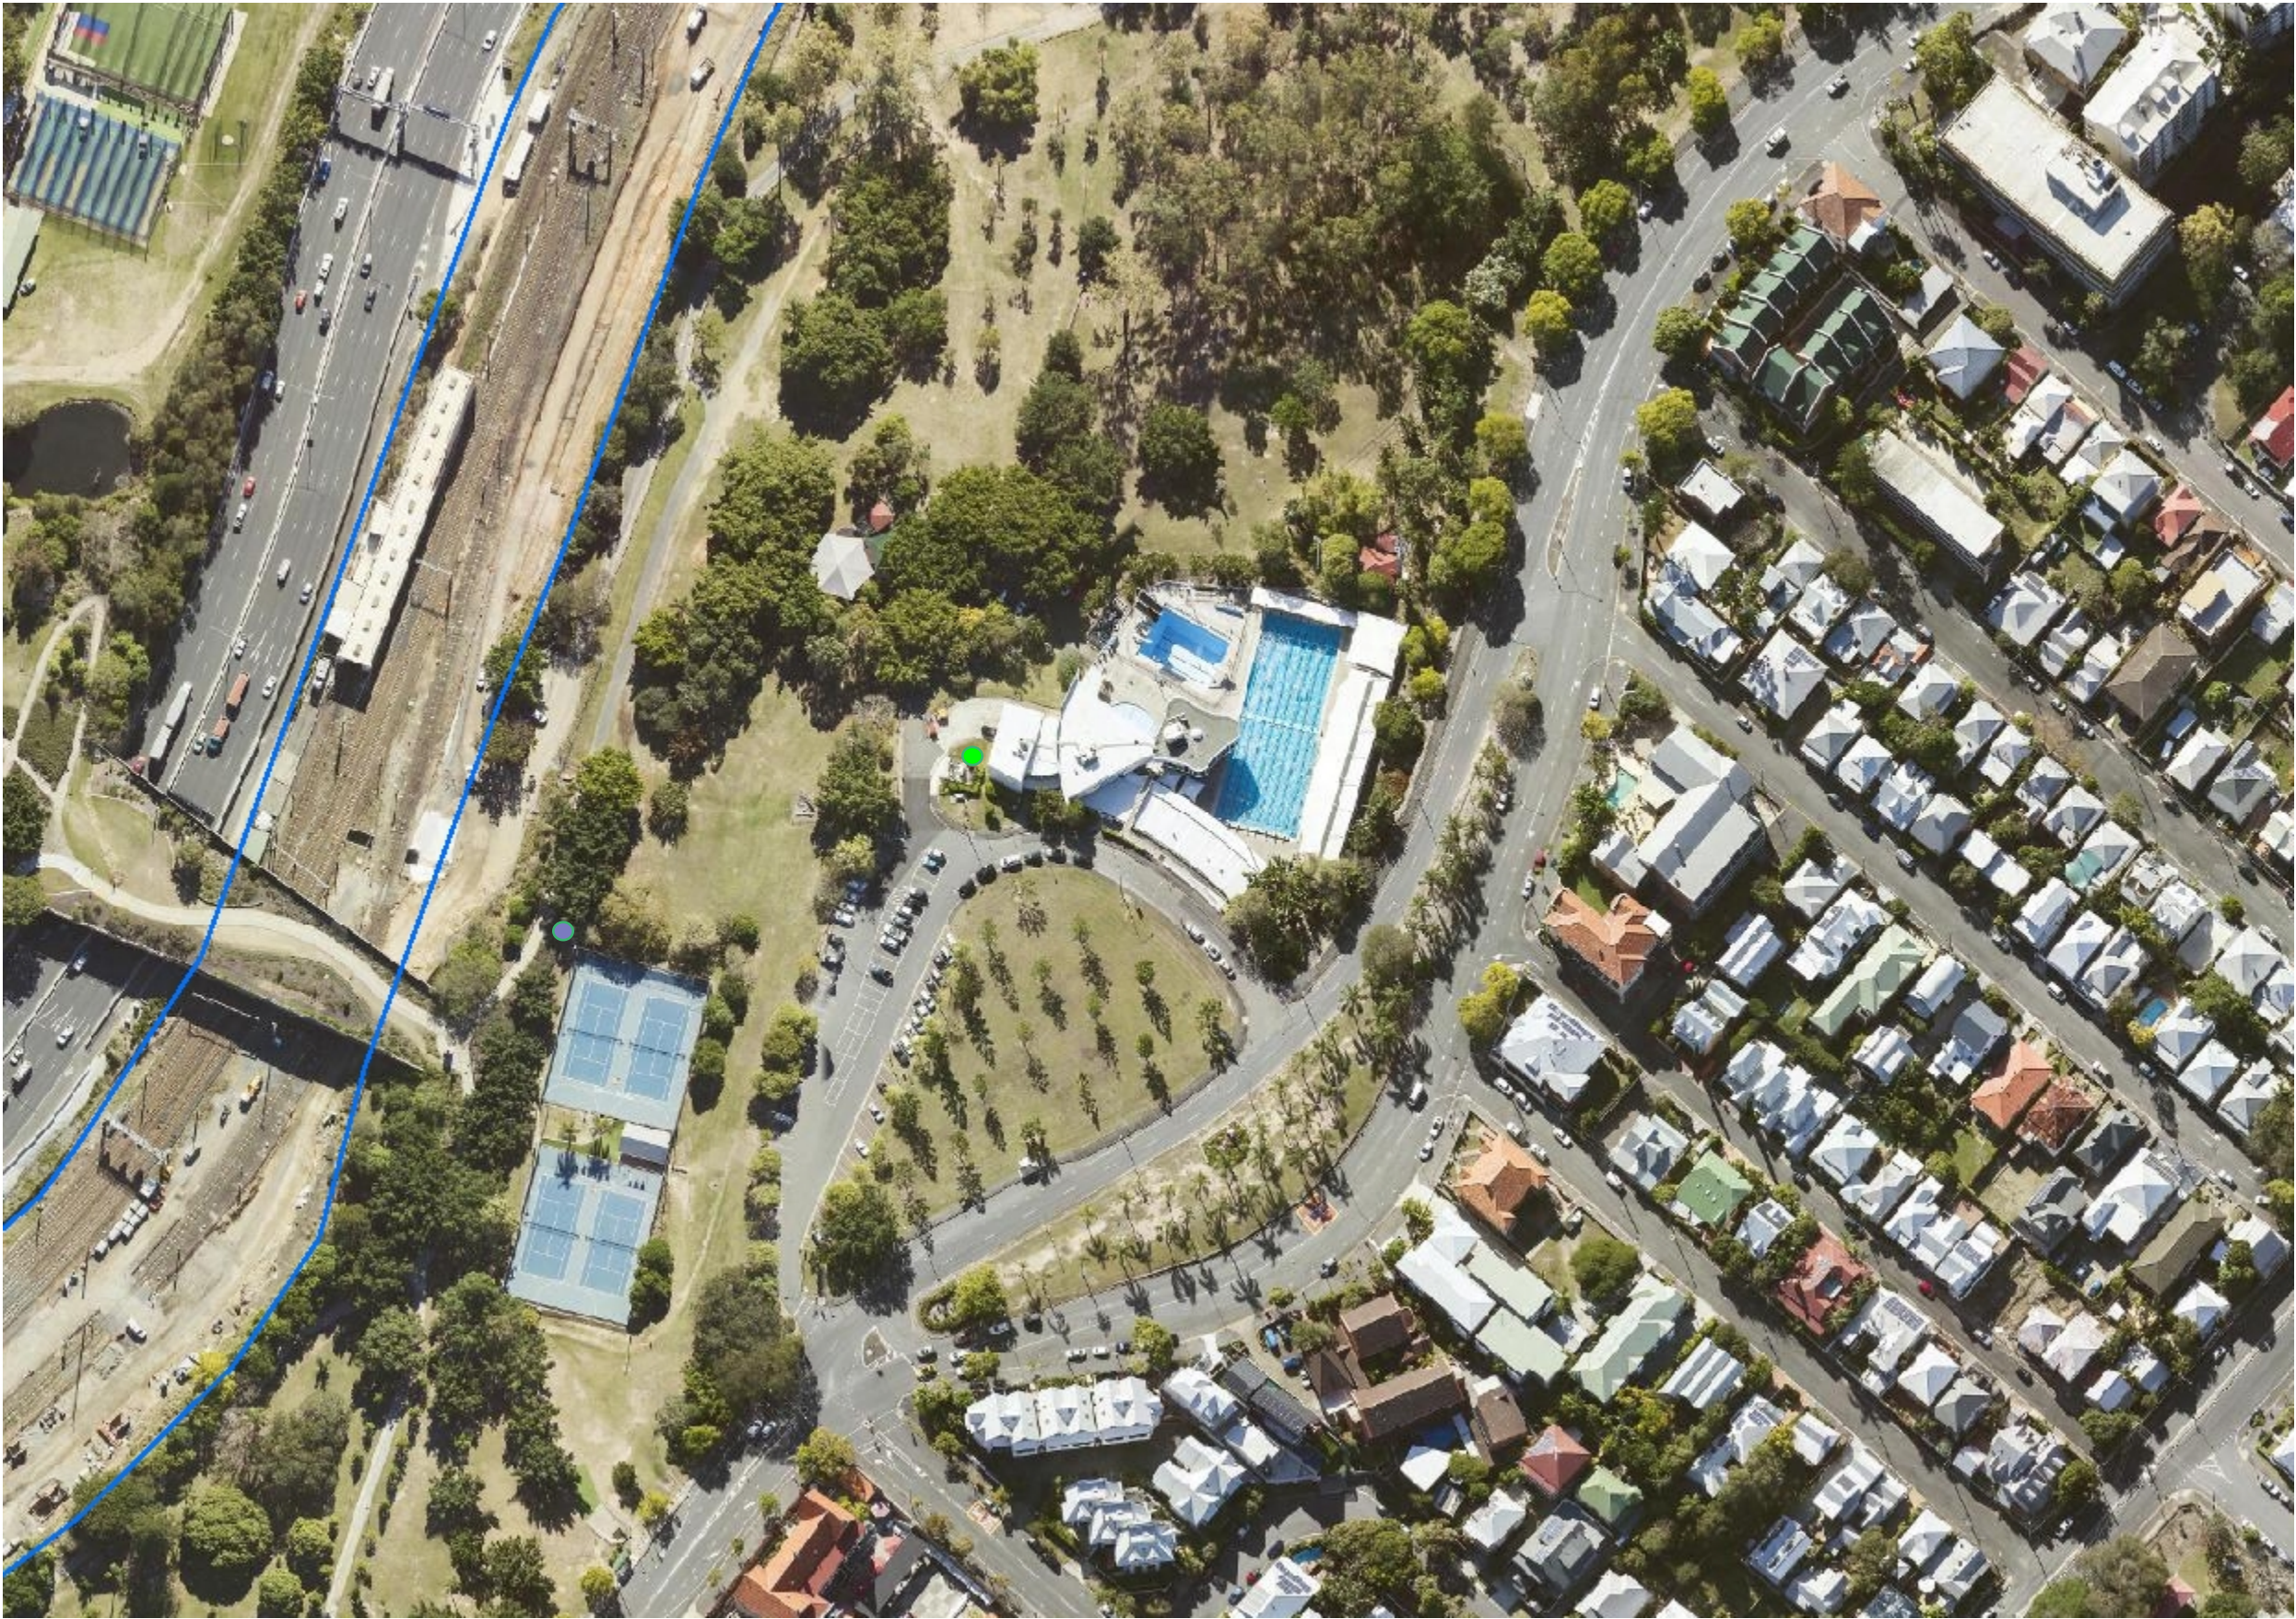
Attachment 2 Monitoring Locations – Noise

Noise Monitoring

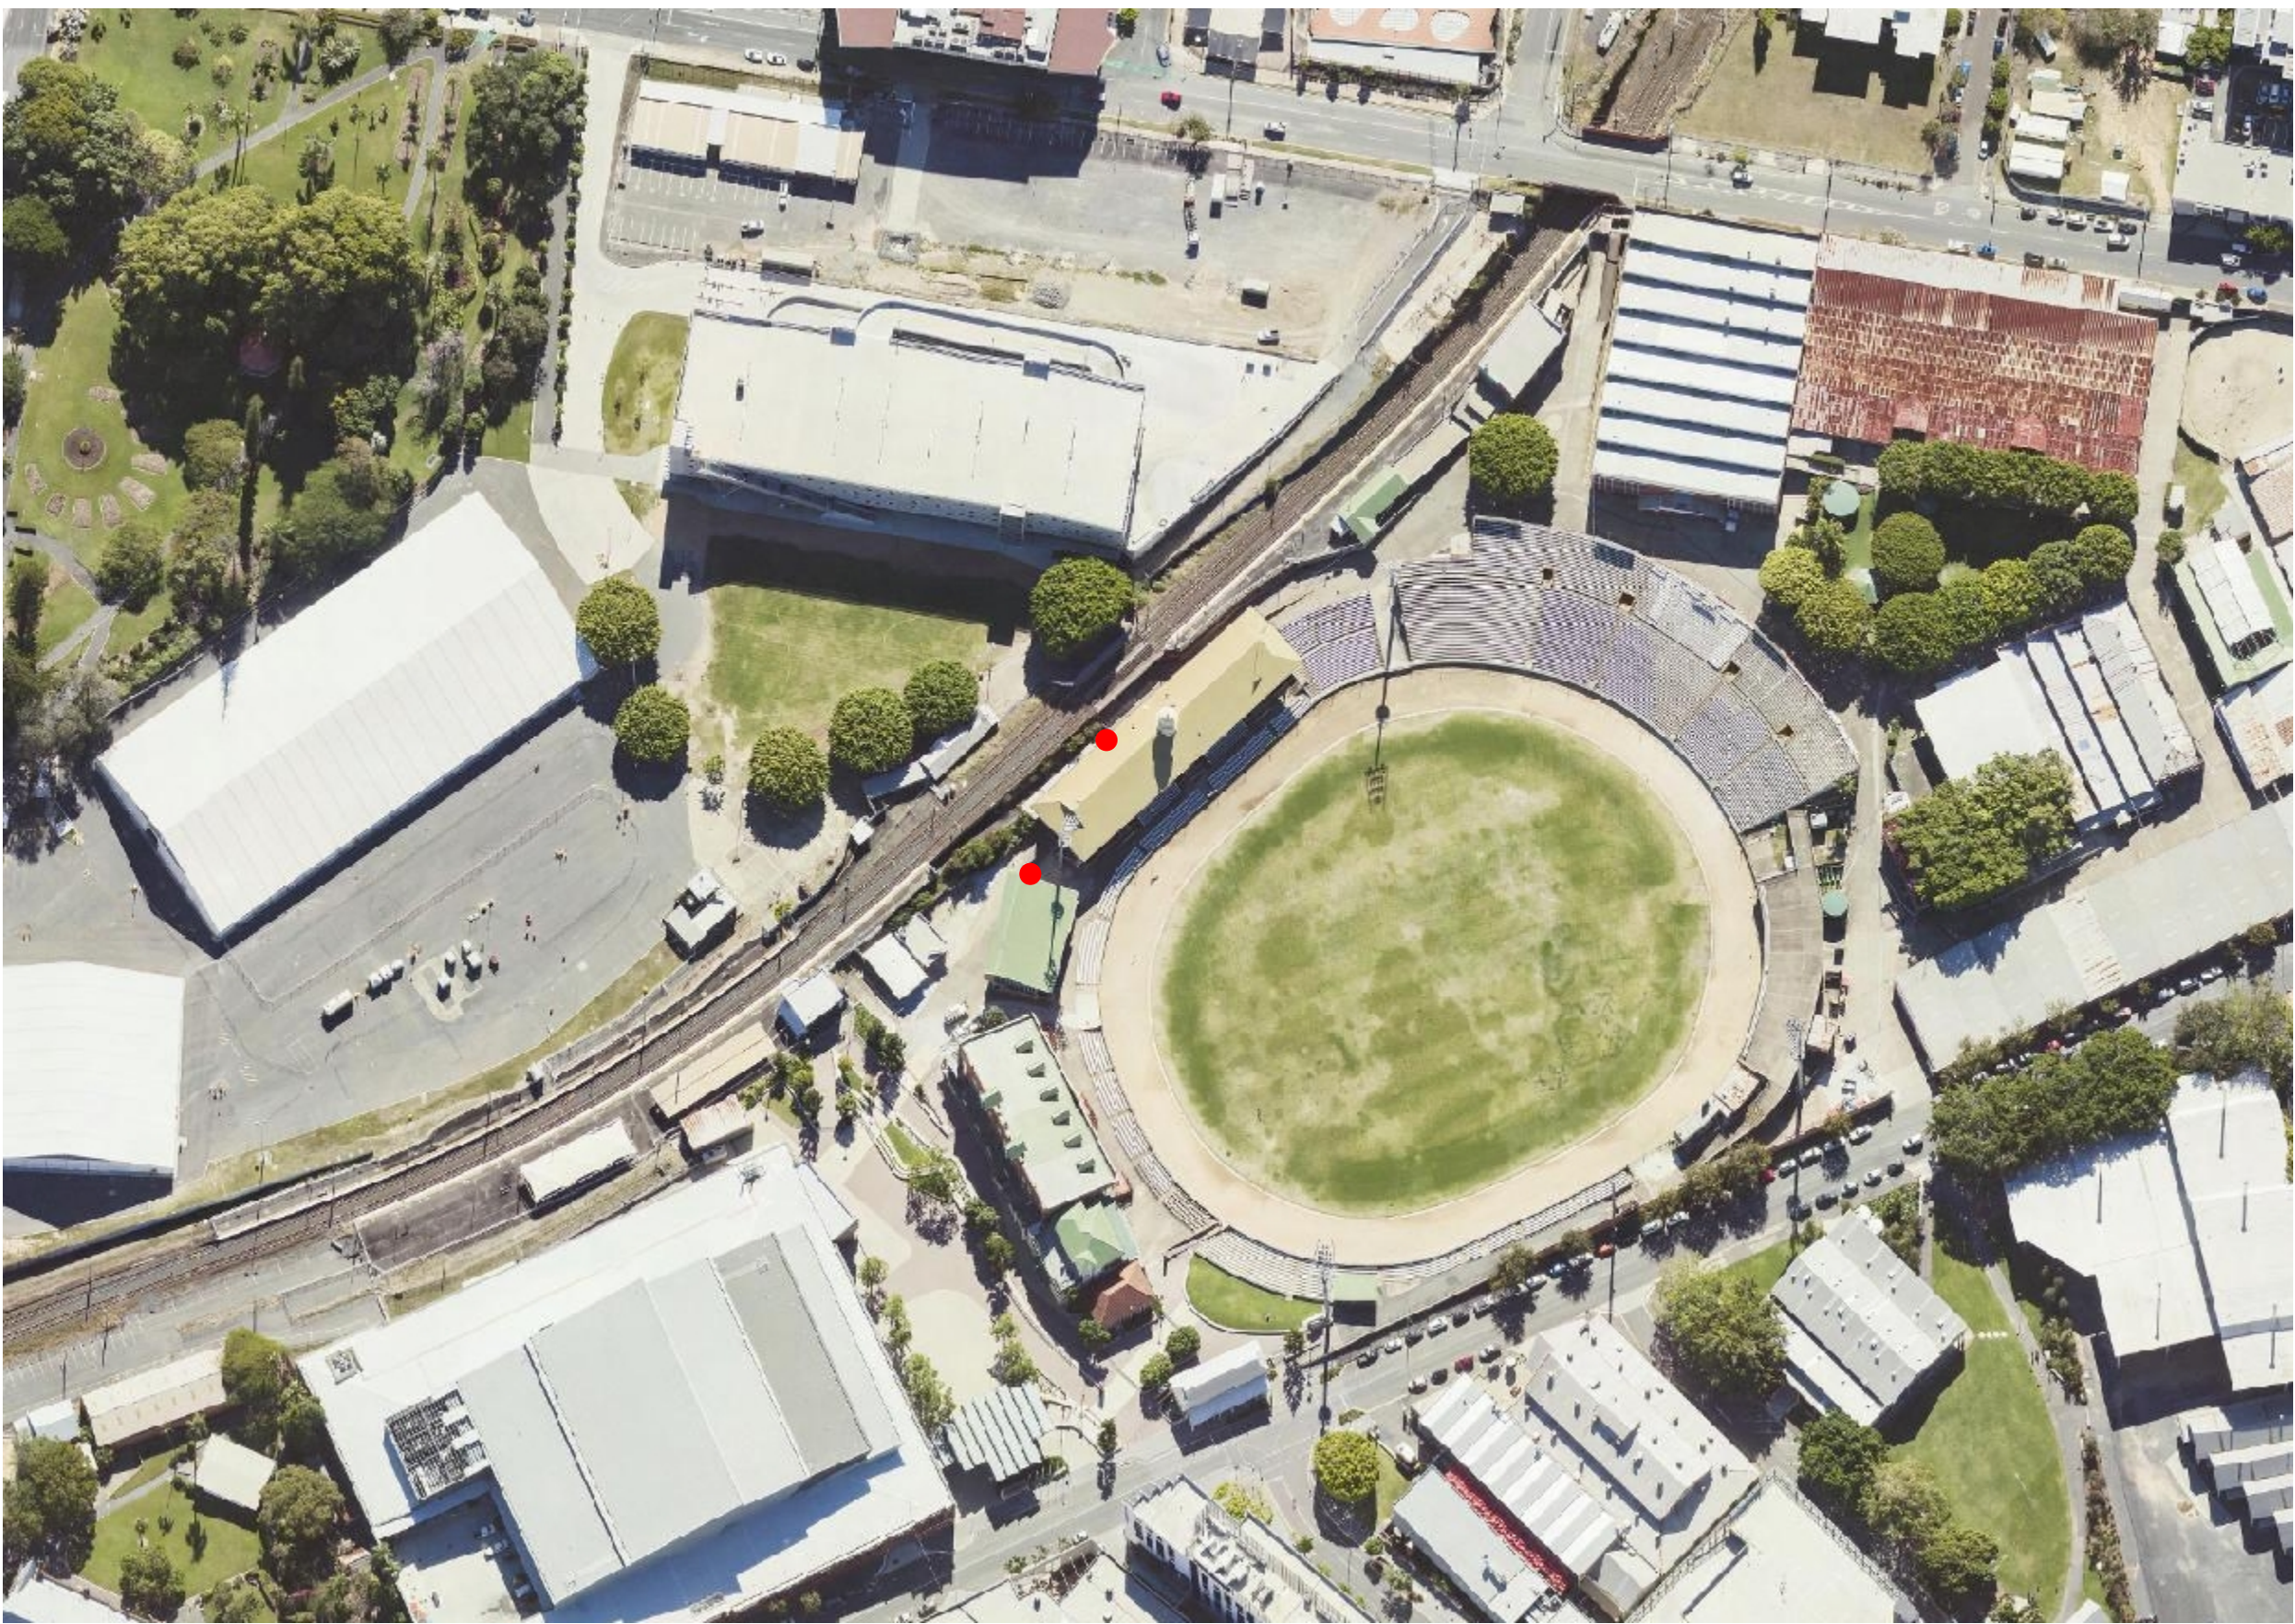
Attachment 3 Monitoring Locations – Vibration

- Brisbane Imagery (25/06/2020)
- Vibration Monitoring at sensitive
recievers

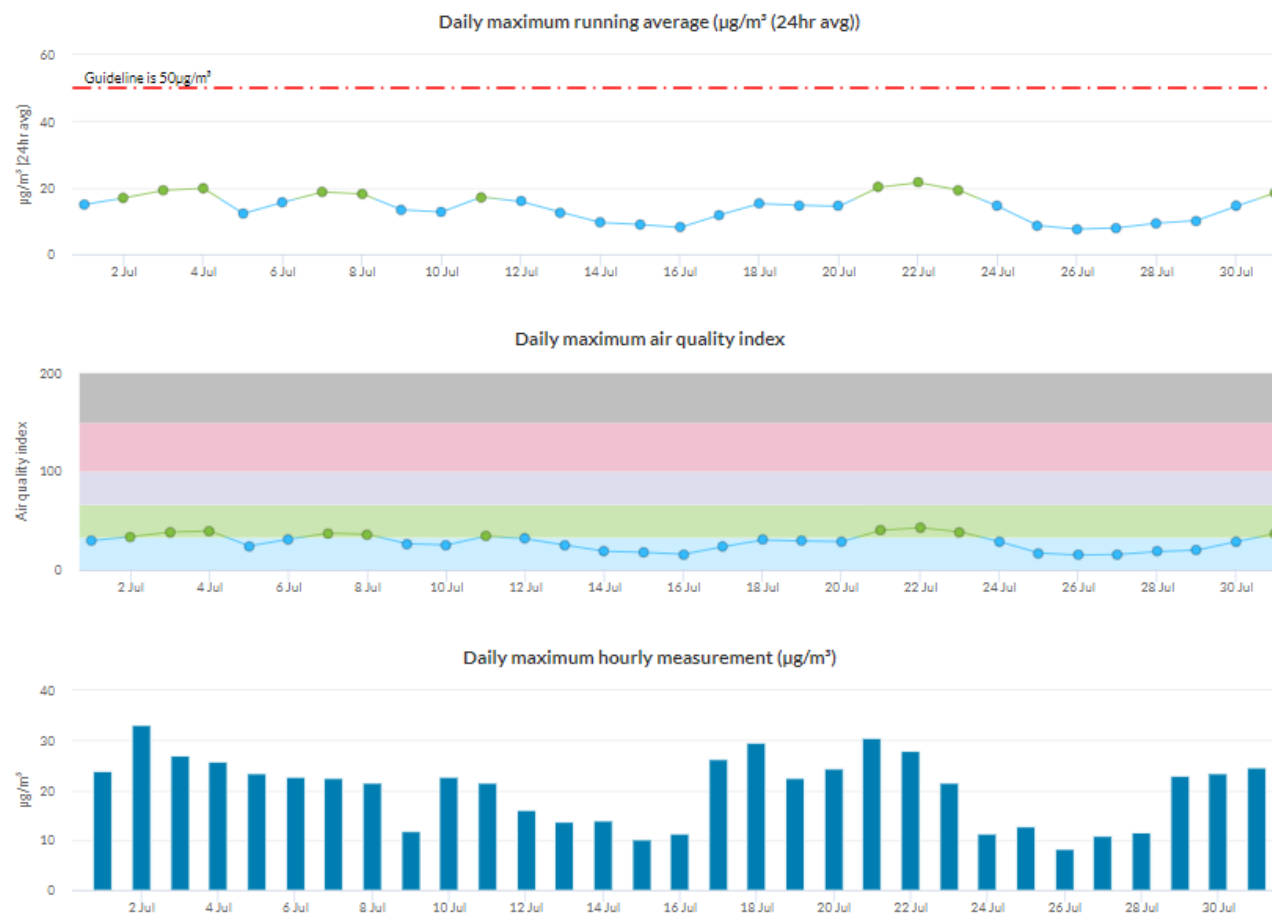
Figure 1: Brisbane CBD – DES Station - PM₁₀ graph for July 2020 (reproduction from the DES website accessed August 2020)

The guideline for Particle PM₁₀ is 50 µg/m³ (24hr avg).

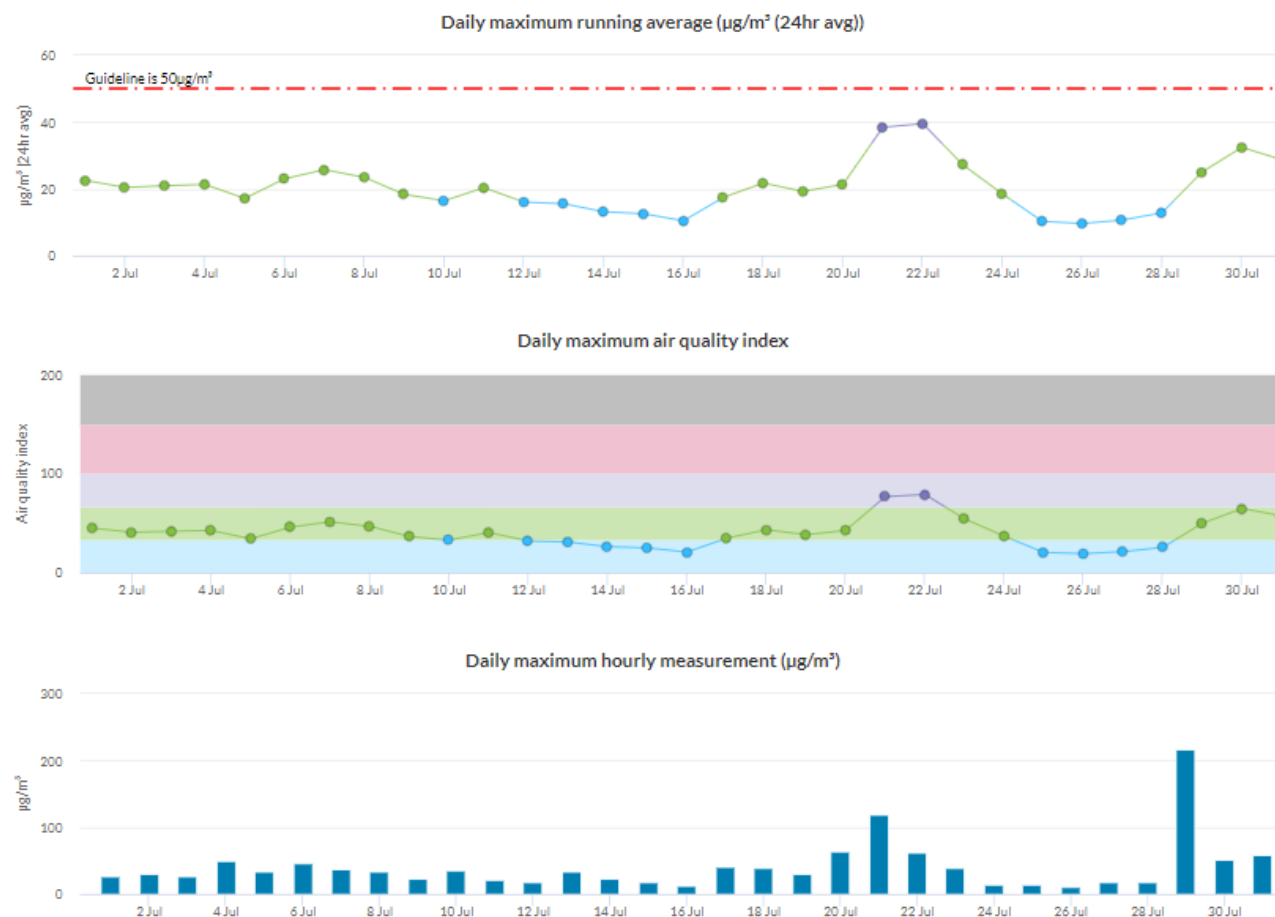
Figure 2: South Brisbane – DES Station - PM₁₀ graph for July 2020 (reproduction from the DES website accessed August 2020)

The guideline for Particle PM₁₀ is 50µg/m³ (24hr avg).

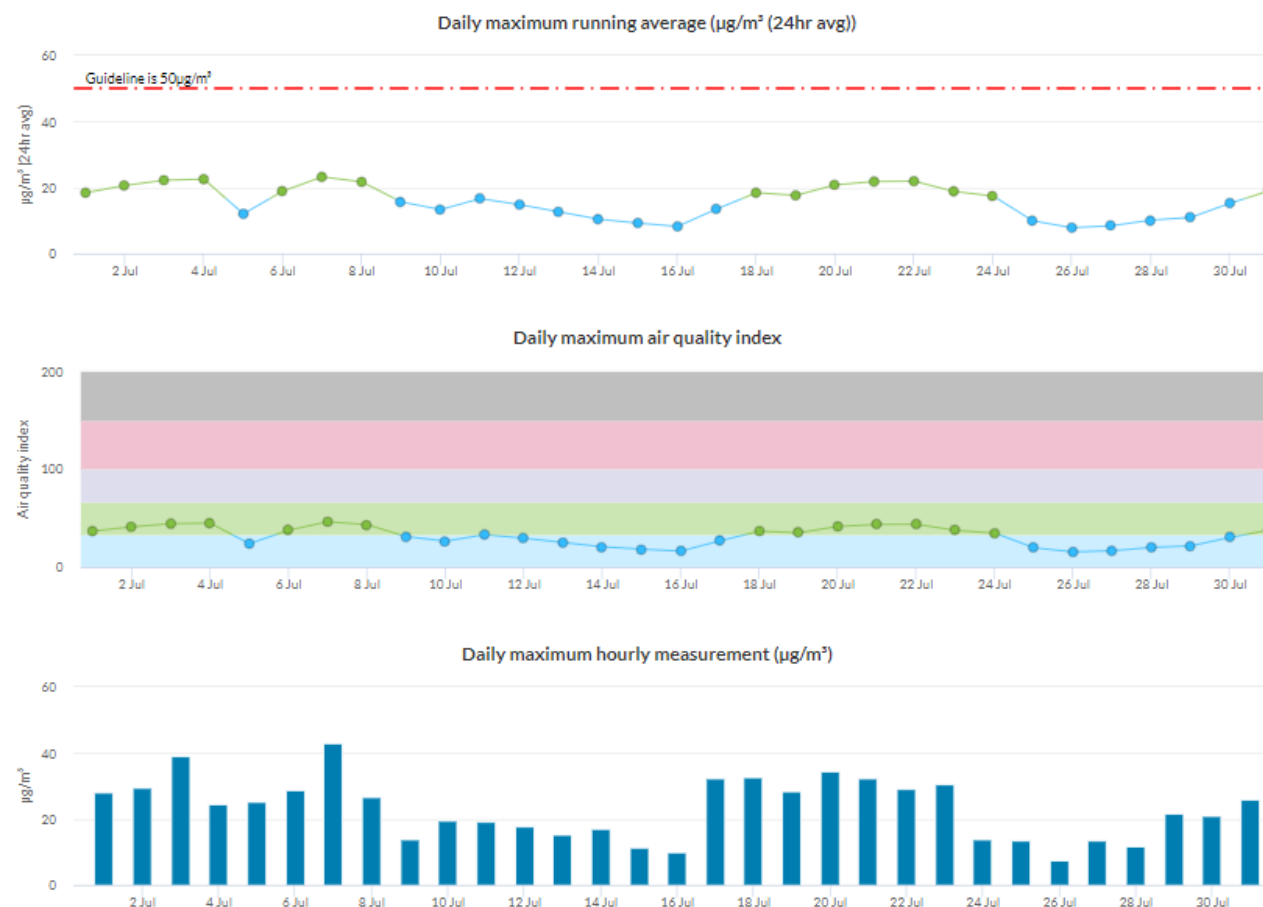
Figure 3: Woolloongabba – DES Station - PM10 graph for July 2020 (reproduction from the DES website accessed August 2020)

The guideline for Particle PM₁₀ is 50µg/m³ (24hr avg).
