# Cross River Rail Project

## Monthly Environmental Report

July 2021

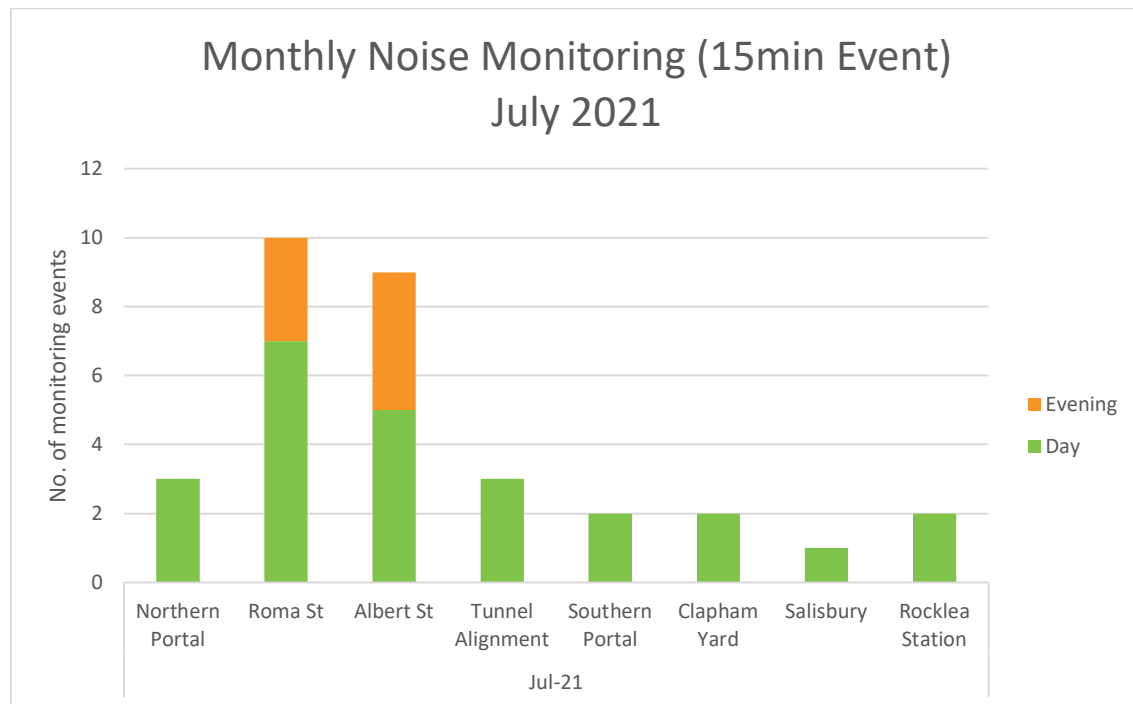
A summary of noise monitoring events for the month is provided in the chart below.

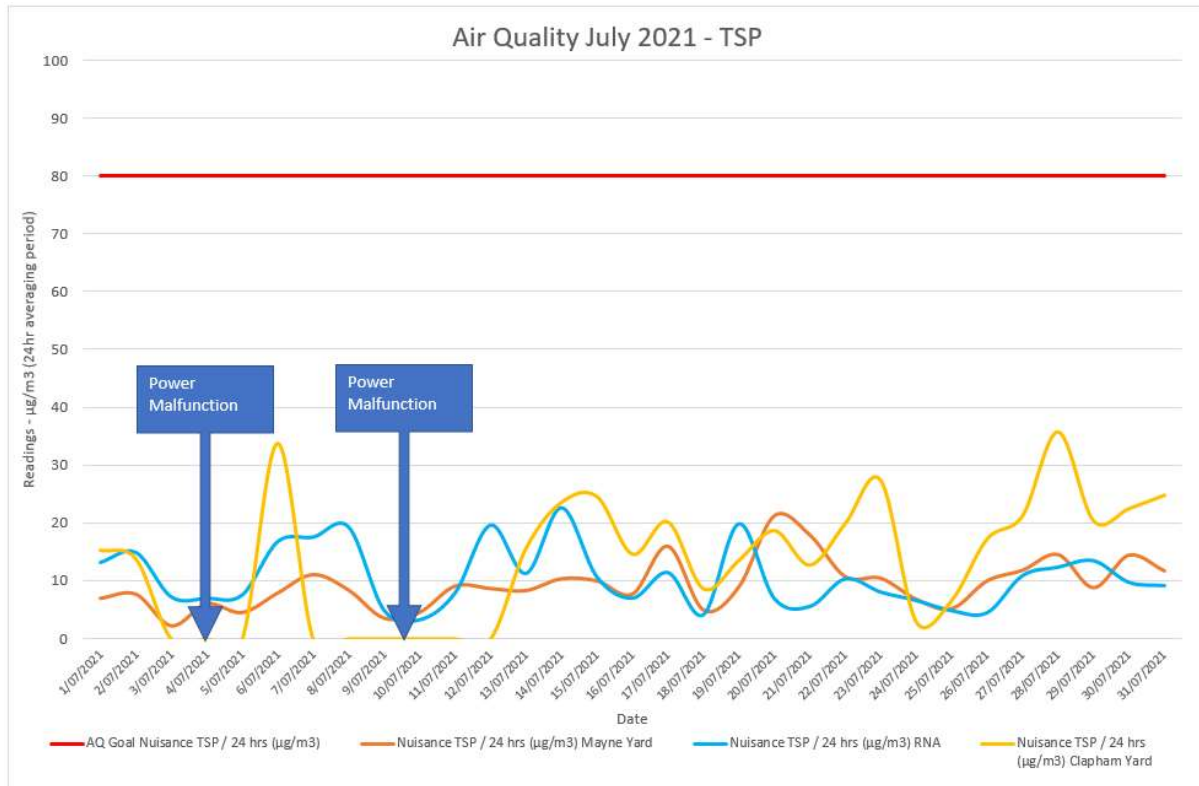
Figure 2 Air Quality Monitoring (TSP) Results

TSP is one of the indicators for which the Coordinator-General has imposed a goal of 80 µg/m<sup>3</sup> (over an averaging period of 24 hours) the project must aim to achieve under Imposed Condition 13(a).

These stations have been set up on site as per AS/NZS 3850 1.1 following consultation with UNITY air quality professionals.

The results are represented in the below figures.

Unity had three (3) active air quality monitoring stations set up for the reporting period. The Clapham Yard station suffered a power failure for nine (9) days. The power failure is attributed to the Easterly facing panel positioned at 90 degrees not catching enough of the sun's rays during the winter period. This issue has now been rectified with the TSP / PM<sub>10</sub> having been relocated on 9 August 2021 at a location where the solar panels powering the station are positioned at the optimal alignment (North facing and as close to perpendicular as possible) and therefore more likely to be exposed to the sun for extended hours during the day.

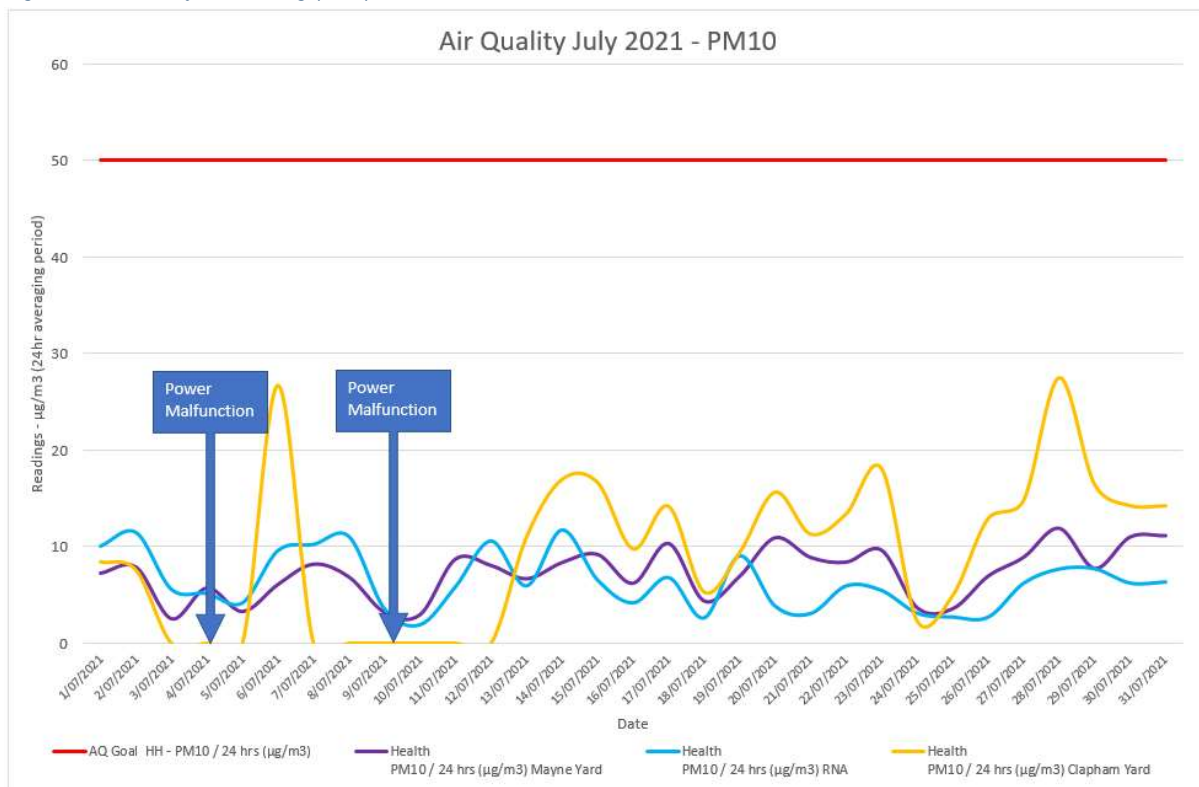
Figure 3 Air Quality Monitoring (PM<sub>10</sub>) Results

PM<sub>10</sub> is one of the indicators for which the Coordinator-General has imposed a goal of 50 µg/m<sup>3</sup> (over an averaging period of 24 hours) the project must aim to achieve under Imposed Condition 13(a).

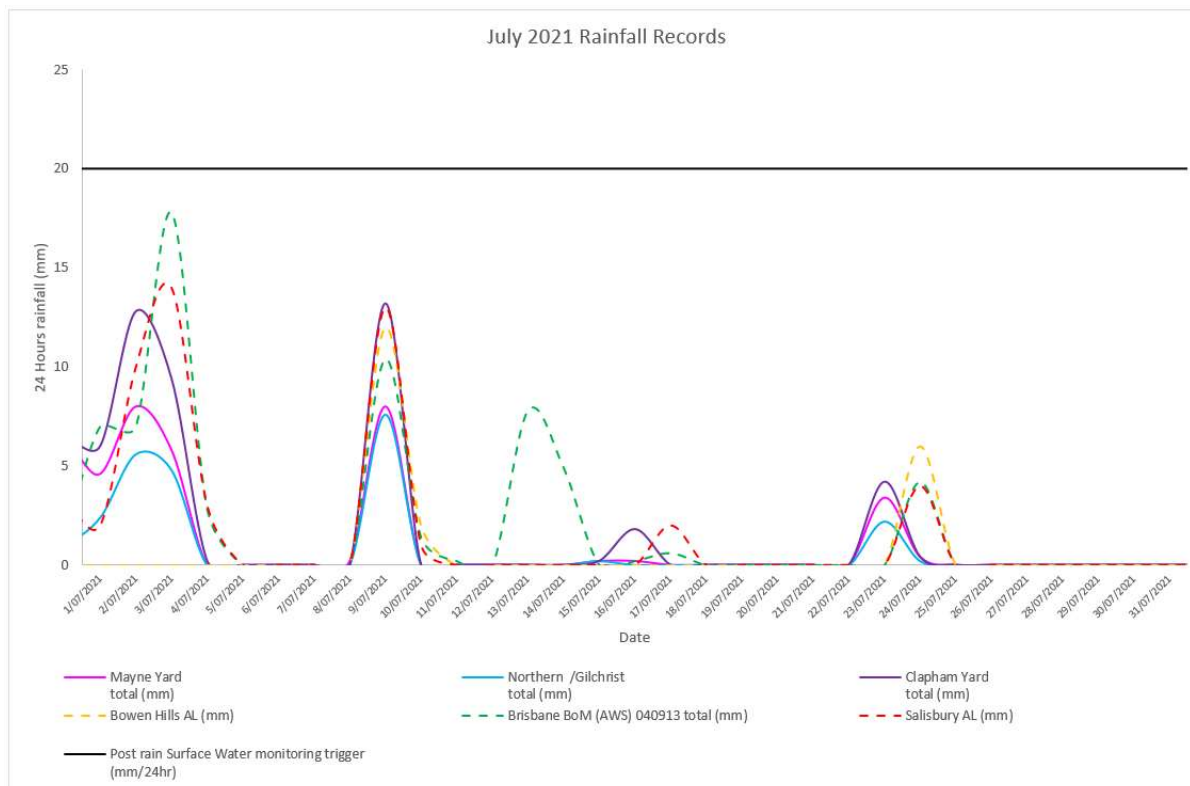
Figure 4 Rainfall Records

Post rainfall monitoring is triggered typically following any rainfall event exceeding 20 to 25 mm over 24 hours, however storm events during the high-risk period of the year (November to March) of lesser amounts but higher intensity may cause run-off which would also trigger post rain monitoring consistent with the C-EMP.

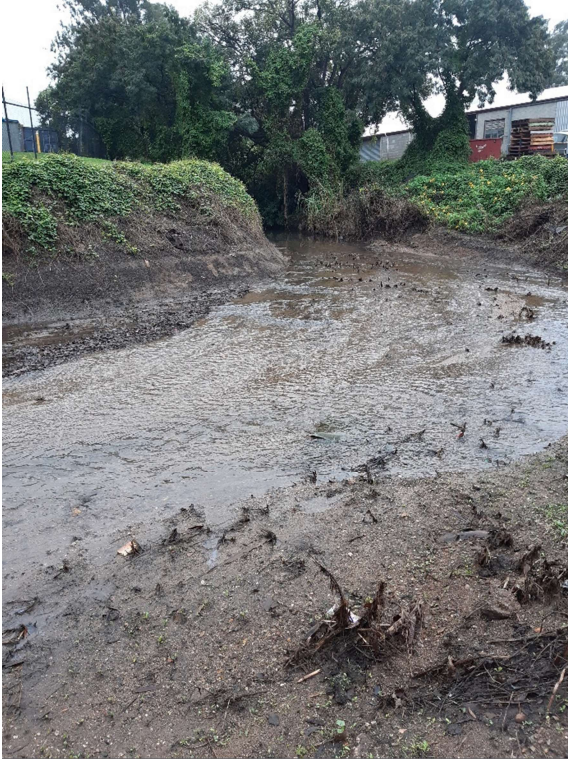
Post rainfall monitoring undertaken at Moolabin Creek identified that water quality was visibly more turbid than usually observed following rainfall events less than 20mm. There were no visible sources of turbid water discharges from site.

*Plate 1: Bed and Bank Vegetation Clearing yet to be stabilised at Moolabin Creek Upstream of the Project Boundaries*

Therefore, the source of the increased turbidity cannot not be reasonably accredited to the Project Works.

Compliance with Imposed Conditions 15 and 18 was met.

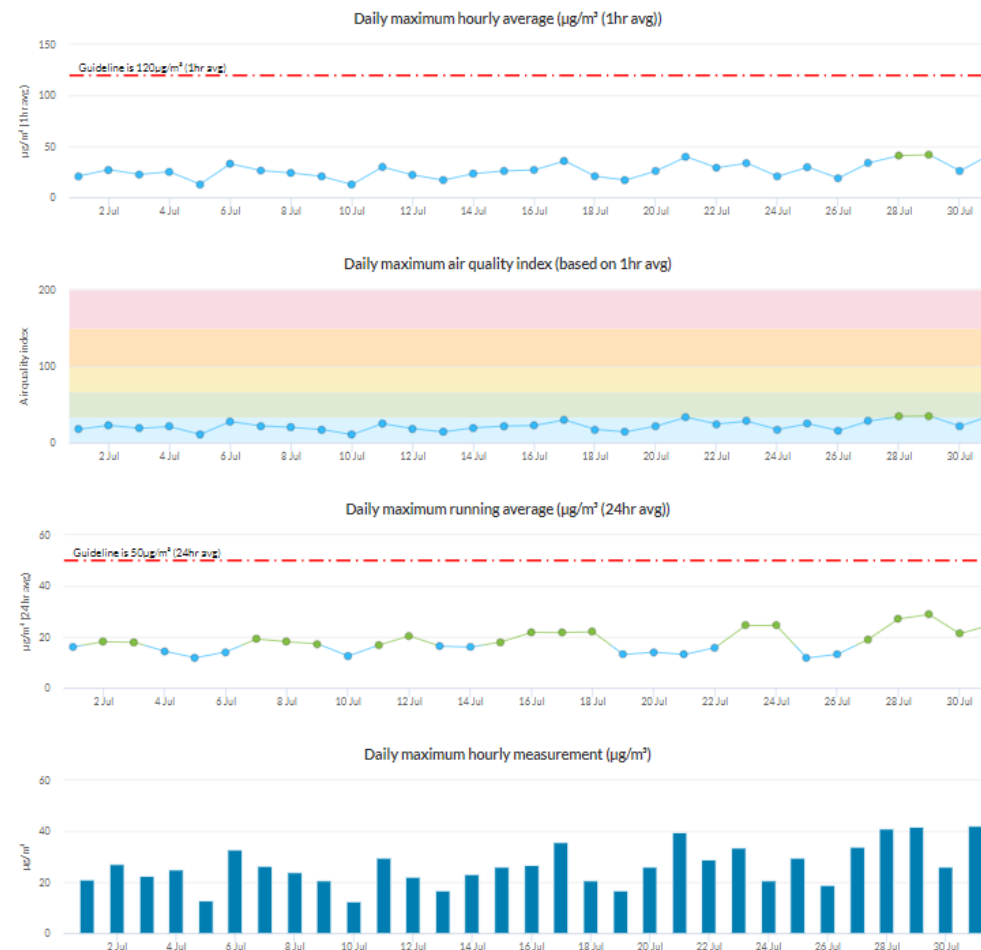
The guideline for Particle PM<sub>10</sub> is 120µg/m<sup>3</sup> (1hr avg) and 50µg/m<sup>3</sup> (24hr avg).

Figure 1: Brisbane CBD – DES Station - PM10 graph for July 2021 (reproduction from the DES website).

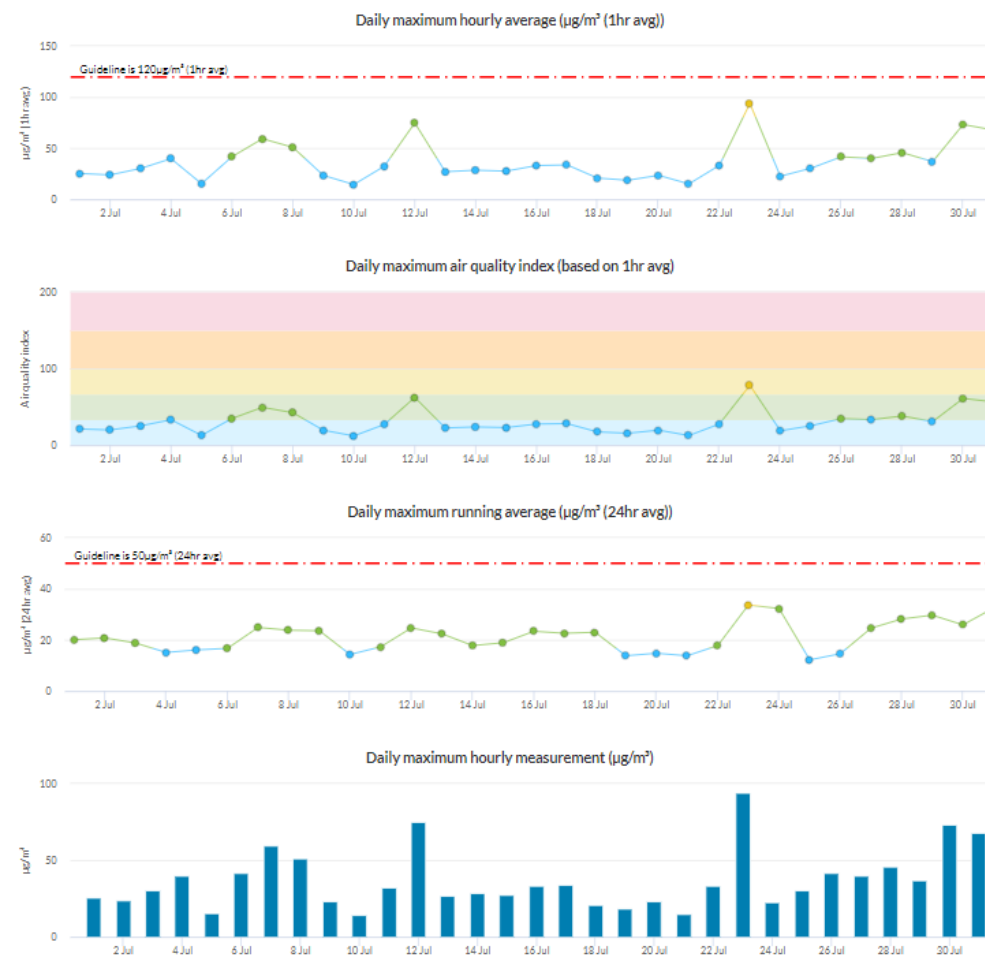
The guideline for Particle PM<sub>10</sub> is 120µg/m<sup>3</sup> (1hr avg) and 50µg/m<sup>3</sup> (24hr avg).

Figure 2: South Brisbane – DES Station - PM<sub>10</sub> graph for July 2021 (reproduction from the DES website accessed).

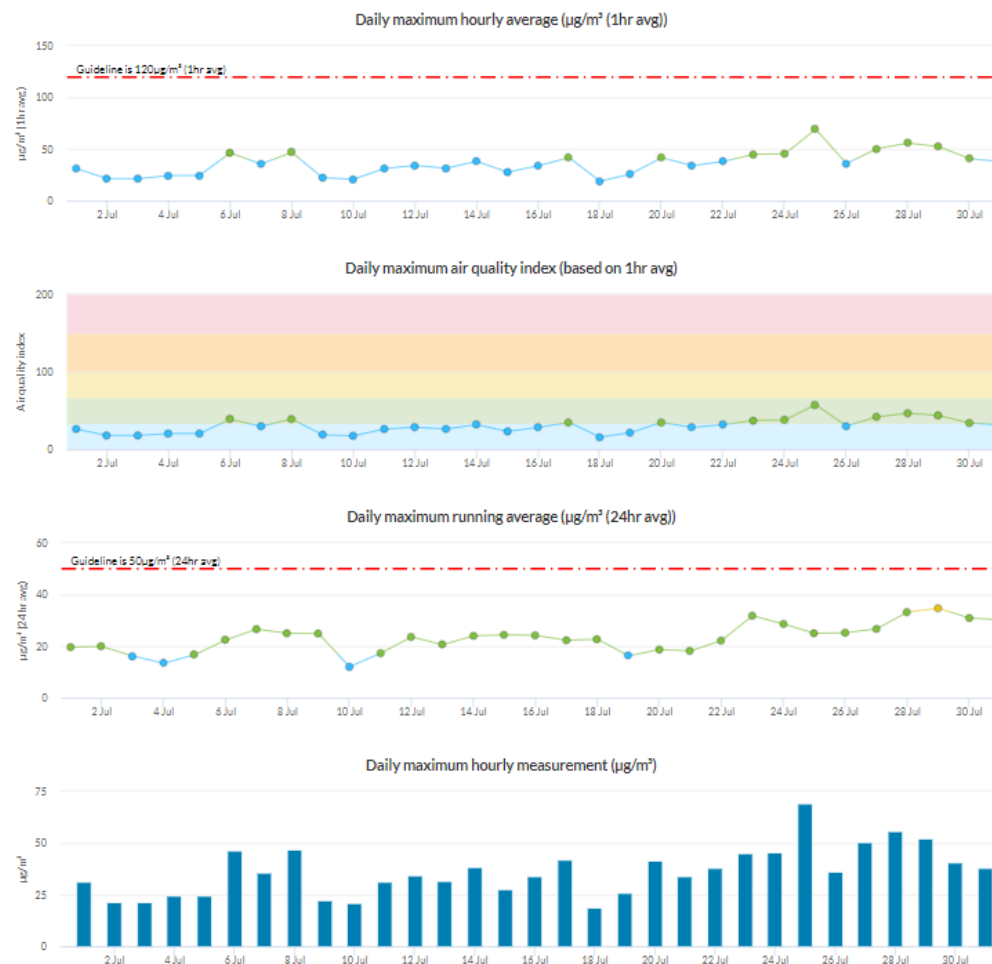
The guideline for Particle PM<sub>10</sub> is 120µg/m<sup>3</sup> (1hr avg) and 50µg/m<sup>3</sup> (24hr avg).

Figure 3: Woolloongabba – DES Station - PM10 graph for July 2021 (reproduction from the DES website).
