Cross River Rail Project

Monthly Environmental Report

March 2023

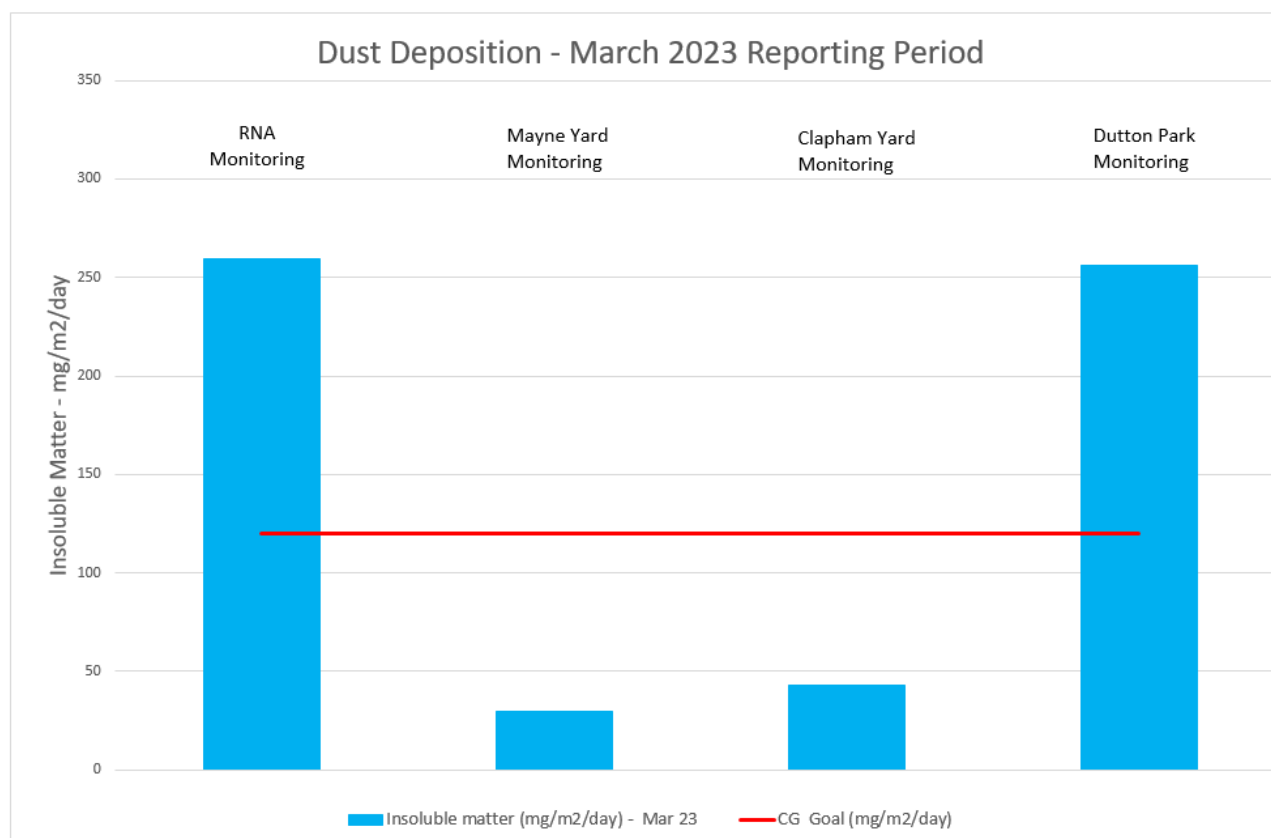
Figure 1 Air Quality Monitoring (Deposited Dust) Results

Note: Results recorded in red indicate an exceedance of the CGCR Goal

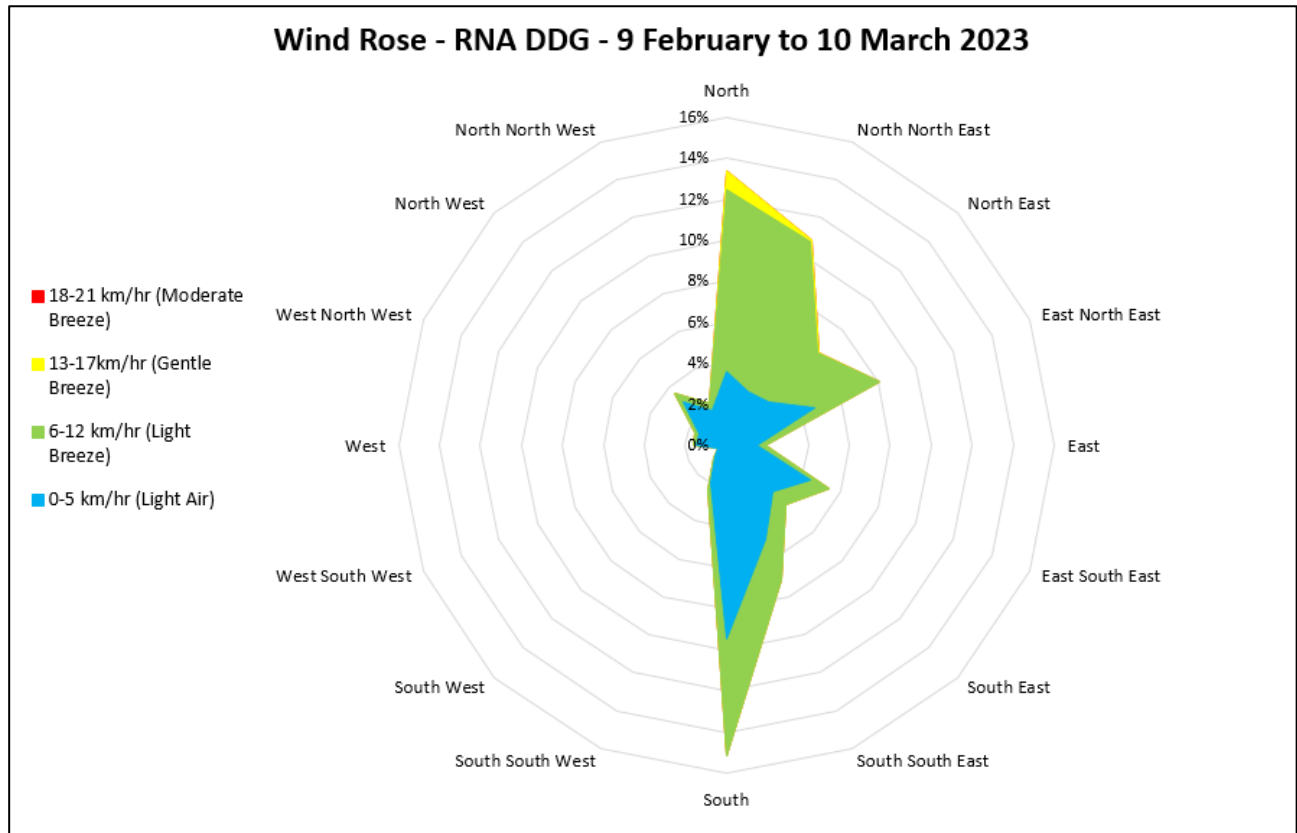
Figure 2 RNA Wind Rose During DDG Measurement Period

- The DDG was downwind of the Project Works 50% of the time, and

- Wind conditions were light to gentle (according to the Beaufort Scale) during the majority (98%) of the measurement period.

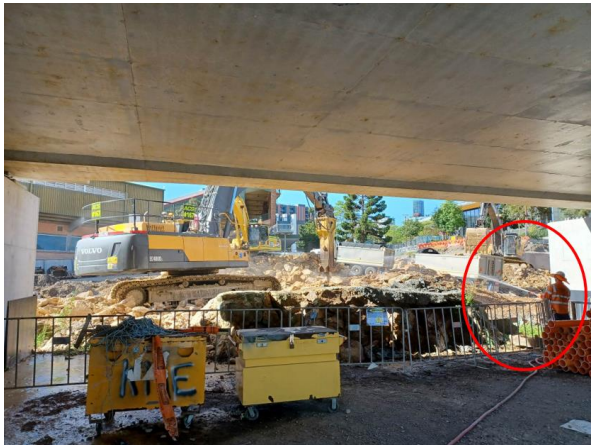
Figure 3 Hosing During Rock Breaking

- Dust suppression (hose spraying during rock breaking and demolition and water carts spraying throughout site) (refer to Figure 3 and Figure 4 below)
- Erosion control (geofabric placed on exposed batters) (refer to Figure 5 below)
- Stabilised access points (minimising tracking onto roads) (refer to Figure 6 below)
- Street sweepers on rotation as required and frequency increased during EXT_018 SCAS (refer to Figure 6 below).

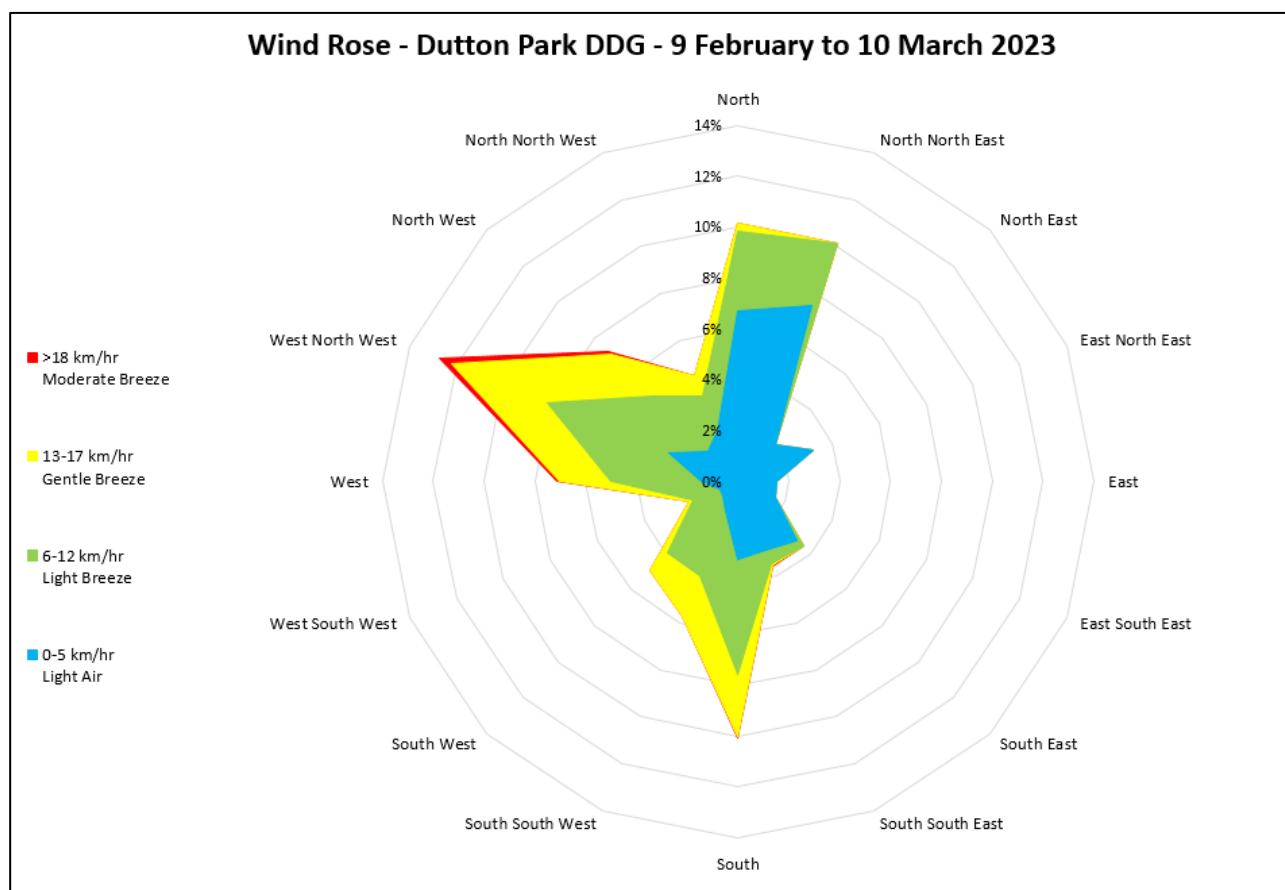
Figure 7 Dutton Park Wind Rose During DDG Measurement Period

- The DDG was downwind of the Project Works 62% of the time, and
- Wind conditions were light to gentle (according to the Beaufort Scale) during the majority (98%) of the measurement period.

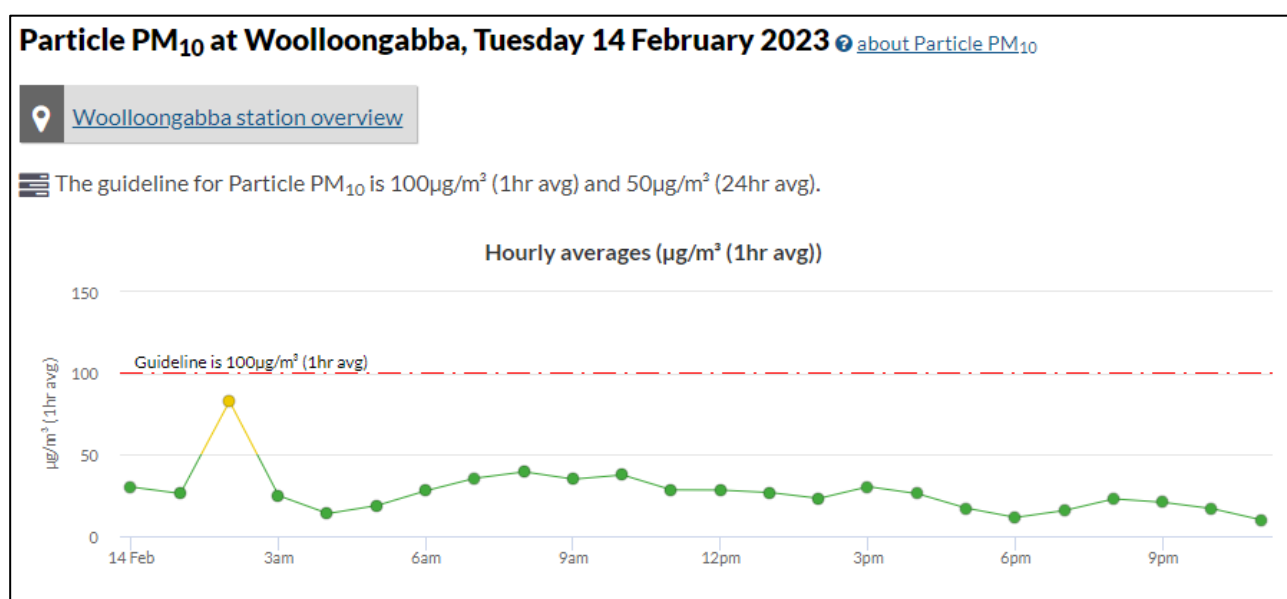
Figure 9 DES Woolloongabba Weather Station PM₁₀ Results 14 February 2023

Figures 9 – 11 below demonstrate the elevated results recorded at the DES Woolloongabba weather station during the days with elevated results.

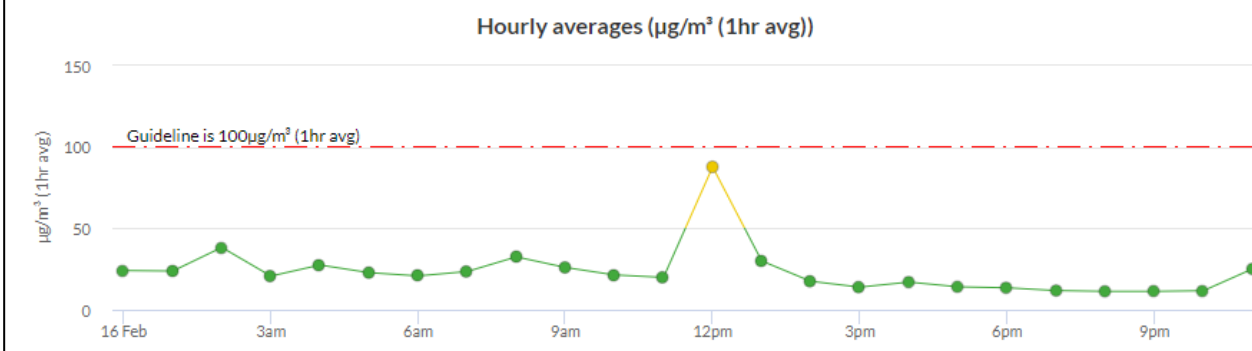
Figure 10 DES Woolloongabba Weather Station PM₁₀ Results 16 February 2023

The guideline for Particle PM₁₀ is 100µg/m³ (1hr avg) and 50µg/m³ (24hr avg).

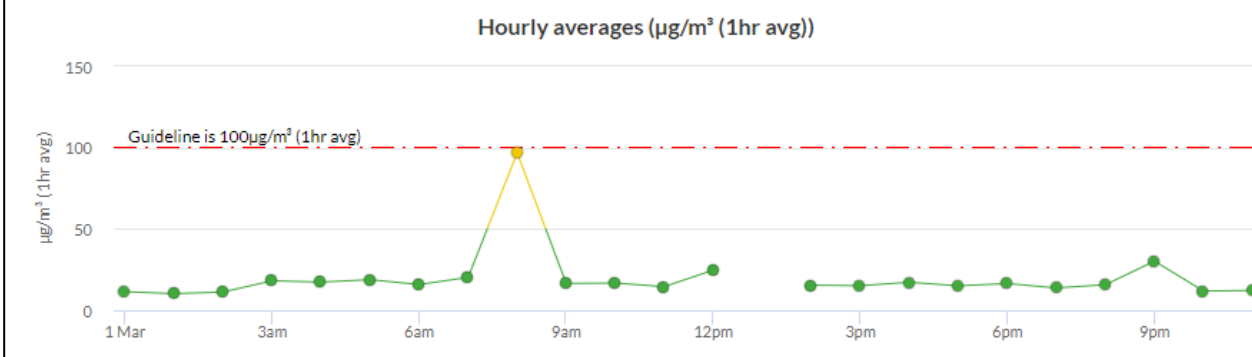
Figure 11 DES Woolloongabba Weather Station PM₁₀ Results 01 March 2023

The guideline for Particle PM₁₀ is 100µg/m³ (1hr avg) and 50µg/m³ (24hr avg).

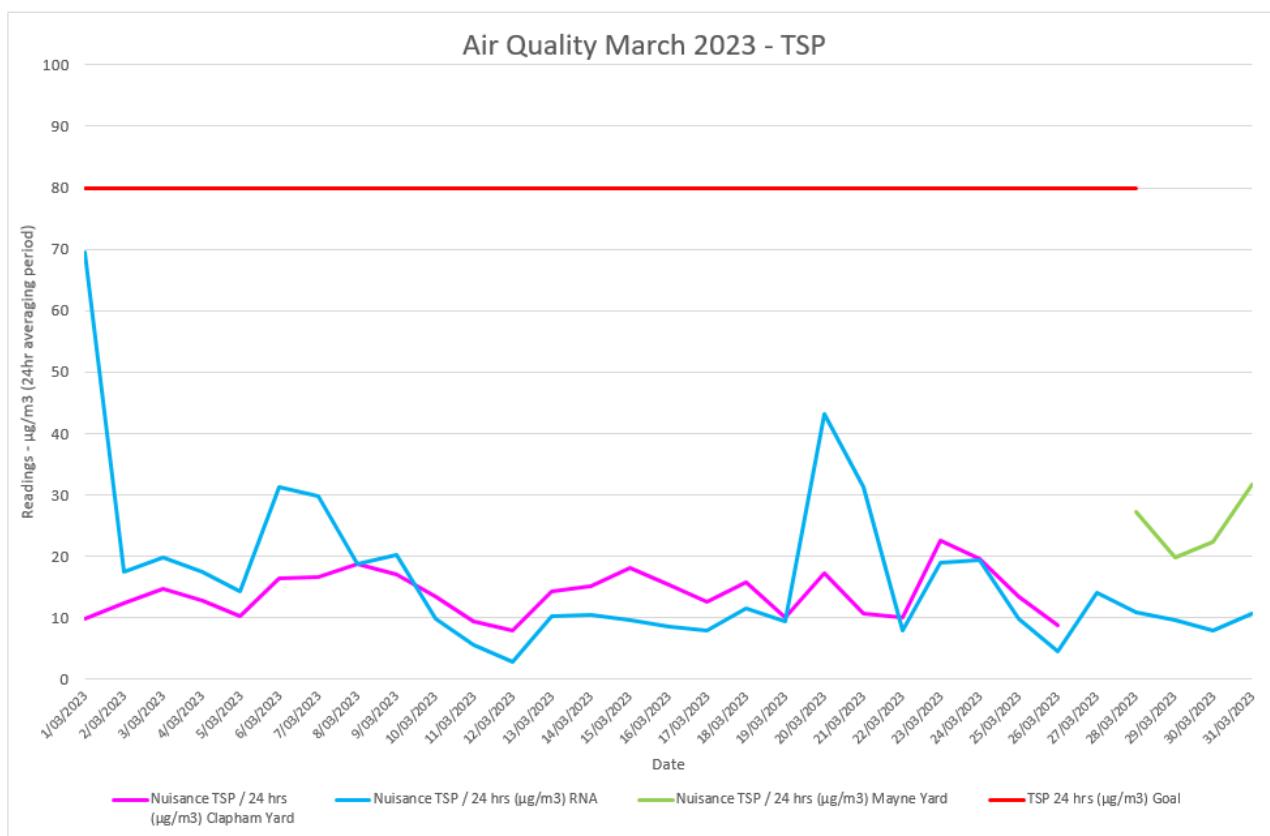
Figure 12 Air Quality Monitoring (TSP) Results

The Clapham Yard DMP began experiencing repeated battery issues which invalidated the data recorded from 27 – 31 March 2023 due to not meeting the minimum 18-hour or 75% threshold over a 24-hour period. This issue rectification is in progress and will be reported in the April 2023 monthly report.

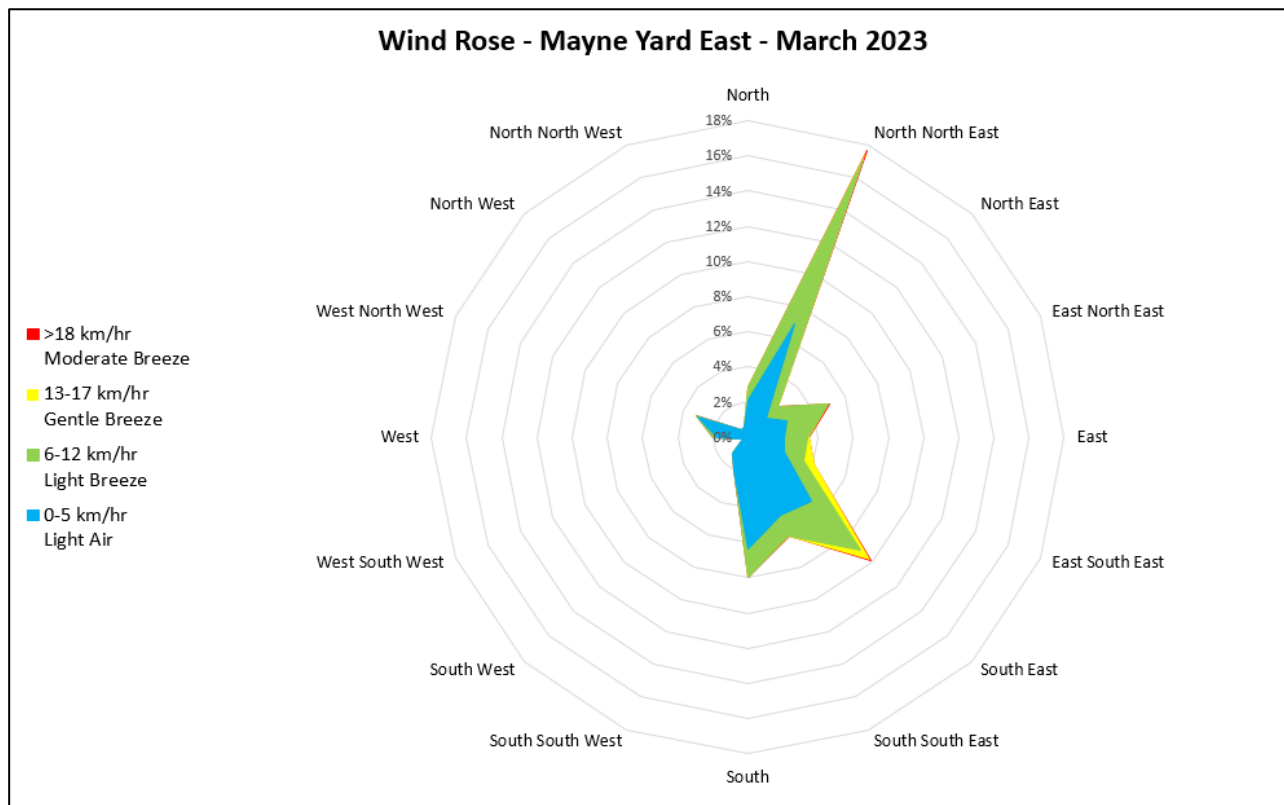
Figure 14 Mayne Yard East Wind Rose March 2023

As shown in the wind rose below (refer Figure 14) the predominant winds during the reporting period were from a north easterly and south easterly direction. As a result, any potential dust generated from UNITY

works would have travelled south-west towards the RNA Showgrounds work area and north-west away from the sensitive receptors located east of Mayne Yard East on Abbotsford Road.

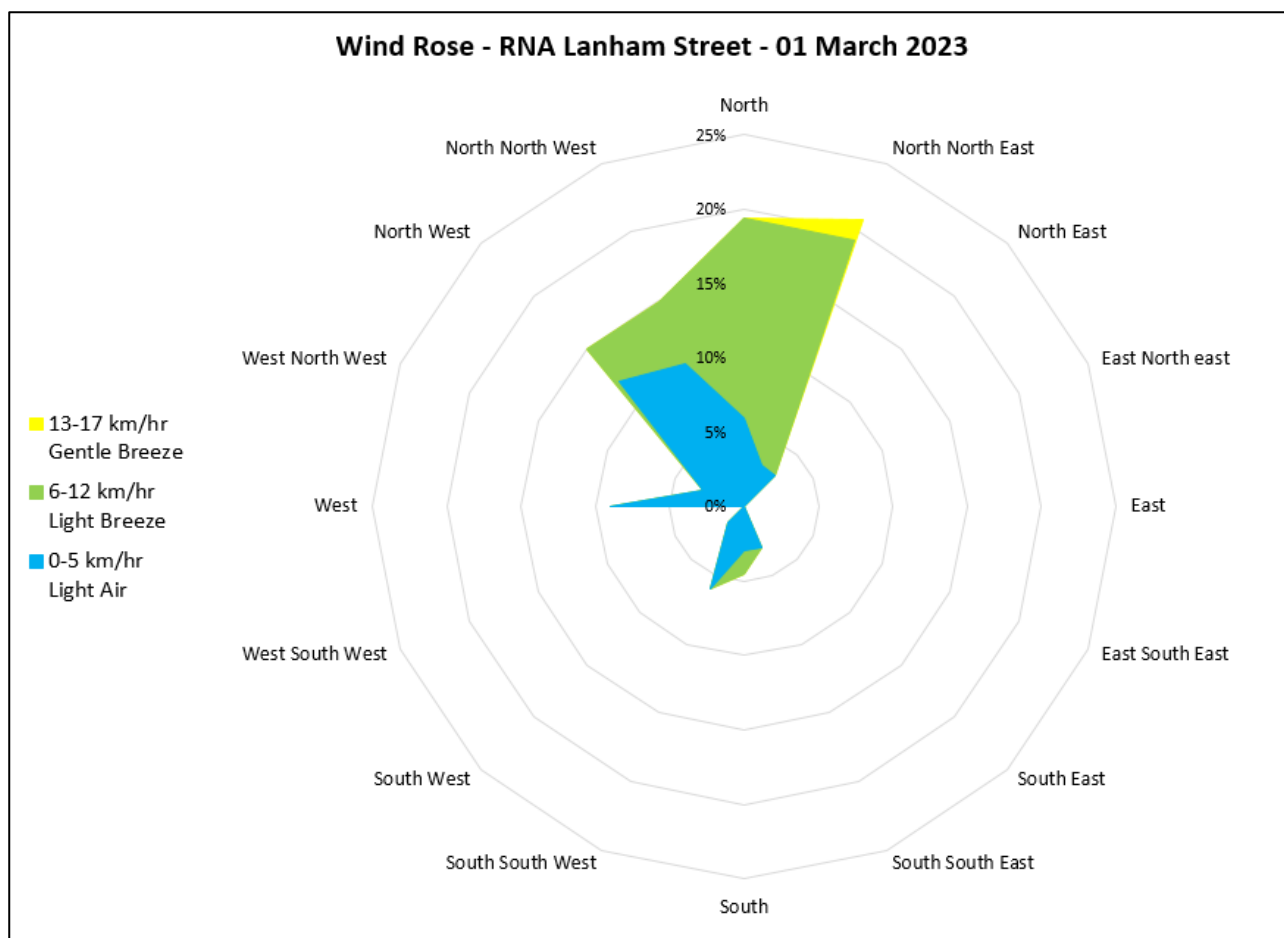
Figure 15 Wind Rose RNA Lanham Street 01 March 2023

The measured PM₁₀ 24-hour average of 52 µg/m³/day is minimally higher than the air quality goal of 50 µg/m³/day, and therefore has been recorded as an exceedance.

A wind rose was completed (refer to Figure 15) to ascertain the predominant winds during the 24-hour measurement period and whether abnormal wind conditions occurred that day.

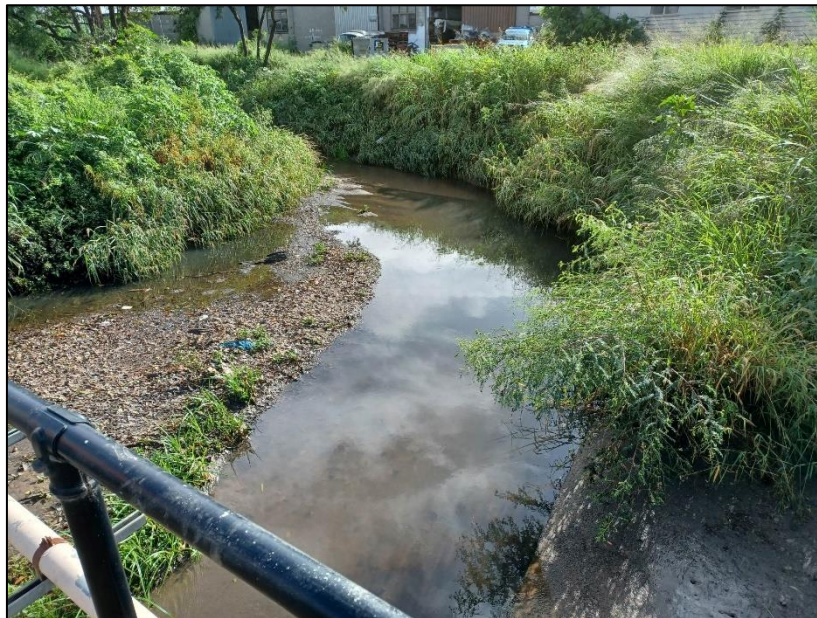
Figure 17 SW-05 Sampling Location Post Rainfall Monitoring 22 March 2023

**Water column depth in-stream at SW-05 (refer to Figure 17) was ca. 100mm, therefore, a grab sample that would have complied with the AS/NZS 5667.6:1998 requirements (minimum 300mm depth) could not be collected.*

No alternative upstream location of the Clapham Yard works could be safely accessed along Moolabin Creek; therefore, the SW-05 data can only be considered an indicative representation of the upstream water quality at the time of sampling.

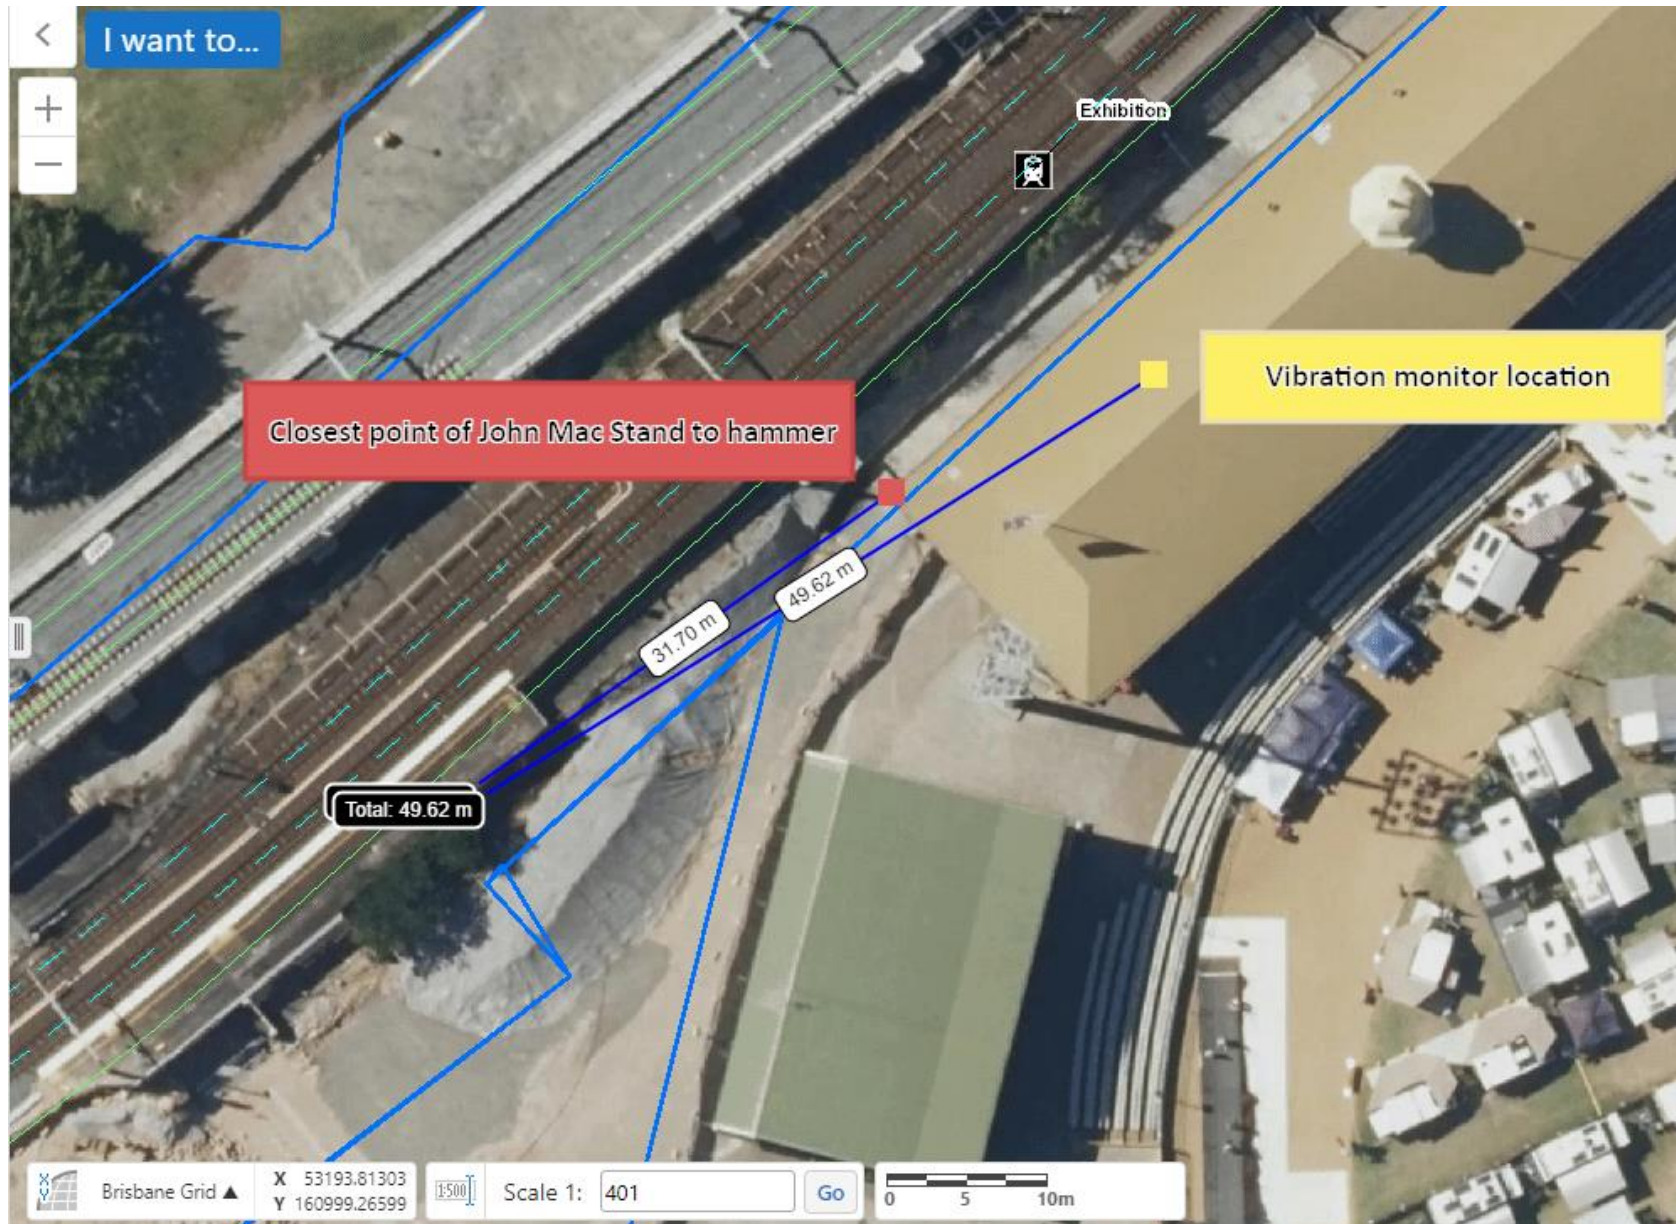
Figure 18 RNA March 2023 Vibration Monitoring

Vibration monitoring during rock breaking works at the RNA Showgrounds was undertaken at the foundation of the State heritage John MacDonald Stand inside a storeroom. This location was selected based on the outcomes of predictive assessments.

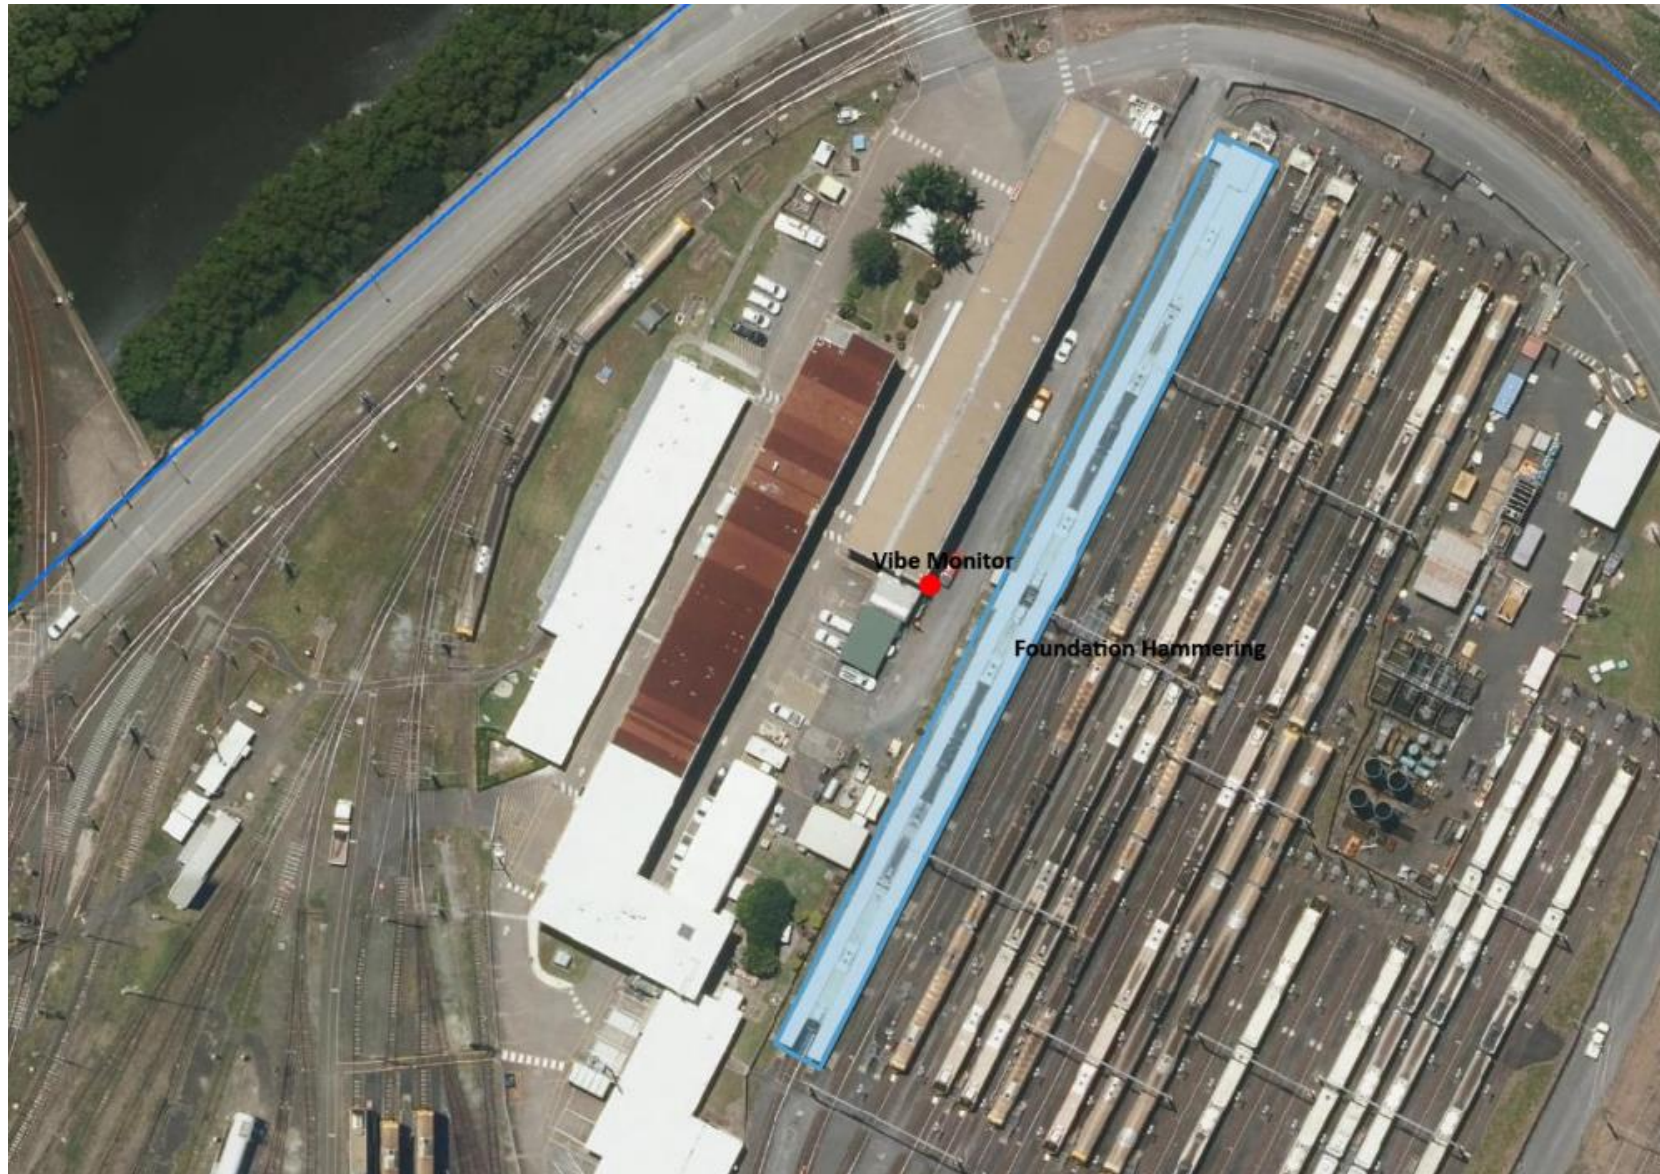
Figure 19 Mayne Yard East QR Building A Monitoring March 2023

Vibration monitoring during foundation breaking works of a redundant QR building was undertaken at the façade of the QR Facility Block A building. This location was selected due to its proximity to the works and because it was occupied by QR employees during the works.

Concrete foundation breaking activities was undertaken as part of Stage 3 Mayne Yard East Works prior to the EXT_018 SCAS. The peak reading of 0.15mm/s is attributed to the hammering and breaking of the redundant building.
