Cross River Rail Project

Monthly Environmental Report

May 2020

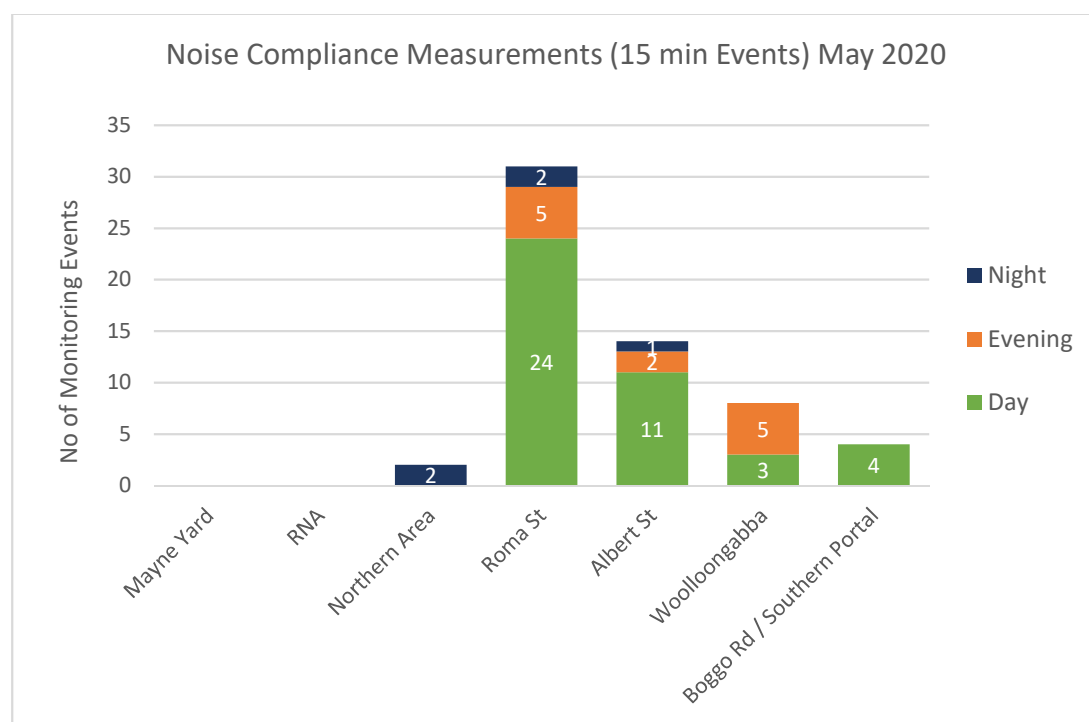
Figure 3: TSD Noise Compliance Measurements

TSD undertook noise monitoring on 57 occasions during the month as summarised in the graph below and detailed in **Appendix B**. Where internal monitoring was not possible for the contractors, they have undertaken external monitoring at nominated locations. The contractors noise consultants have then nominated suitable façade attenuation corrections, considering receiver property type, to determine compliance against the project's noise goals and to provide further calibration of the completed modelled predictions. The contractors have reported that the project noise goals have been met during this reporting month. A breakdown of the 57 monitoring events by time of day and location is shown in Figure 3 below.

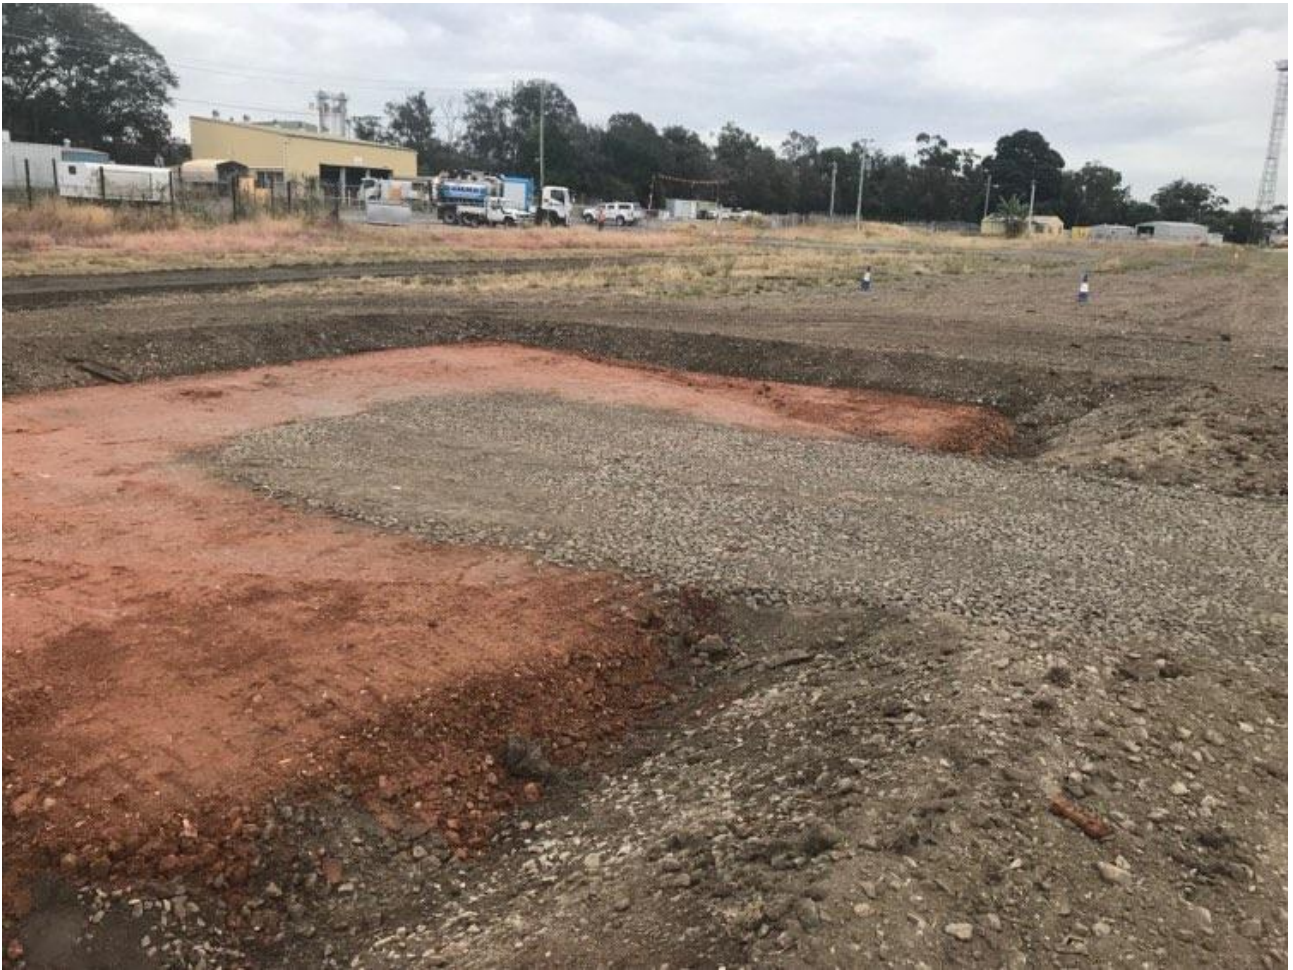
Figure 1 A small Acid Sulphate Soil Treatment Pad was installed on site in accordance with the Mayne Yard North ASSMP for treating material excavated from Under Track Crossings (UTX)

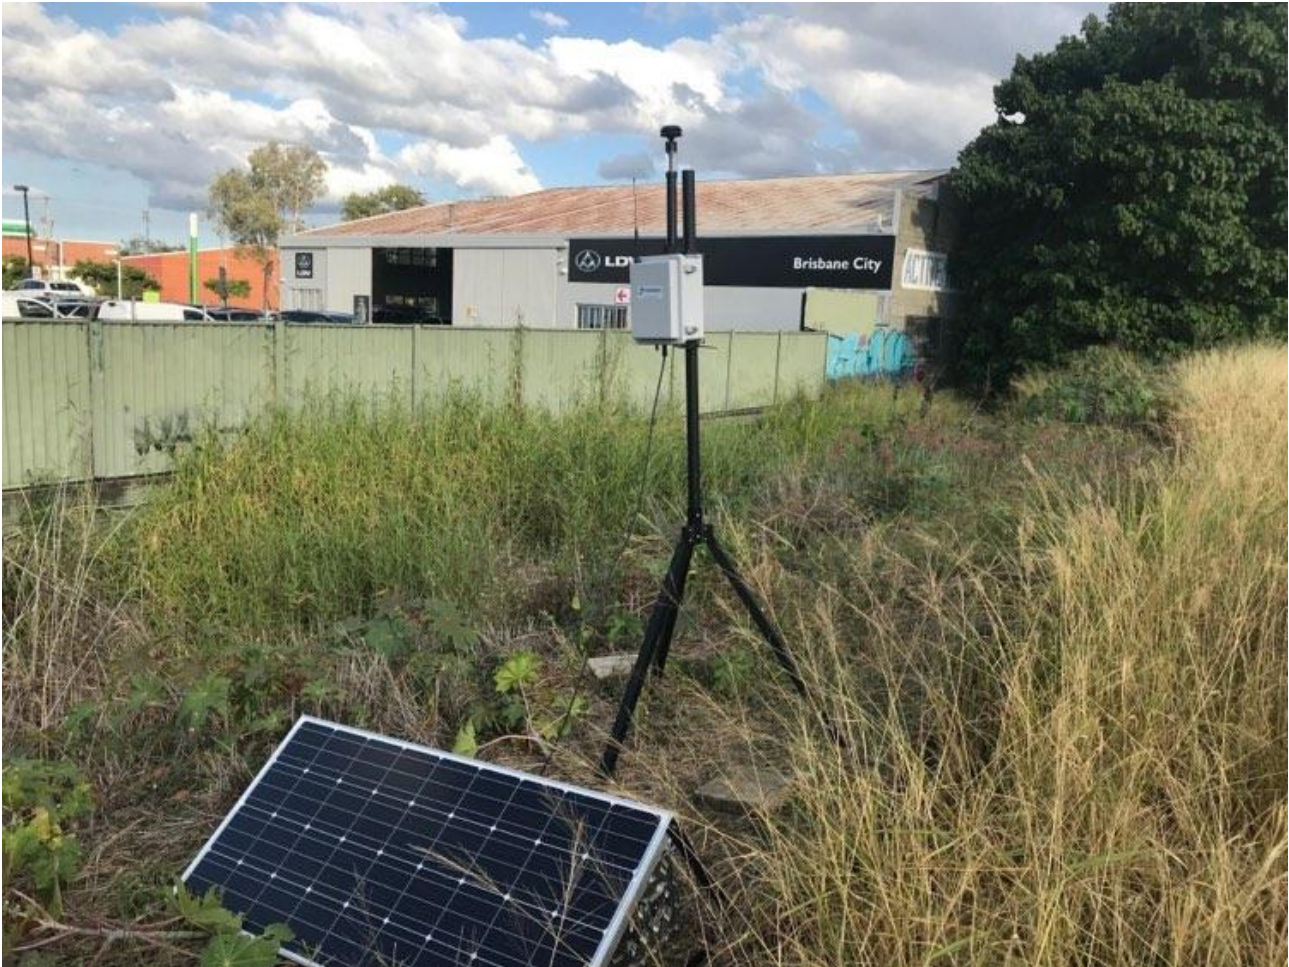
Figure 2 Example of one of the Dust Master Pro set up on site (Mayne Yard pictured)

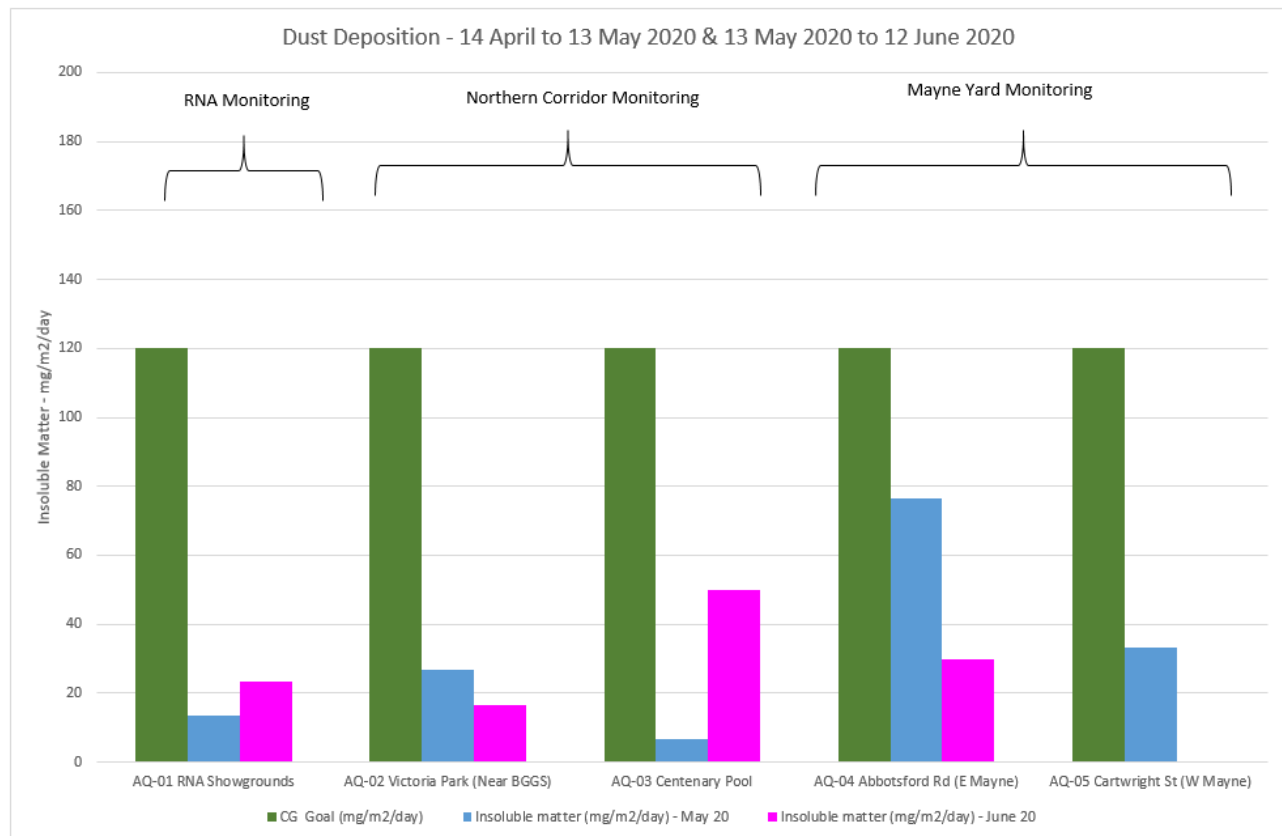
Table 5: Dust deposition gauge results for period 13 May 2020 to 12 June 2020.

Dust Deposition Results did not exceed the deposited Dust Nuisance Goal.

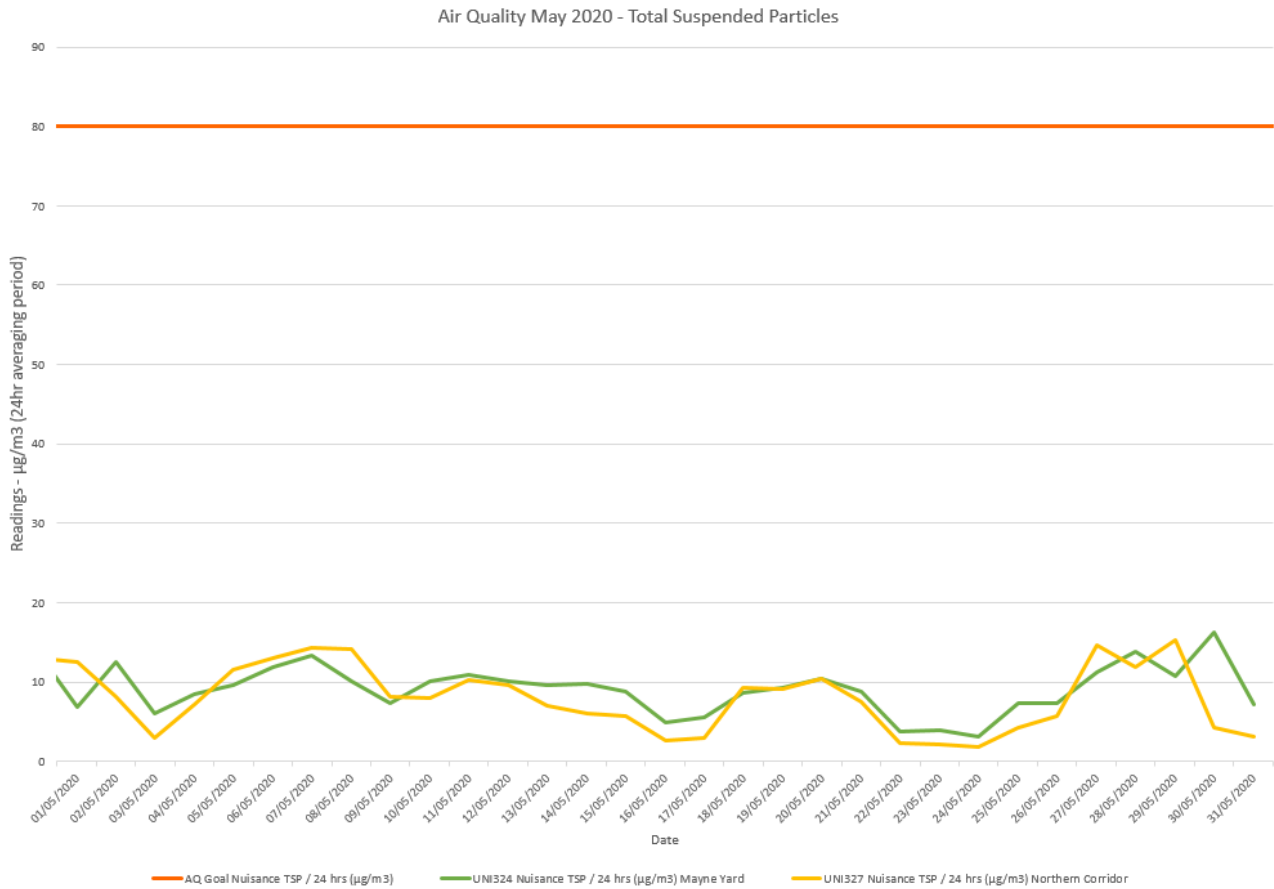
PM₁₀ is one of the indicators for which the Coordinator General has imposed a goal of 50 µg/m³ (over an averaging period of 24 hours) the project must aim to achieve under Imposed Condition 13(a).

TSP is one of the indicators for which the Coordinator General has imposed a goal of 80 µg/m³ (over an averaging period of 24 hours) the project must aim to achieve under Imposed Condition 13(a).

These stations have been set up on site as per AS/NZS 3850 1.1 following consultation with UNITY Air Quality Professionals.

Figure 4: Air Quality Monitoring (TSP) - May 2020 Results

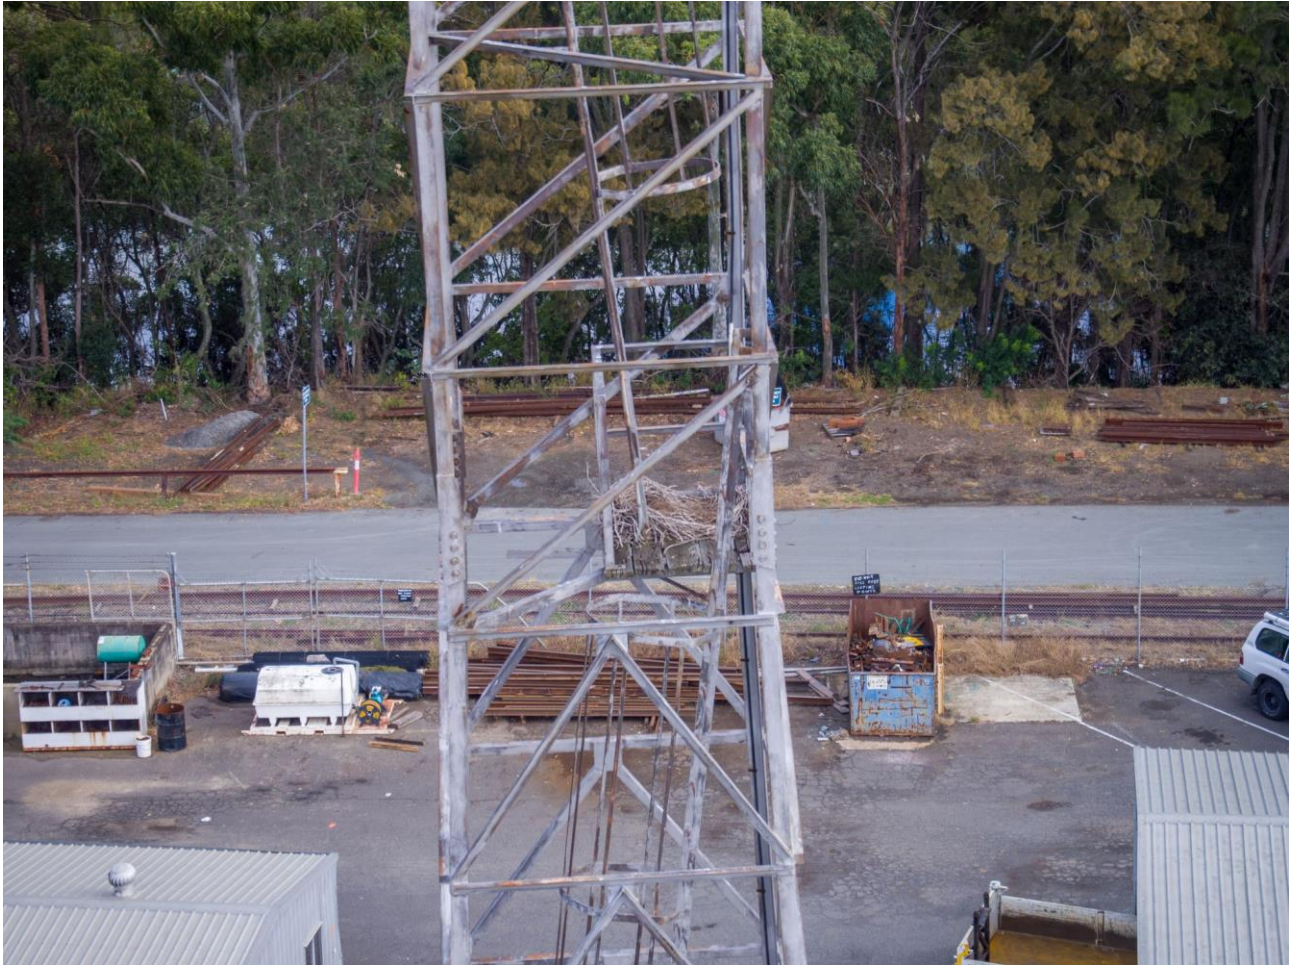
- No Non-Compliance events occurred during the reporting period.
- There were no complaints received associated with the Project Works. This is the sixth month in a row.
- Unity undertook pre-demolition fauna surveys for the three lighting towers using a drone with a high-definition camera to view nests, removing the risks associated with working at heights. The fauna spotter catcher was on site at the time of inspection and was able to determine the nests were no longer in use and cleared the towers for demolition.
