Cross River Rail Project

Monthly Environmental Report

May 2023

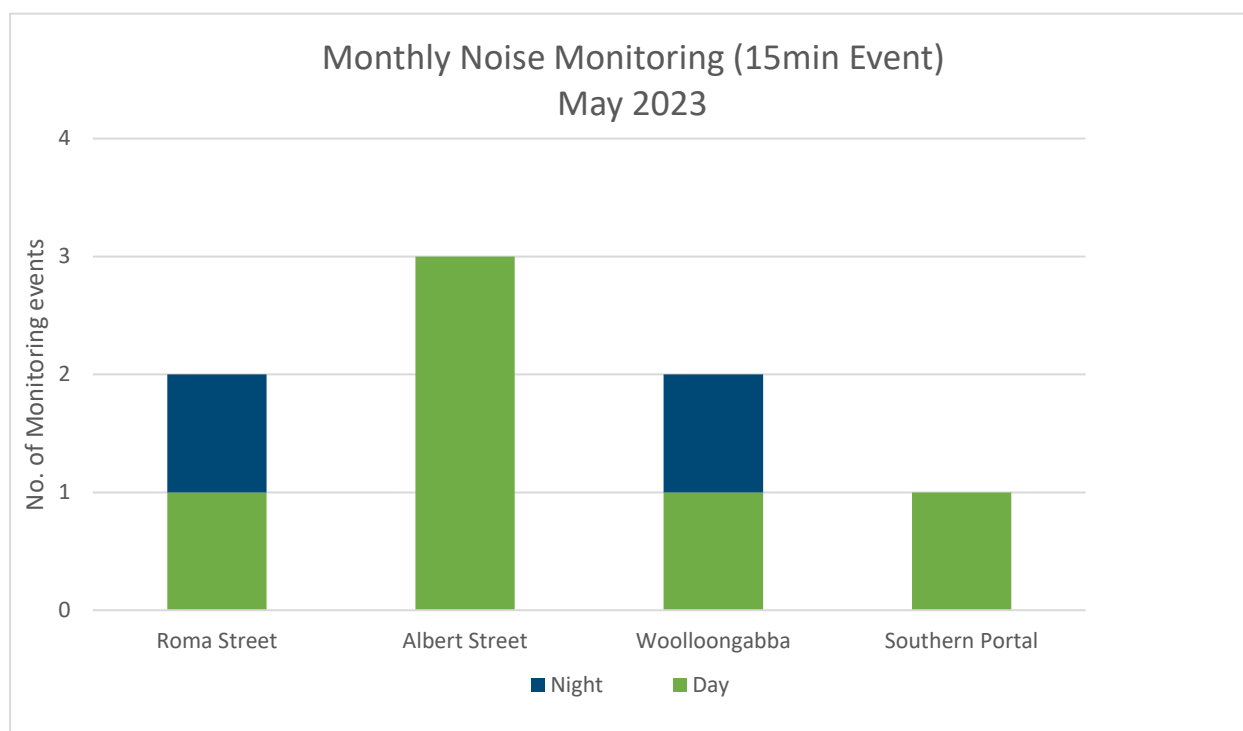
A summary of noise monitoring events for the month is provided in the chart below.

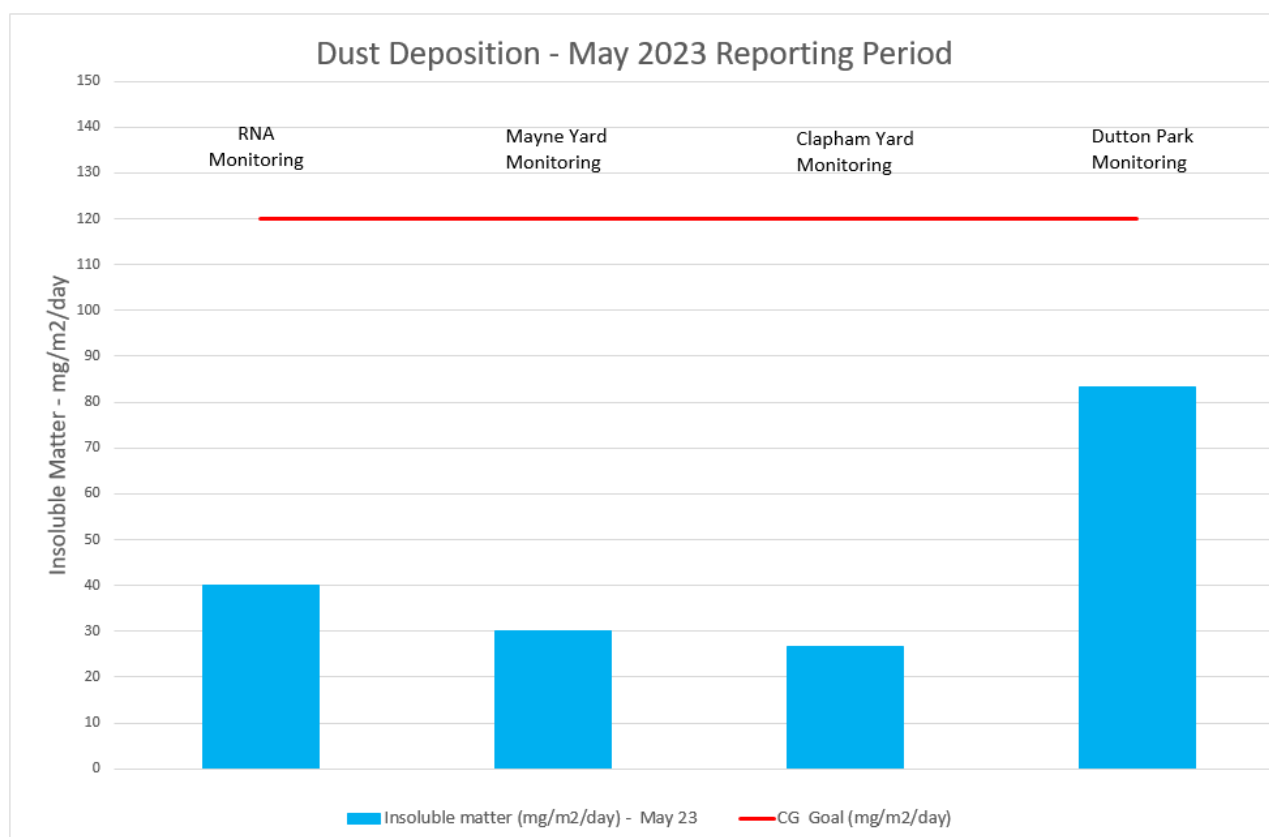
Figure 1 Air Quality Monitoring (Deposited Dust) Results

No exceedances of the dust deposition goal were recorded during the reporting period.

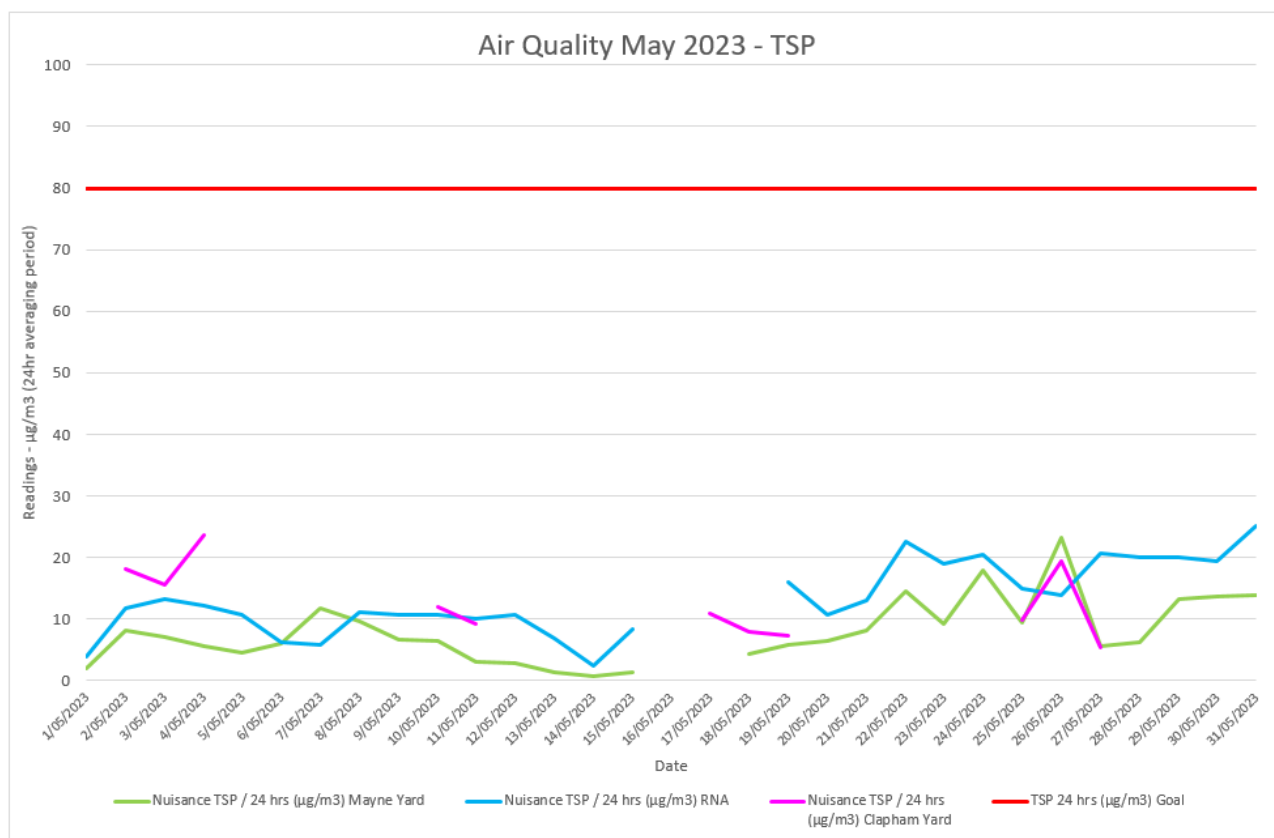
Figure 2 Air Quality Monitoring (TSP) Results

TSP is one of the indicators for which the Coordinator-General has imposed a goal of 80 $\mu\text{g}/\text{m}^3$ (over an averaging period of 24 hours) the project must aim to achieve under Imposed Condition 13(a).

These stations have been installed on-site as per AS/NZS 3850 1.1 following consultation with UNITY air quality professionals. The results are represented in the below figures.

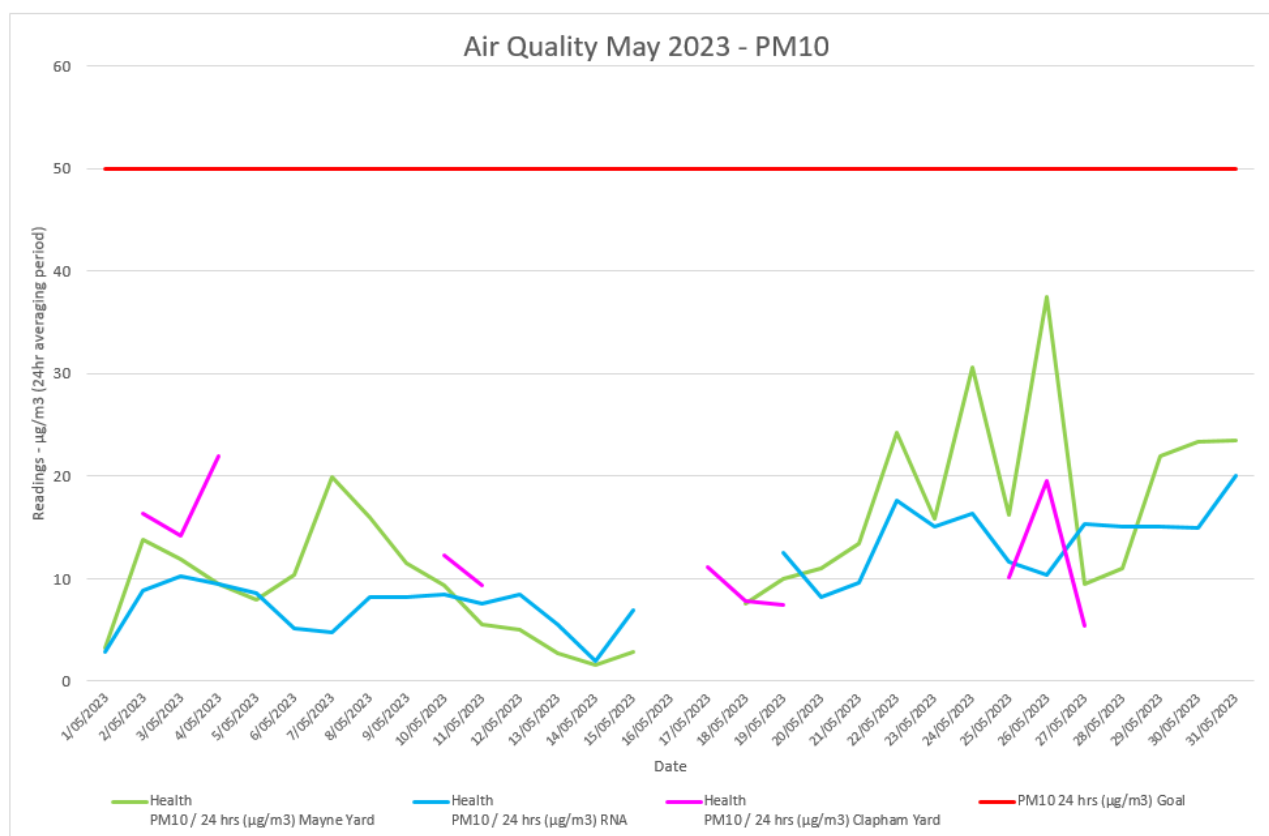
Figure 3 Air Quality Monitoring (PM10) Results

PM_{10} is one of the indicators for which the Coordinator-General has imposed a goal of 50 $\mu\text{g}/\text{m}^3$ (over an averaging period of 24 hours) the project must aim to achieve under Imposed Condition 13(a).

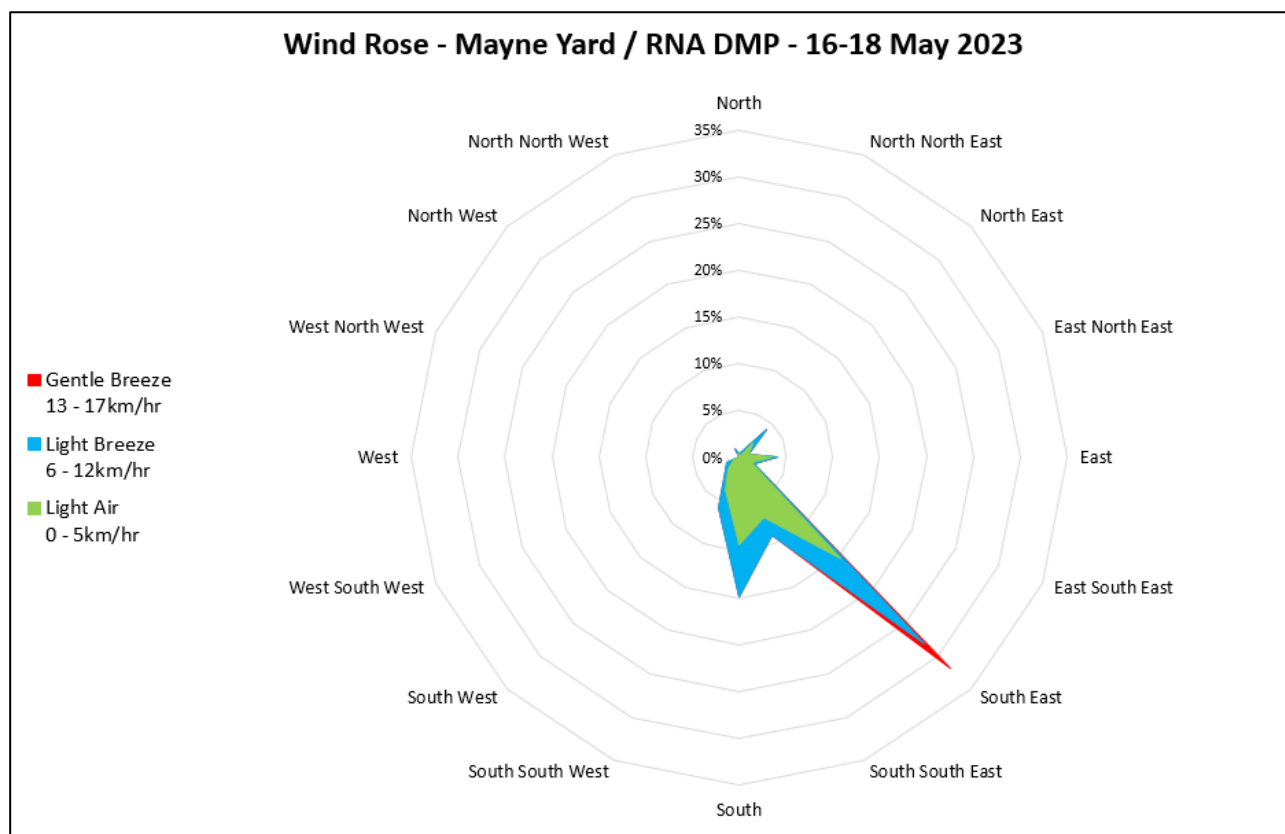
Figure 4 Mayne Yard / RNA DMP Wind Rose 16-18 May 2023

As shown in the wind rose below (refer Figure 4) the predominant winds during the measurement period were from a south-easterly direction. As a result, any potential dust generated from UNITY works would have travelled west across the Mayne Yard and RNA work areas and away from sensitive receivers (refer to Attachment 3).

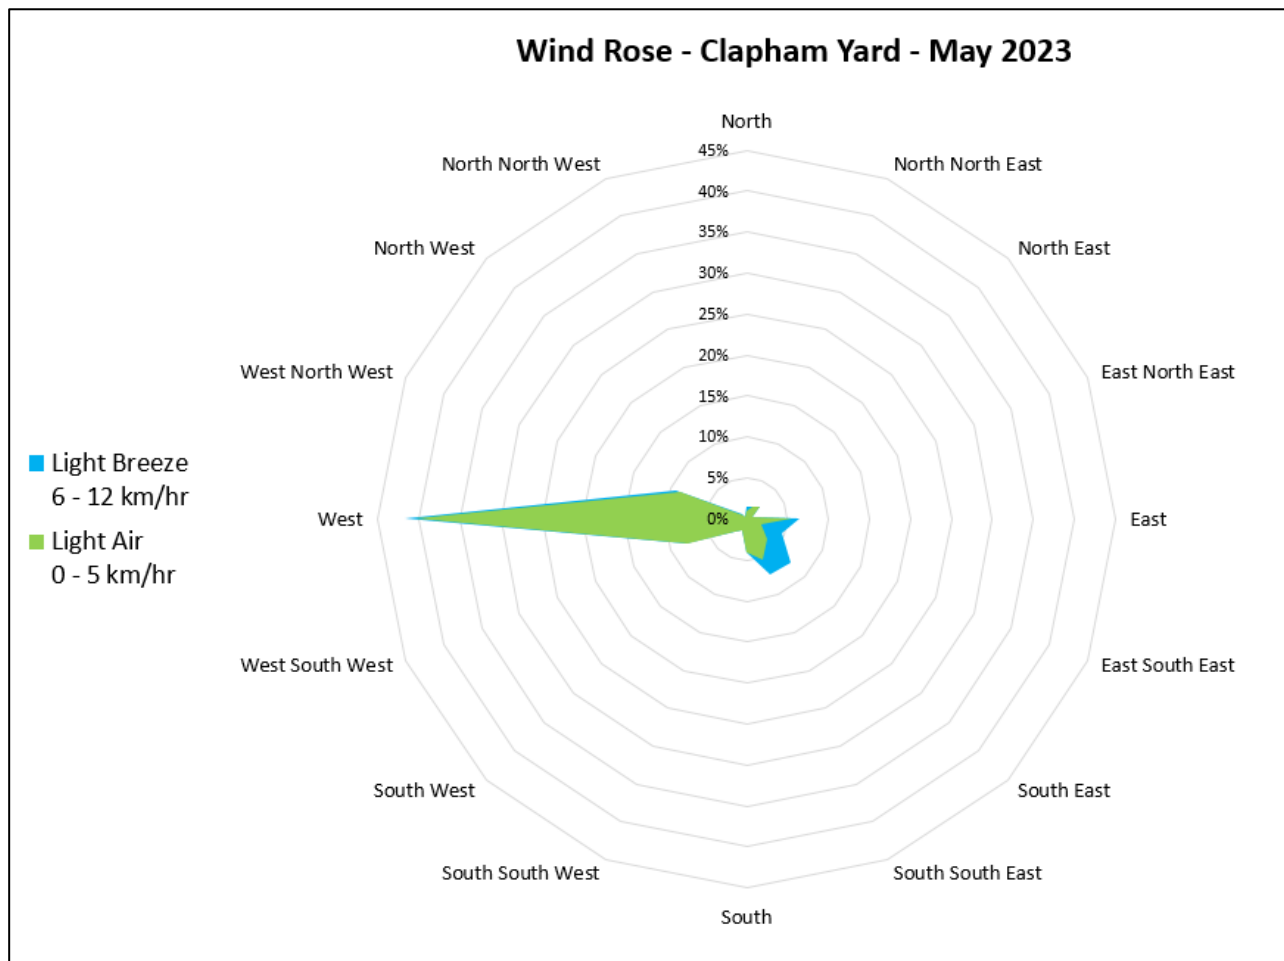
Figure 5 Clapham Yard Wind Rose May 2023

As shown in the wind rose below (refer Figure) the predominant winds during the reporting period were from a westerly and south-easterly direction. As a result, any potential dust generated from UNITY works

would have travelled east across the Clapham Yard work area and towards the dust deposition gauge located at Unwin Street, Moorooka (refer to Attachment 3).

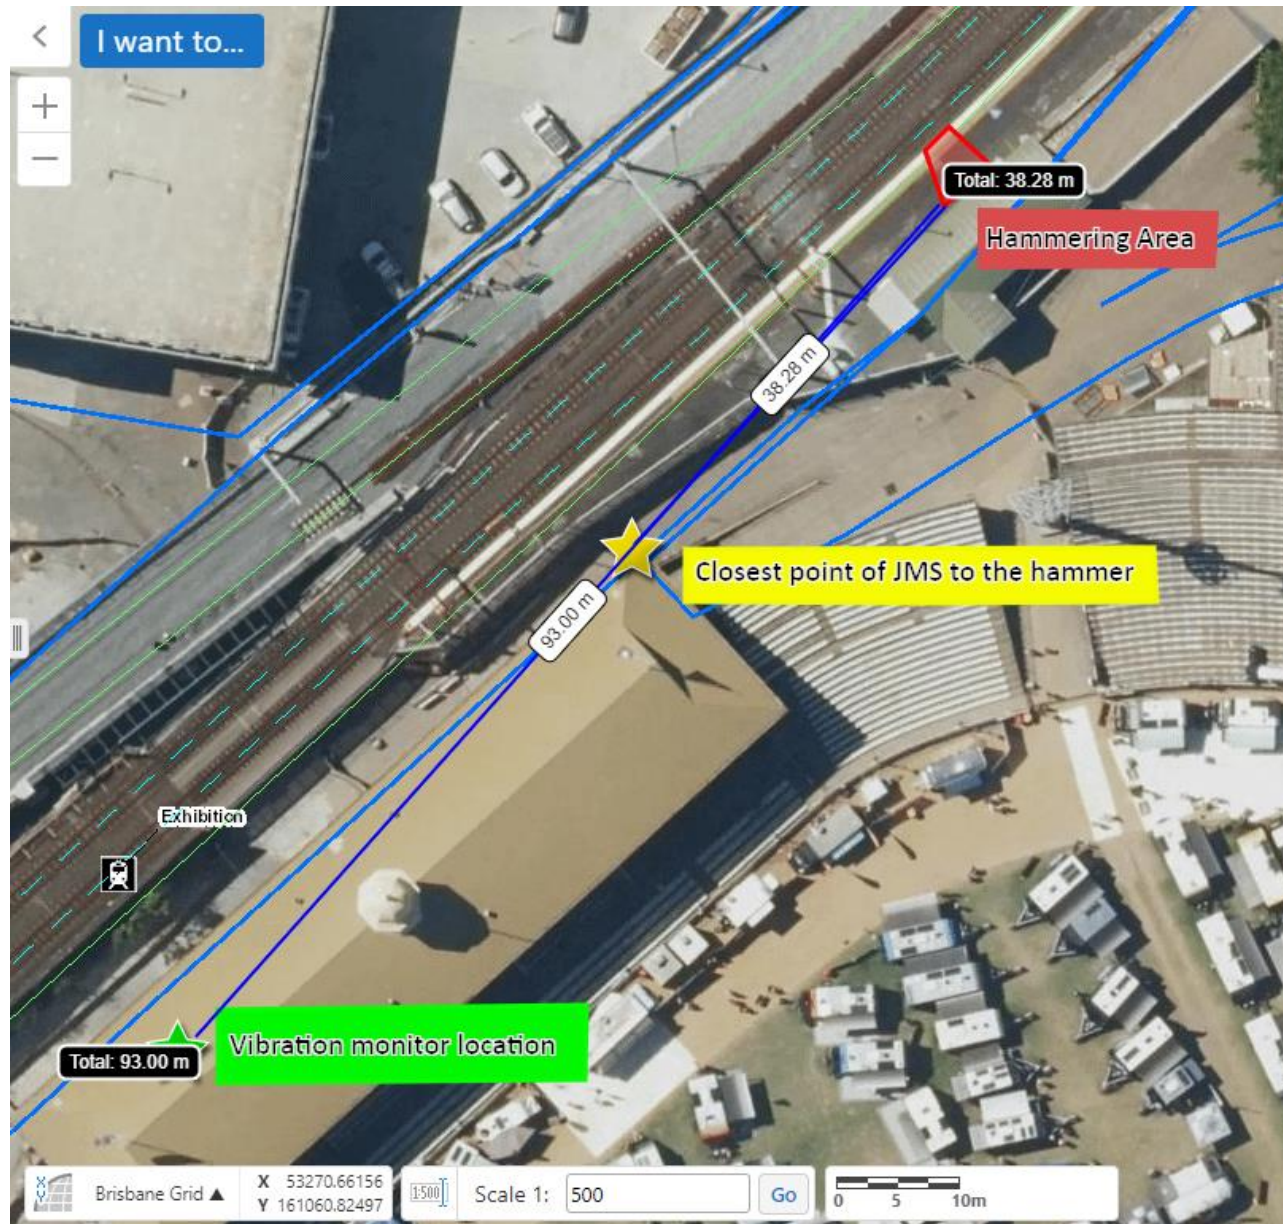
Figure 6 RNA May 2023 Vibration Monitoring

Vibration monitoring during platform demolition at the redundant Exhibition Station (RNA) was undertaken at the foundation of the State heritage John MacDonald Stand inside a storeroom. This location was selected based on the outcomes of predictive assessments.

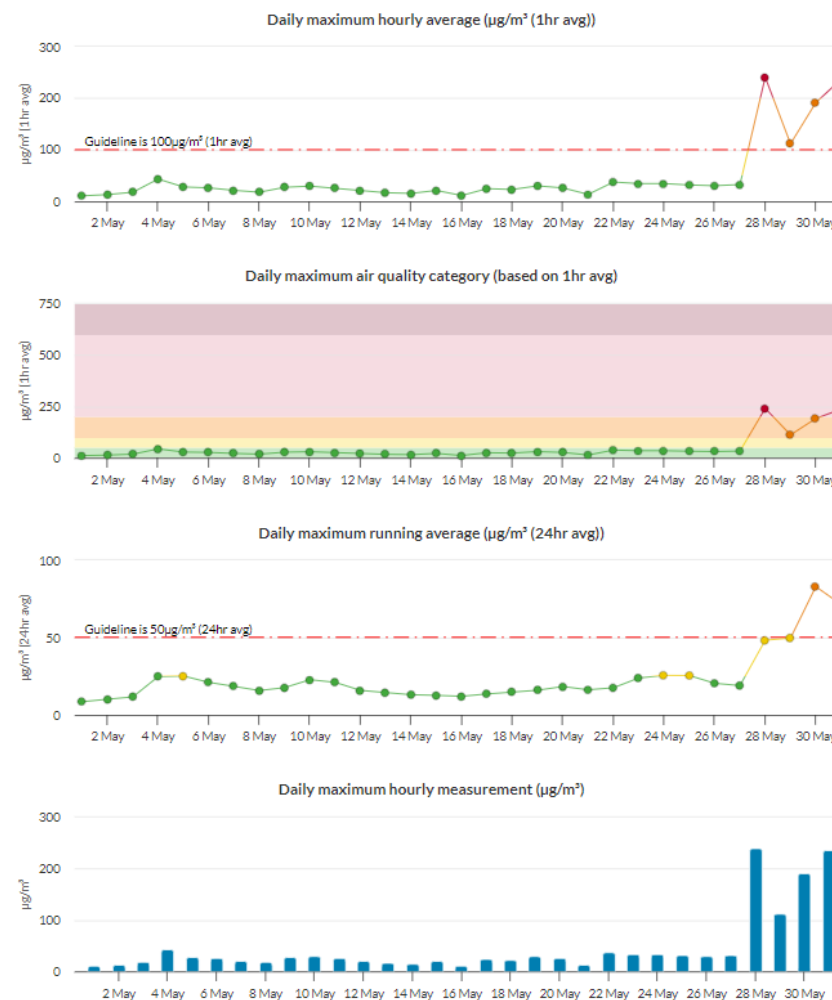
The guideline for Particle PM₁₀ is 100µg/m³ (1hr avg) and 50µg/m³ (24hr avg).

Figure 1: Brisbane CBD – DES Station - PM10 graph for May 2023 (reproduction from the DES website).

The TSD contractor recorded exceedances of the TSP and PM₁₀ air quality goals across Northern Portal, Woolloongabba and Boggo Road worksites over multiple days. Upon further investigation, it was confirmed that Brisbane experienced elevated smoke and particulate concentration during 28 May to 31 May 2023. This was due to a regional scale controlled burning event that had a significant impact on reported particulate concentrations. Nearby Department of Environment and Science (DES) air

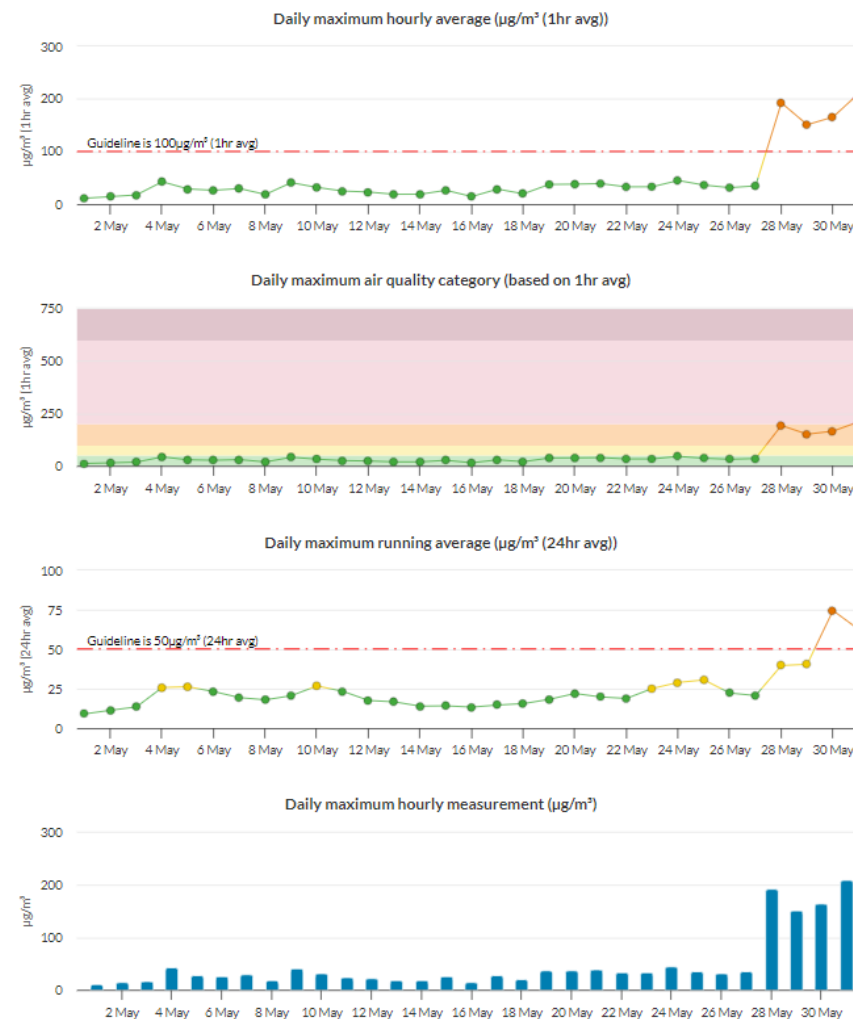
The guideline for Particle PM₁₀ is 100µg/m³ (1hr avg) and 50µg/m³ (24hr avg).

Figure 2: South Brisbane – DES Station - PM10 graph for May 2023 (reproduction from the DES website).

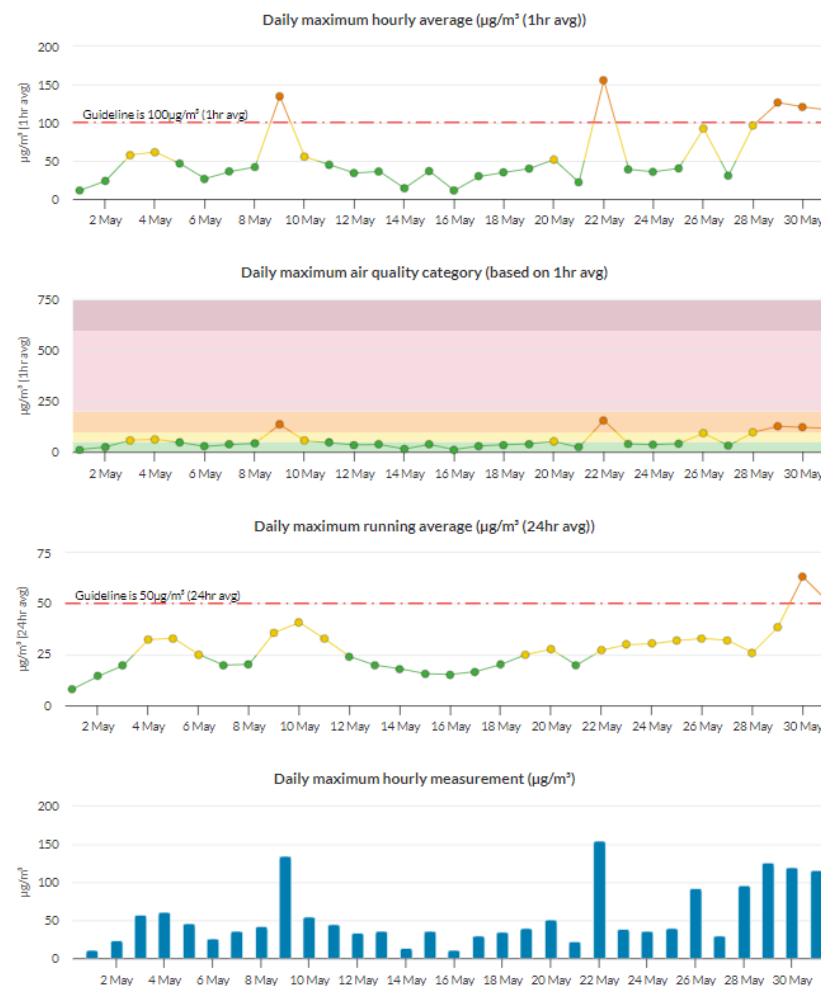
The guideline for Particle PM₁₀ is 100µg/m³ (1hr avg) and 50µg/m³ (24hr avg).

Figure 3: Woolloongabba – DES Station - PM10 graph for May 2023 (reproduction from the DES website).
