Cross River Rail Project

Monthly Environmental Report

November 2021

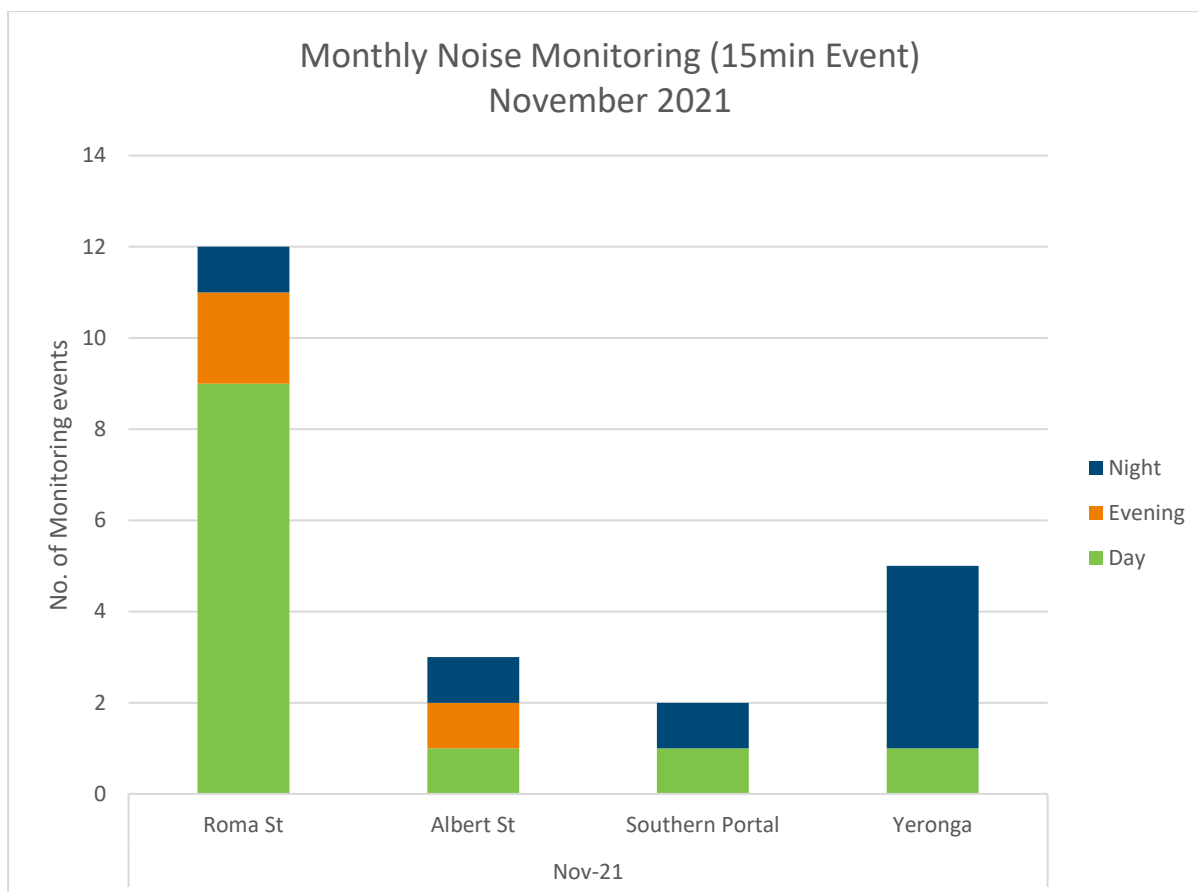
In the Southern Area, noise monitoring was undertaken to validate the predictive model during a crane lift for the pedestrian overpass at Yeronga and during use of a vacuum truck at Rocklea during extended hours. Monitored noise levels met project requirements. Noise monitoring in response to complaints was not triggered. Monitoring results for the Southern Area are detailed in Table 4, **Appendix A**.

A summary of noise monitoring events for the month is provided in the chart below.

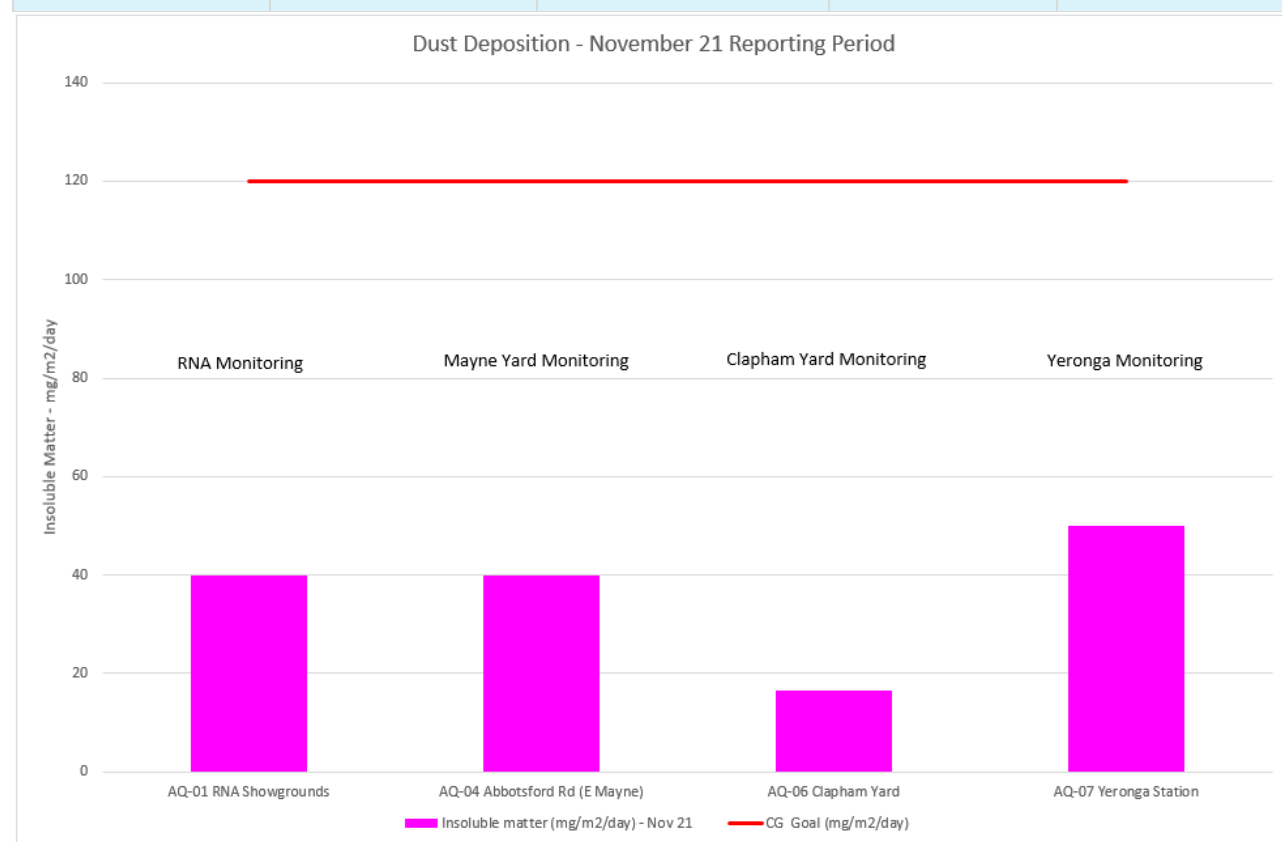
Figure 1 Air Quality Monitoring (Deposited Dust) Results

| CGCR Goal (mg/m ² /day) | AQ-01 - RNA Showgrounds (mg/m ² /day) | AQ-04 Abbotsford Rd (E Mayne) (mg/m ² /day) | AQ-06– Clapham Yard (mg/m ² /day) | AQ-07– Yeronga Station (mg/m ² /day) |
|---|--|--|--|---|
| 120 | 40 | 40 | 17 | 50 |
| Total Rainfall during Period | 76.6 | 76.6 | 148 | 148 |

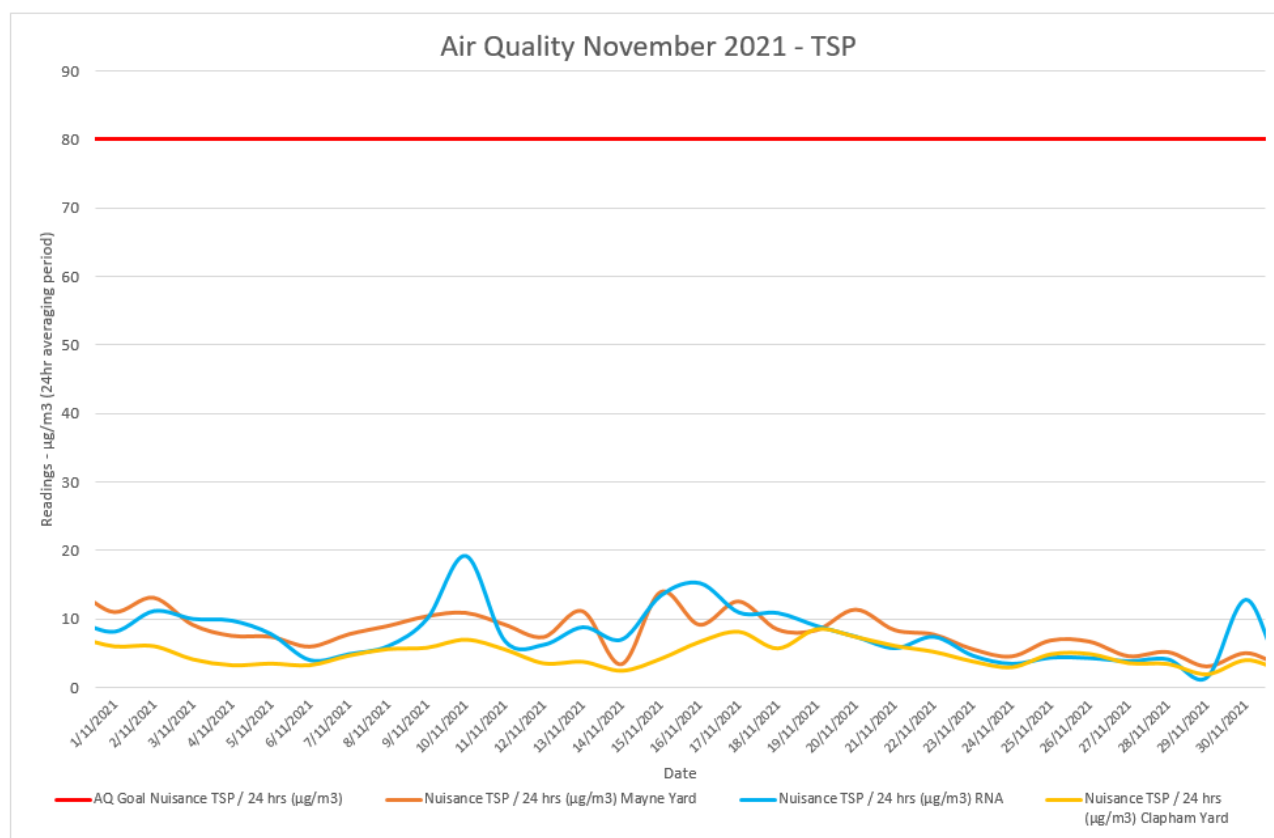
Figure 2 Air Quality Monitoring (TSP) Results

TSP is one of the indicators for which the Coordinator-General has imposed a goal of 80 µg/m³ (over an averaging period of 24 hours) the project must aim to achieve under Imposed Condition 13(a).

These stations have been set up on-site as per AS/NZS 3850 1.1 following consultation with UNITY air quality professionals.

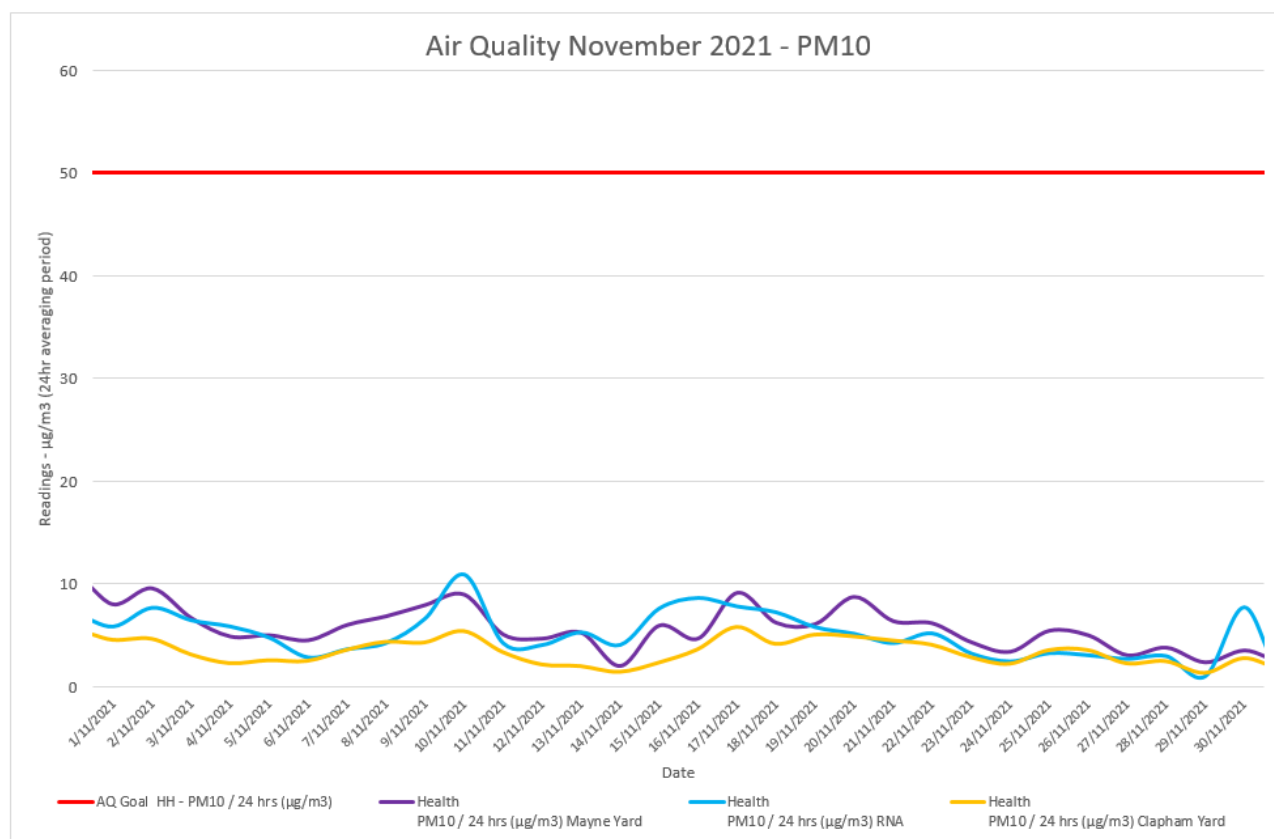
Figure 3 Air Quality Monitoring (PM₁₀) Results

PM₁₀ is one of the indicators for which the Coordinator-General has imposed a goal of 50 µg/m³ (over an averaging period of 24 hours) the project must aim to achieve under Imposed Condition 13(a).

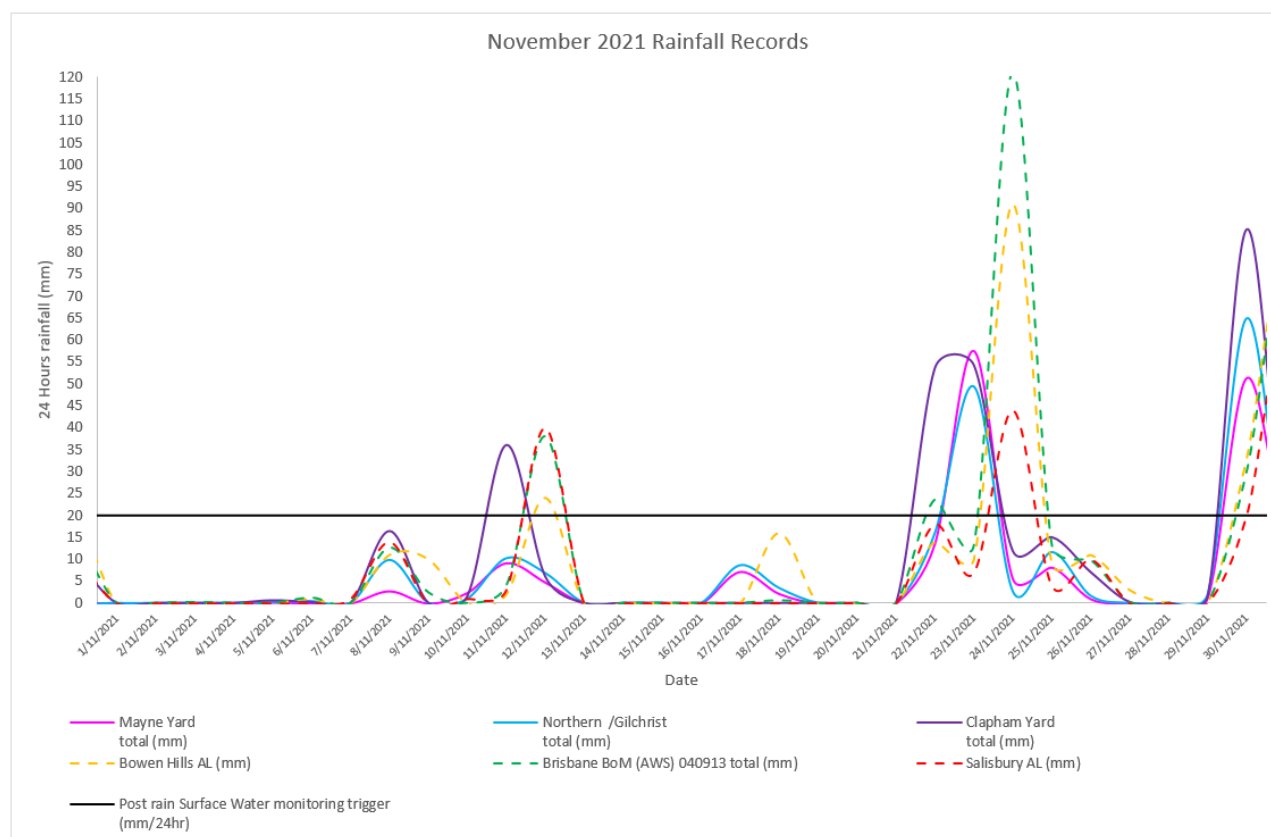
Figure 4 Rainfall Records

Water quality monitoring to demonstrate compliance with Condition 15(b) and Condition 18 was triggered. The rain events recorded during the reporting period at Mayne Yard and Clapham Yard had the potential to result in run-off being generated from these two active worksites.

Post rainfall monitoring is triggered typically following any rainfall event exceeding 20 to 25 mm over 24 hours, however, storm events during the high-risk period of the year (November to March) of lesser amounts but of a higher intensity may cause run-off which would also trigger post-rain monitoring consistent with the CEMP.

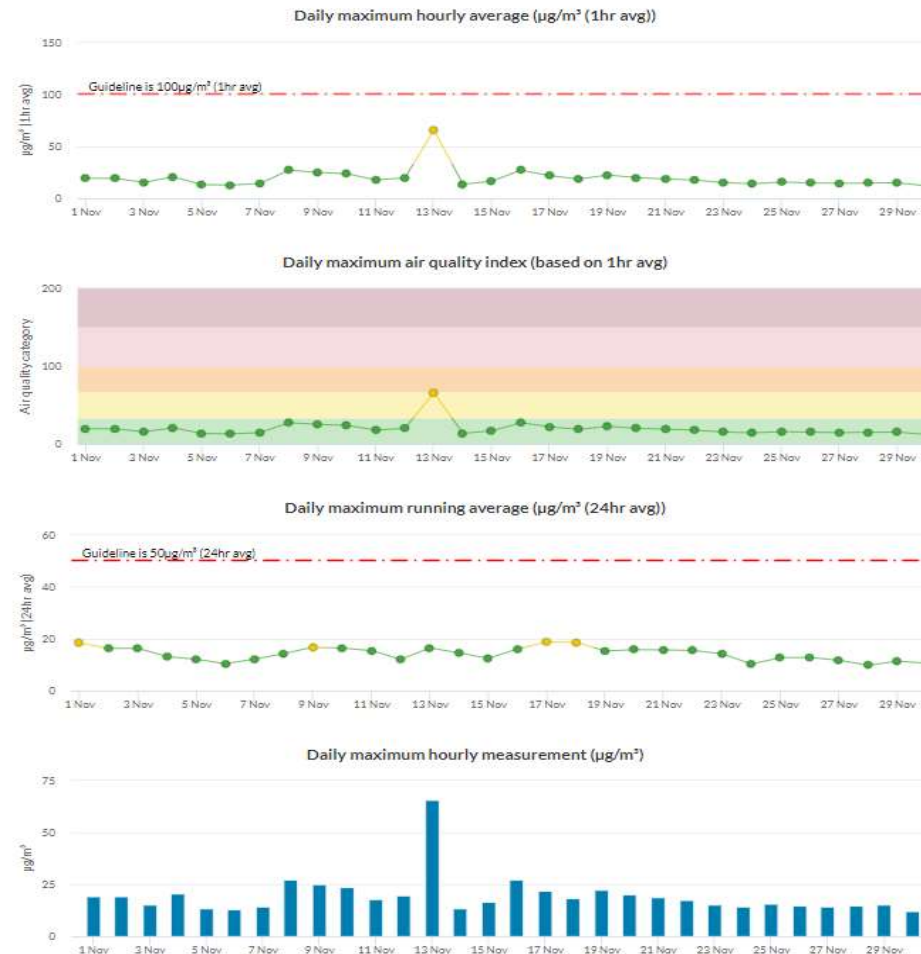
Figure 1: Brisbane CBD – DES Station - PM10 graph for November 2021 (reproduction from the DES website).

The guideline for Particle PM10 is 100µg/m³ (1hr avg) and 50µg/m³ (24hr avg).

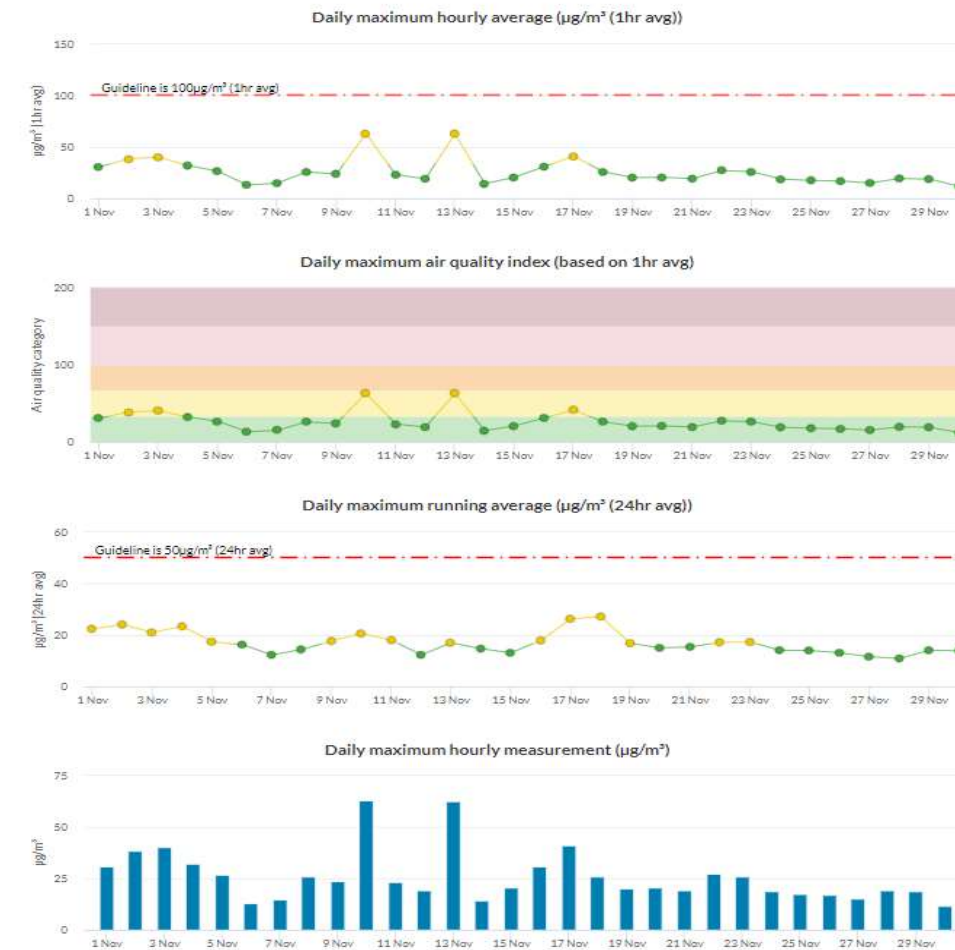
Figure 2: South Brisbane – DES Station - PM10 graph for November 2021 (reproduction from the DES website accessed).

The guideline for Particle PM10 is 100 $\mu\text{g}/\text{m}^3$ (1hr avg) and 50 $\mu\text{g}/\text{m}^3$ (24hr avg).

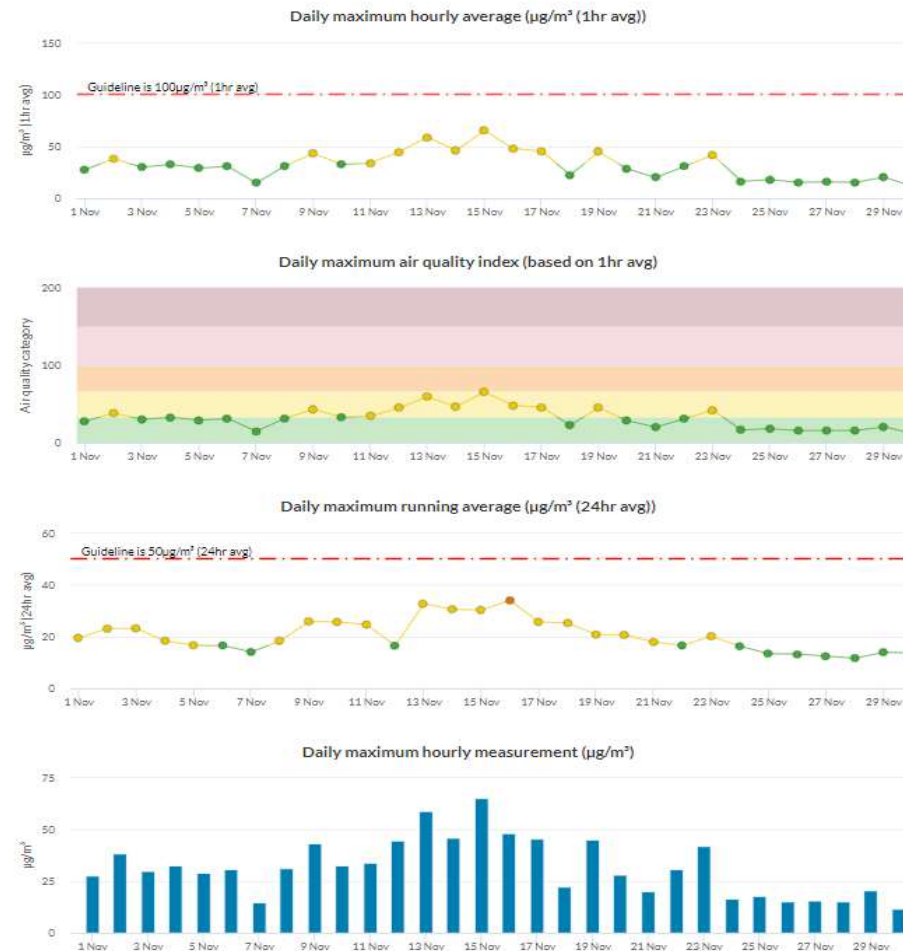
Figure 1: Woolloongabba – DES Station - PM10 graph for November 2021 (reproduction from the DES website).

The guideline for Particle PM10 is 100µg/m³ (1hr avg) and 50µg/m³ (24hr avg).
