Cross River Rail Project

Monthly Environmental Report

October 2022

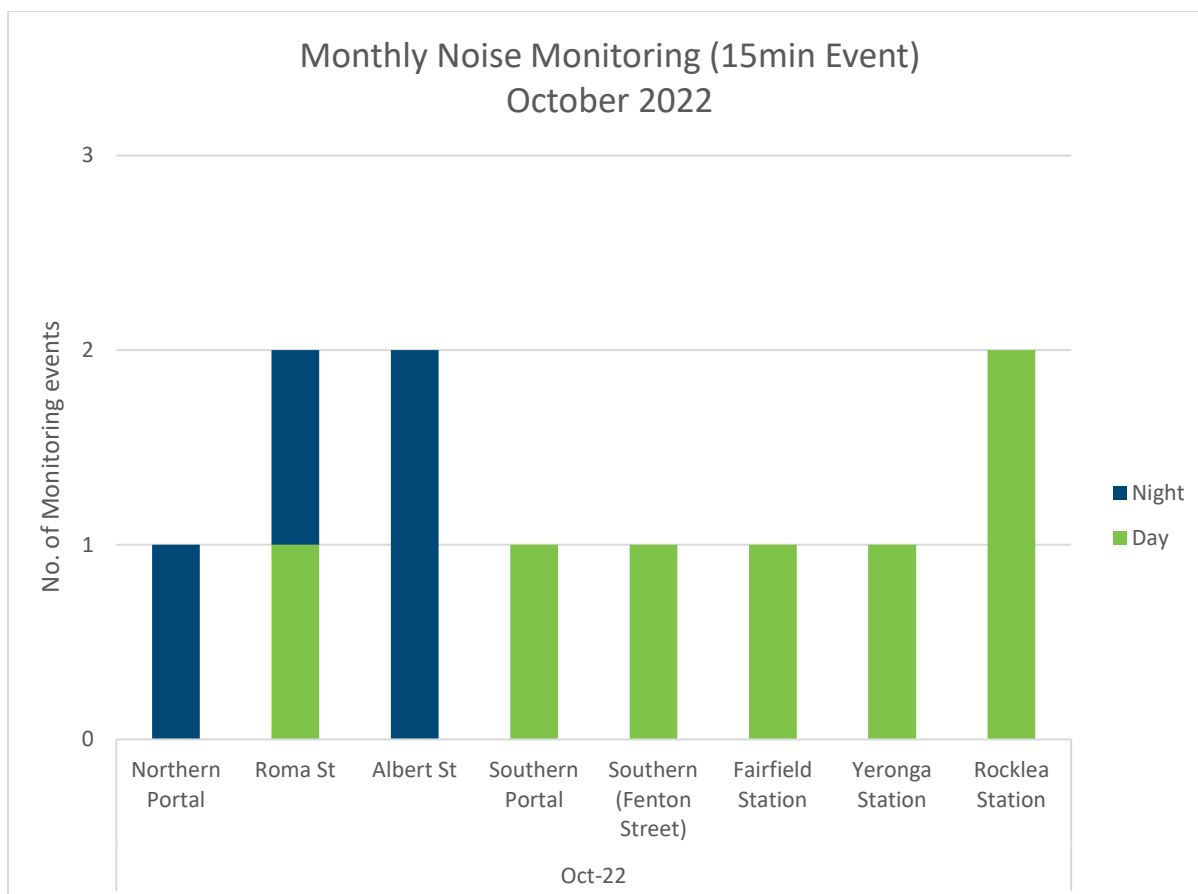
In the Southern Area, noise monitoring was undertaken by the RIS contractors to validate predictive modelling at sensitive places. This occurred at sensitive receivers nearby to Rocklea station, Yeronga Station and Southern (Fenton Street) for noise intensive activities associated with the October SCAS Project Works. The monitoring was consistent with the predictive noise levels. One round of monitoring was undertaken in response to a noise complaint at Fairfield station related to October SCAS activities. The monitoring confirmed the extended hours noise goals + 20dBA were not exceeded. The RIS scope of works continued to achieve the project requirements.

A summary of noise monitoring events for the month is provided in the chart below.

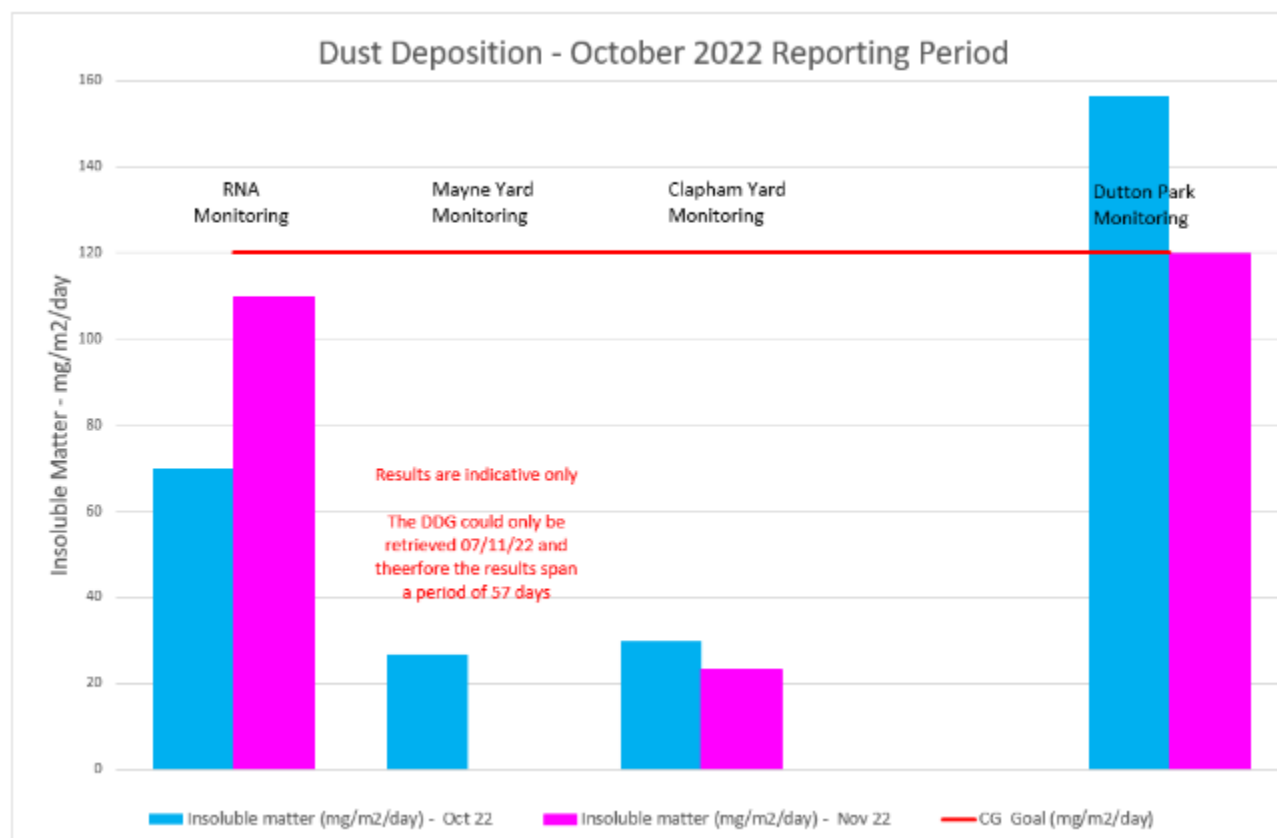
Figure 1 Air Quality Monitoring (Deposited Dust) Results

CGCR Goal (mg/m ² /day)	AQ-01 - RNA Showgrounds (mg/m ² /day)	AQ-04 Abbotsford Rd (E Mayne) (mg/m ² /day)	AQ-06– Clapham Yard (mg/m ² /day)	AQ-08 – Dutton Park (mg/m ² /day)
120 (15/09/22 to 11/11/22)	-	27*	-	-
Total Rainfall during Period (mm)	107.8	107.2	228.6	113

* Results are indicative only – DDG was in place for 57 days

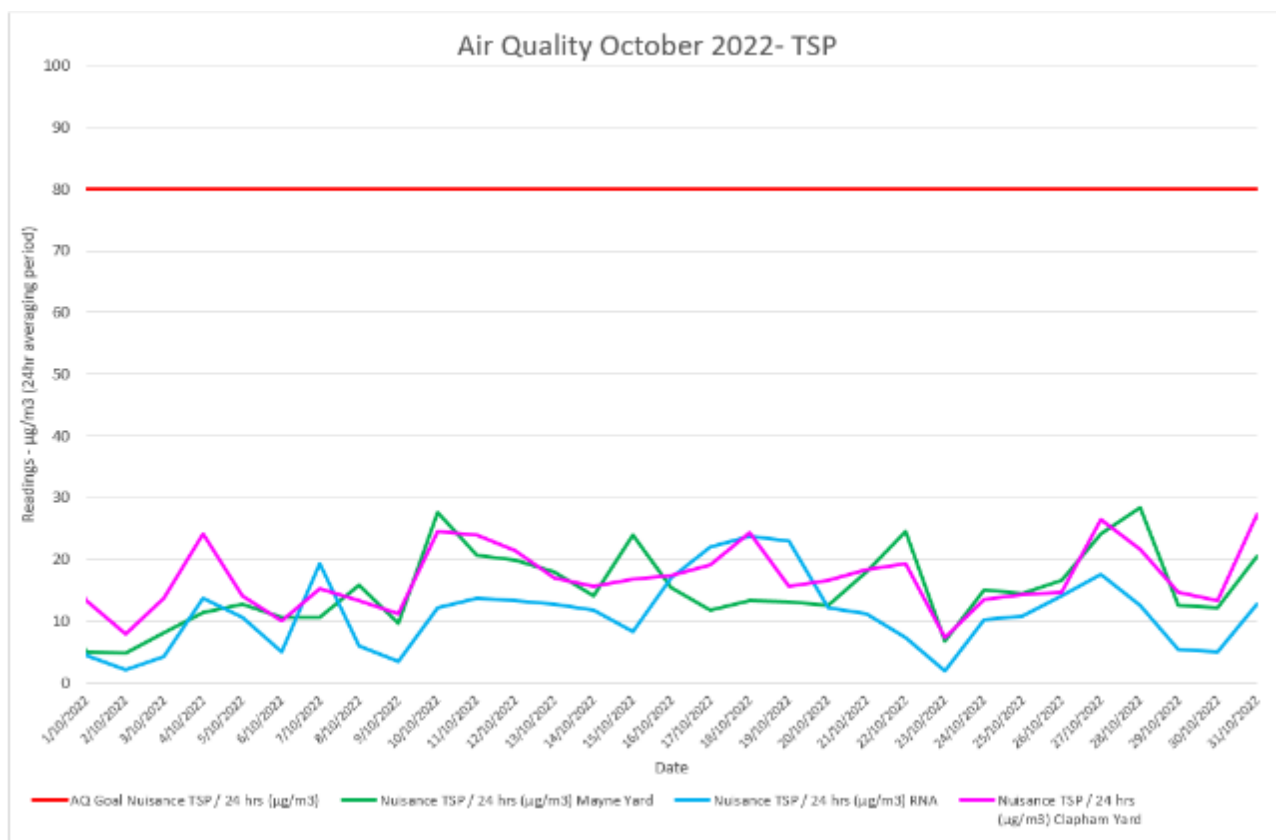
Figure 2 Air Quality Monitoring (TSP) Results

The deposited dust result also met the Air Quality Goal, and significant erosion control (soil binder) and active dust suppression (water carts) were implemented at Clapham Yard during non-rainy days.

It is therefore unlikely that the particulate results for PM₁₀ and TSP were exceeded on the days of the data loss.

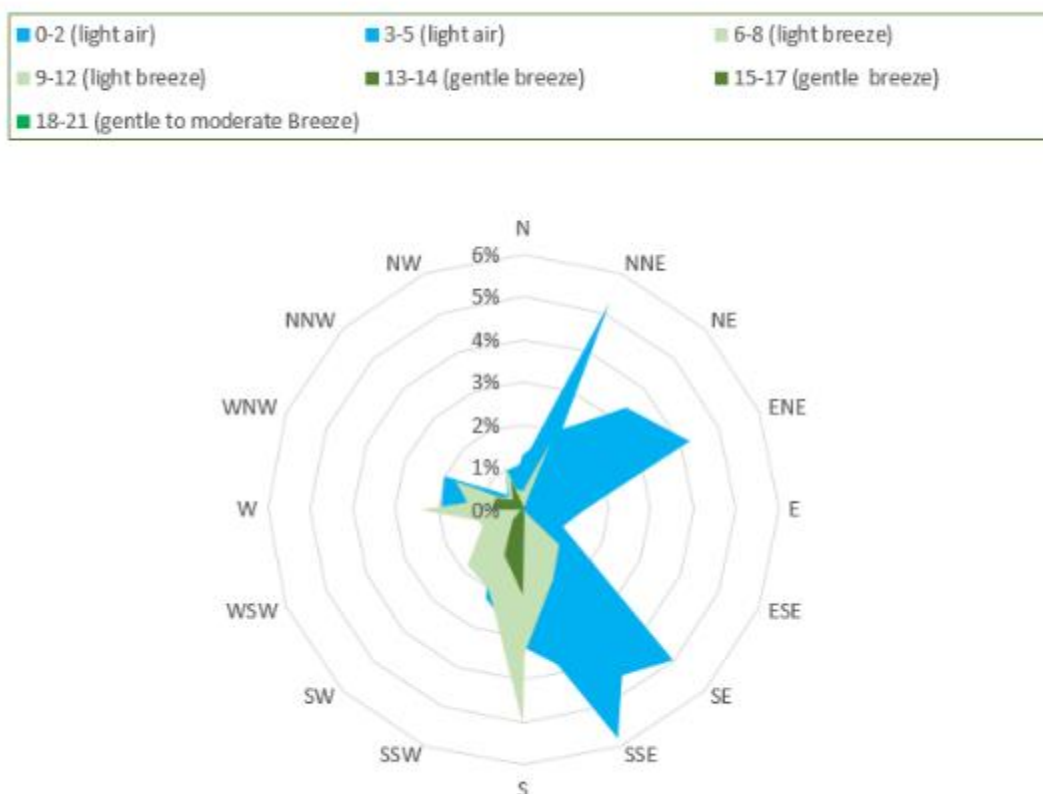
Figure 4 Southern Wind Rose)

- The DDG was downwind of the Project Works 54% of the time, and
- That wind conditions were light to gentle (under the Beaufort Scale) during the entire DDG exposure period.

Finally, a review of the DDG results over the last 3 months has confirmed a progressive increase of the deposited dust results as the scale and intensity of the Project Works increased.

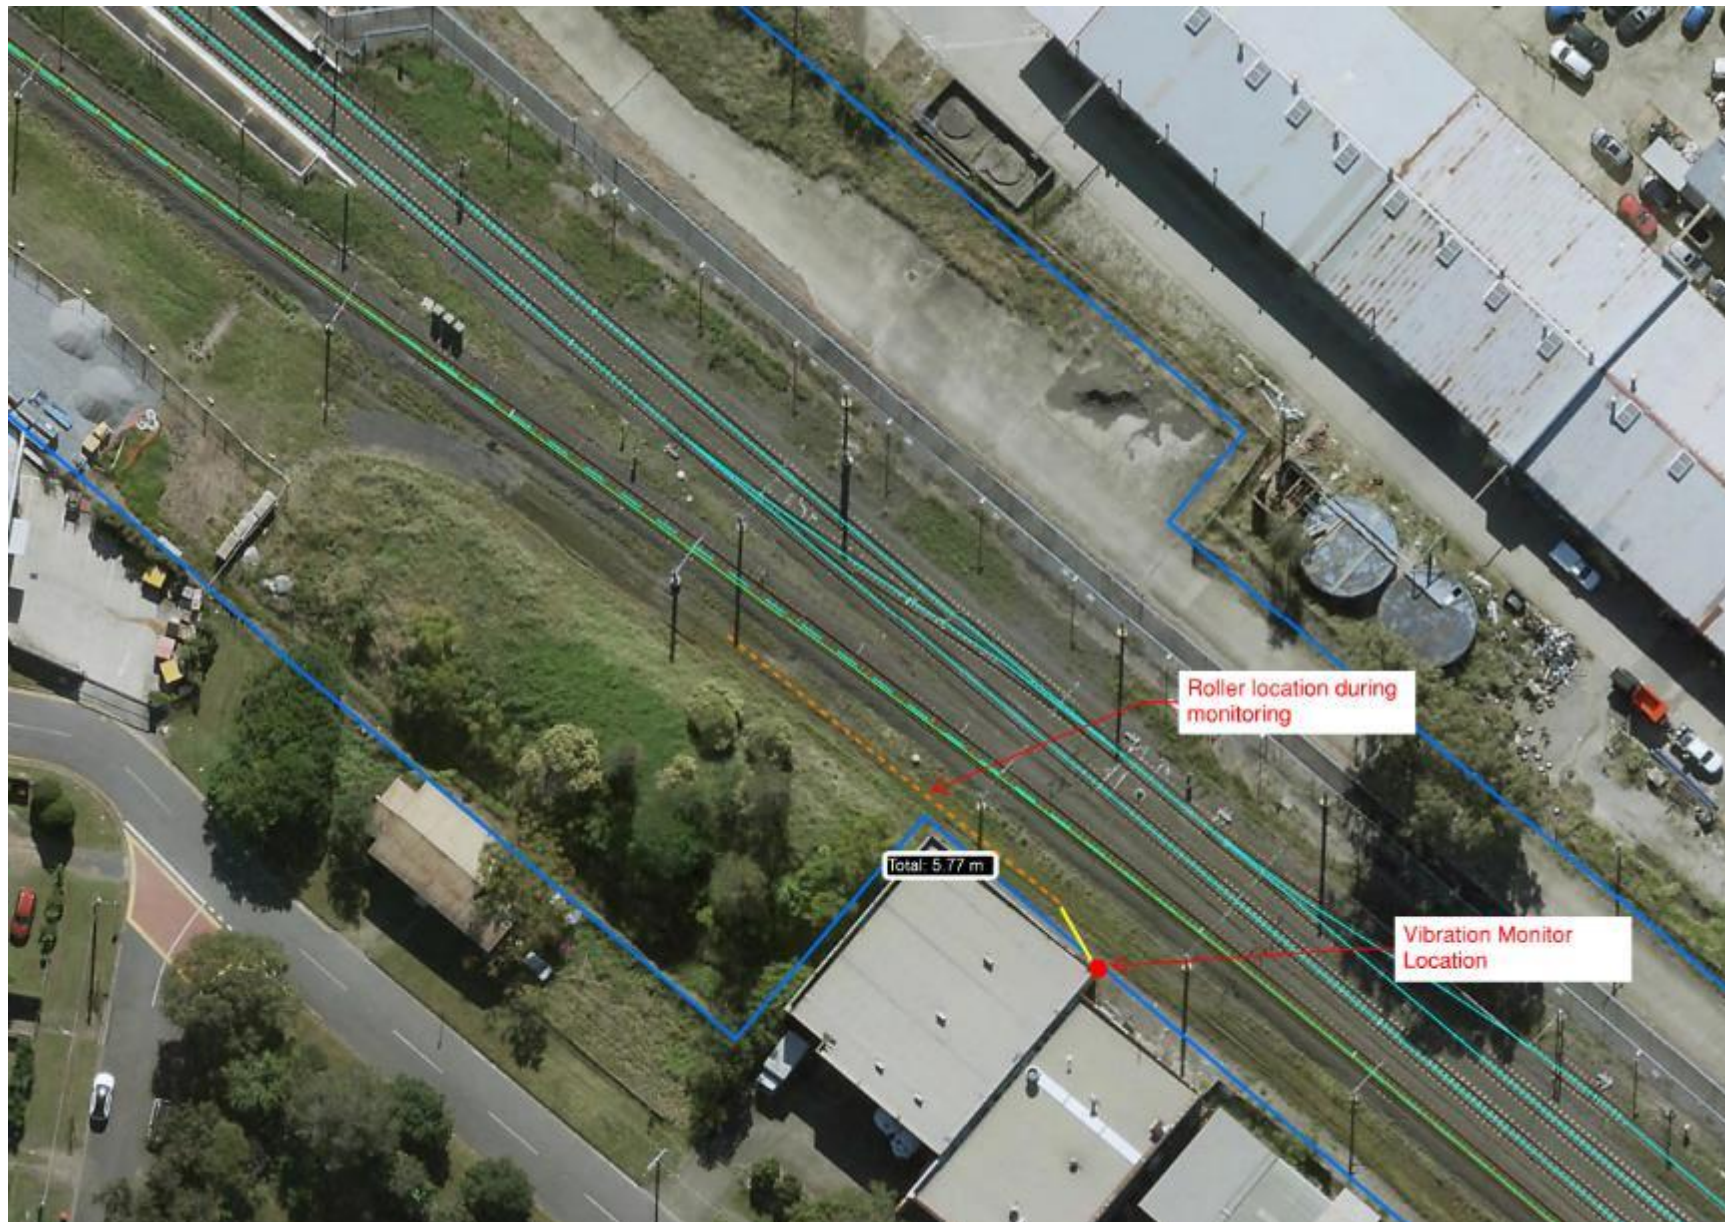
Rocklea Station Track Lowering – 1 – 3 October (Vibration)

In the Southern Area, vibration monitoring was triggered at Rocklea Station during the use of a 12T vibratory roller. No exceedance of the vibration goal for cosmetic damage was recorded. The RIS contractors reported that the project vibration requirements have been met for the reporting period.

No exceedance of the vibration goal for Cosmetic Damage was recorded.

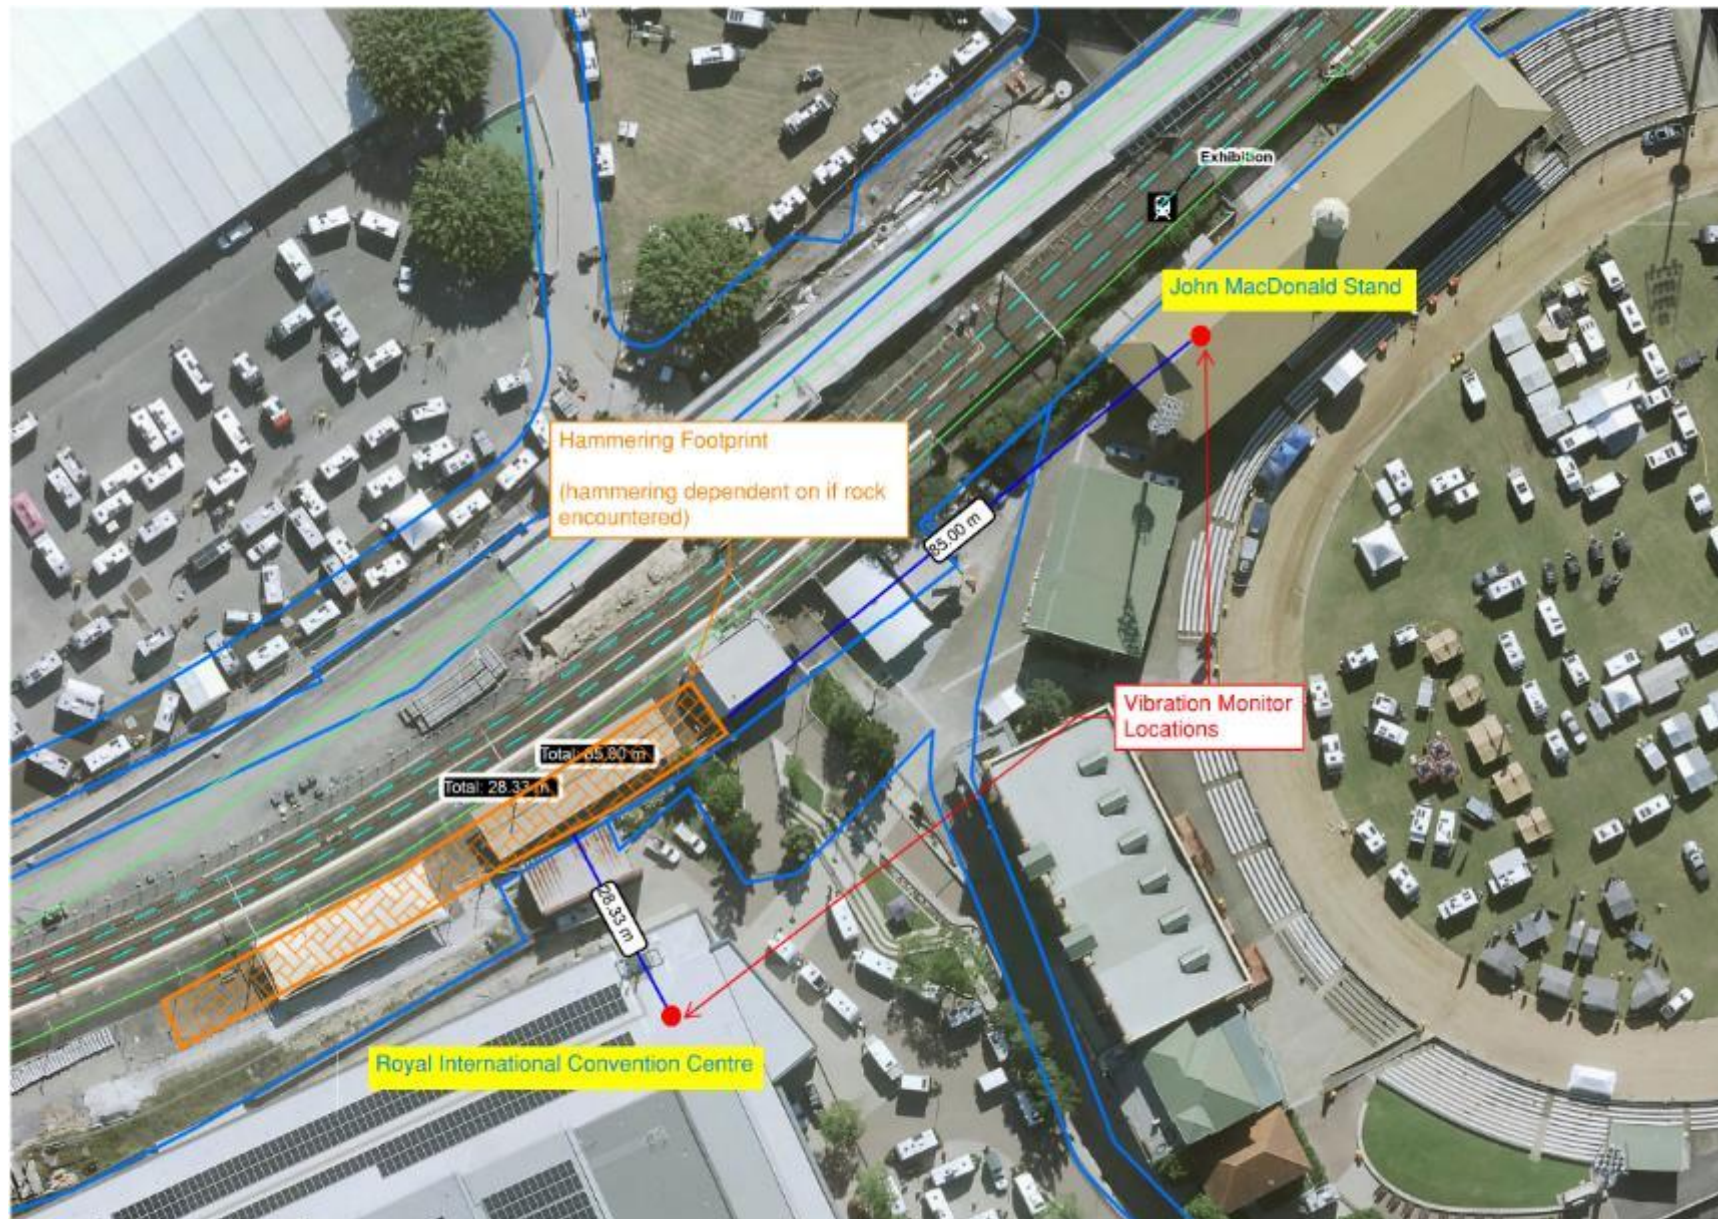
RNA – October 2022 – John MacDonald Stand and Royal International Convention Centre (Vibration)

In the Northern Area, vibration monitoring continued at RNA during the use of a 430kg hammer in close proximity to the State heritage listed John MacDonald Stand. Monitoring results did not exceed the vibration goal and are detailed in **Appendix A** (Table 5).

Vibration monitoring during rock breaking works at the RNA Showgrounds was undertaken at the foundation of the State heritage listed John MacDonald Stand within the Bar Room and the Royal International Convention Centre inside a storeroom. These locations were selected based on the outcomes of predictive assessments.

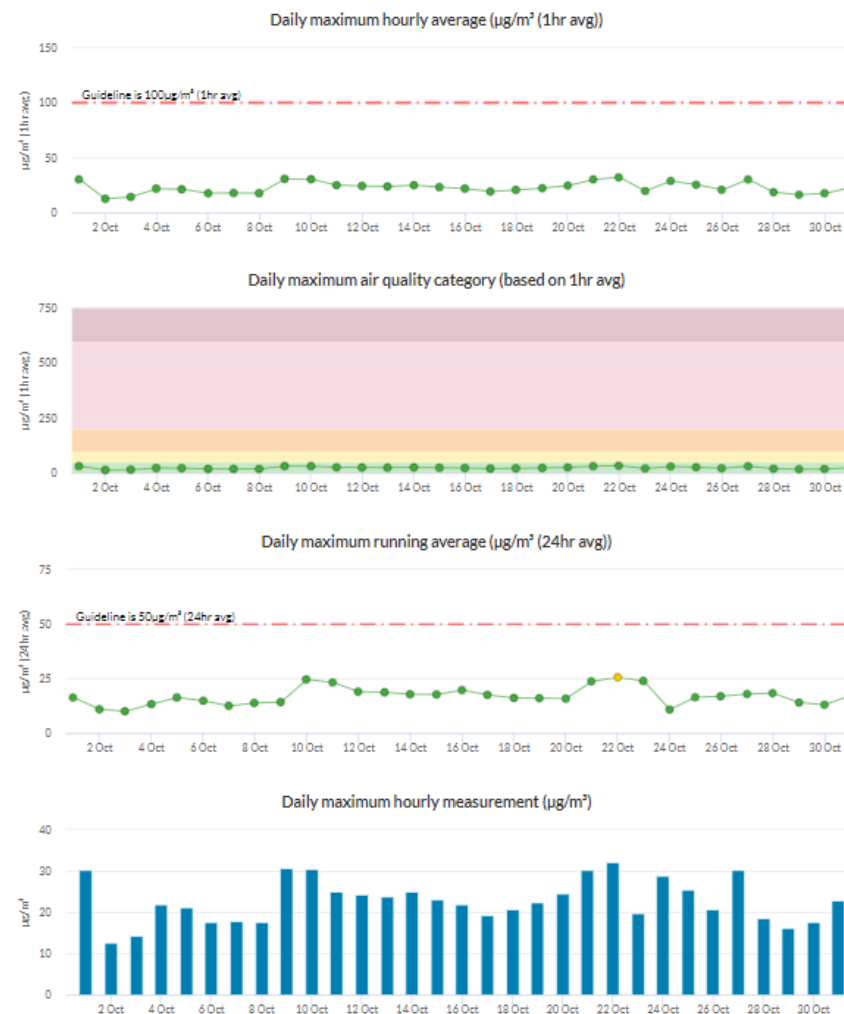
Figure 2: South Brisbane – DES Station - PM10 graph for October 2022 (reproduction from the DES website).

The guideline for Particle PM₁₀ is 100µg/m³ (1hr avg) and 50µg/m³ (24hr avg).
