Cross River Rail Project

Monthly Environmental Report

September 2020

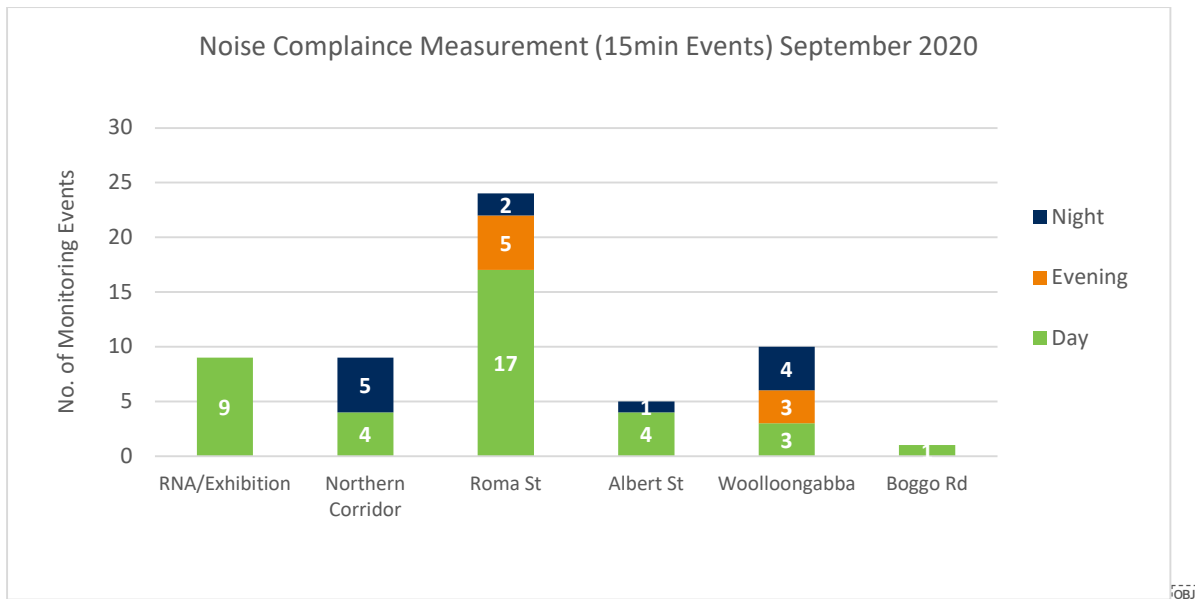
The graph below shows that the majority of the noise monitoring events were taken at and around the Roma Street worksite where major demolition works were occurring throughout the day and evening.

In the Central area, noise monitoring was undertaken for model verification, complaint response and for sensitive places that surround the project worksites. This is detailed in Table 1, **Appendix B**. Where internal monitoring was not possible, contractors have undertaken external monitoring at nominated locations. The contractors used recommended façade attenuation corrections, considering receiver property type, to determine compliance with the project's noise requirements and to provide calibration of the completed modelled predictions. The TSD contractors reported that the project noise requirements have been met during this reporting month.

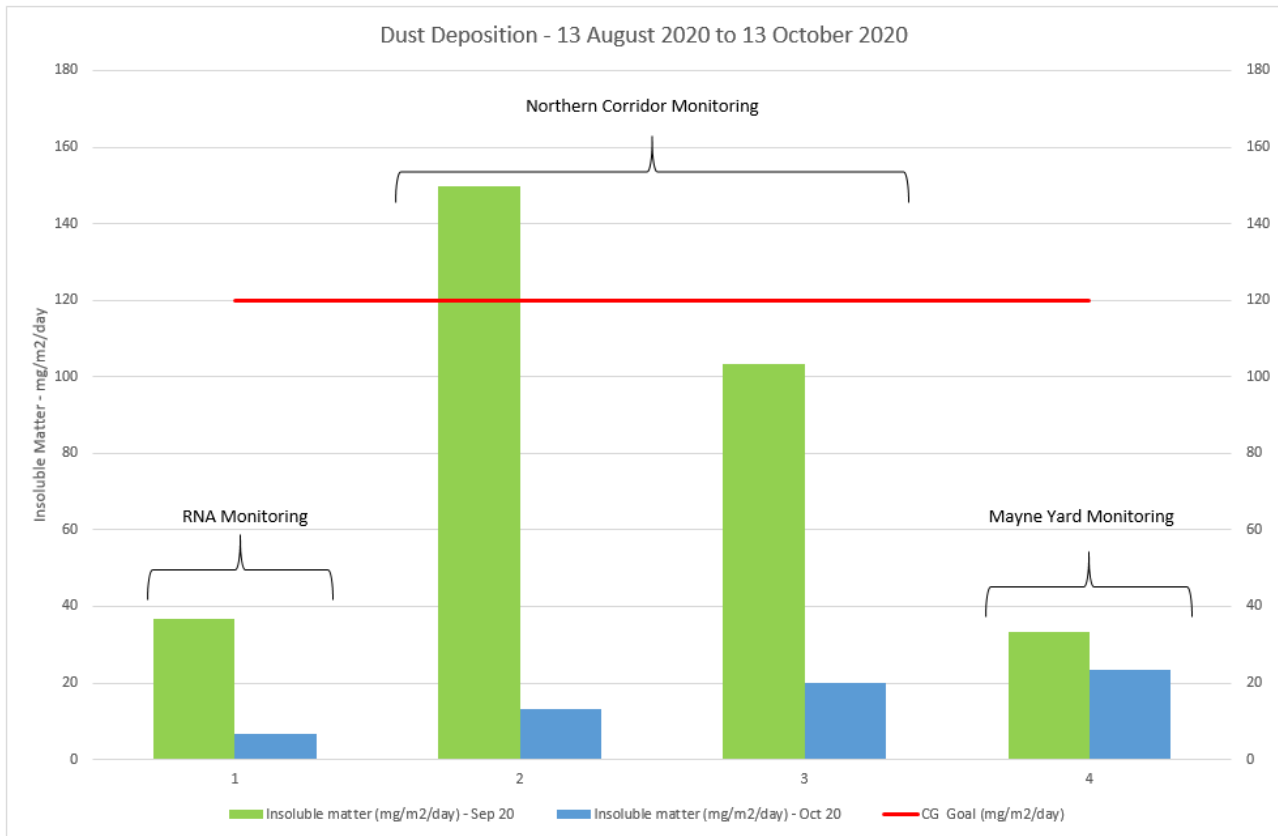
Figure 1: Air Quality Monitoring (Deposited Dust) 13 August – 13 October 2020 Results

Table 5: Dust deposition gauge results for period 13 August 2020 to 13 October 2020.

CGCR Goal (mg/m ² /day)	Period	AQ-01 Results - RNA Showgrounds (mg/m ² /day)	AQ-02 Results - BGS (mg/m ² /day)	AQ-03 Centenary Pool (mg/m ² /day)	AQ-04 Abbotsford Rd (E Mayne) (mg/m ² /day)
120	13 August 2020 to 14 September 2020	37	150	103	33
Total Rainfall during Period		2.8mm	2.8mm	2.8mm	5.2mm
120	14 September to 13 October 2020	7	13	20	23
Total Rainfall during Period		0.0mm	0.0mm	0.0m	0.8 mm

The dust deposition gauges result for the reporting period are detailed below and complied with Imposed Condition 13(b) of the CGCR.

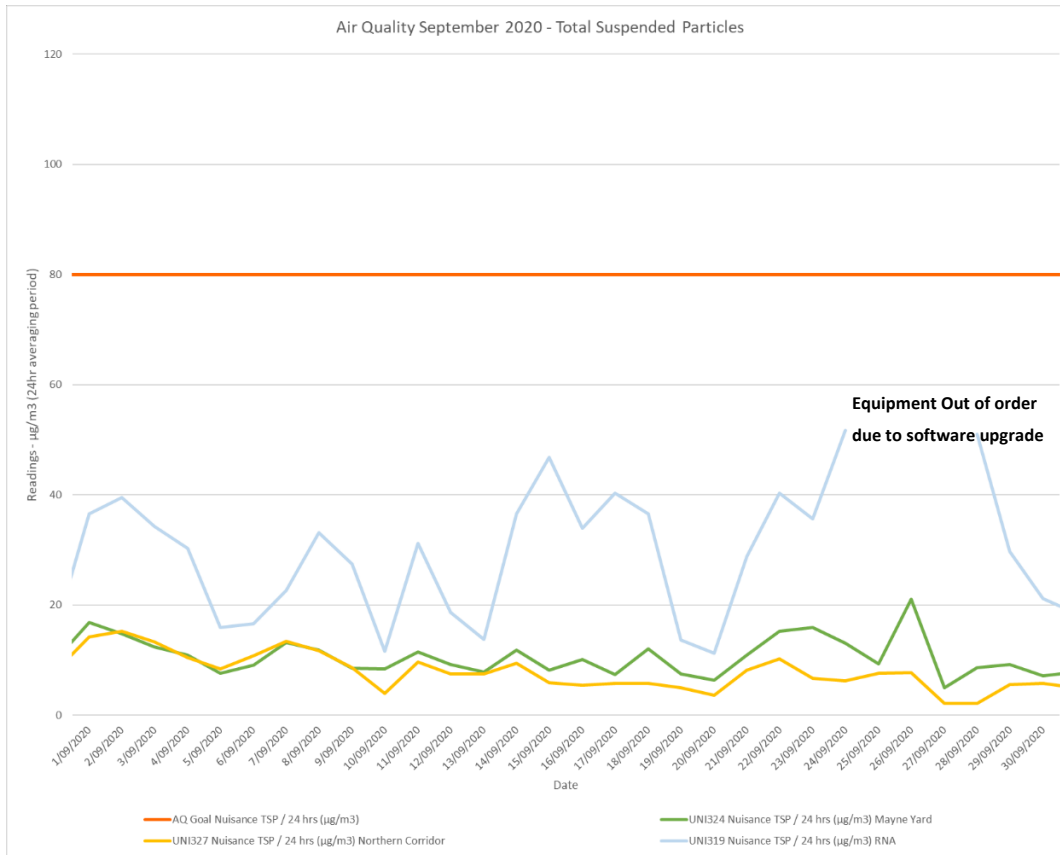
Figure 2: Air Quality Monitoring (TSP) - September 2020 Results

The results are represented in the below figures.

TSP is one of the indicators for which the Coordinator-General has imposed a goal of 80 $\mu\text{g}/\text{m}^3$ (over an averaging period of 24 hours) the project must aim to achieve under Imposed Condition 13(a).

These stations have been set up on site as per AS/NZS 3850 1.1 following consultation with UNITY Air Quality Professionals.

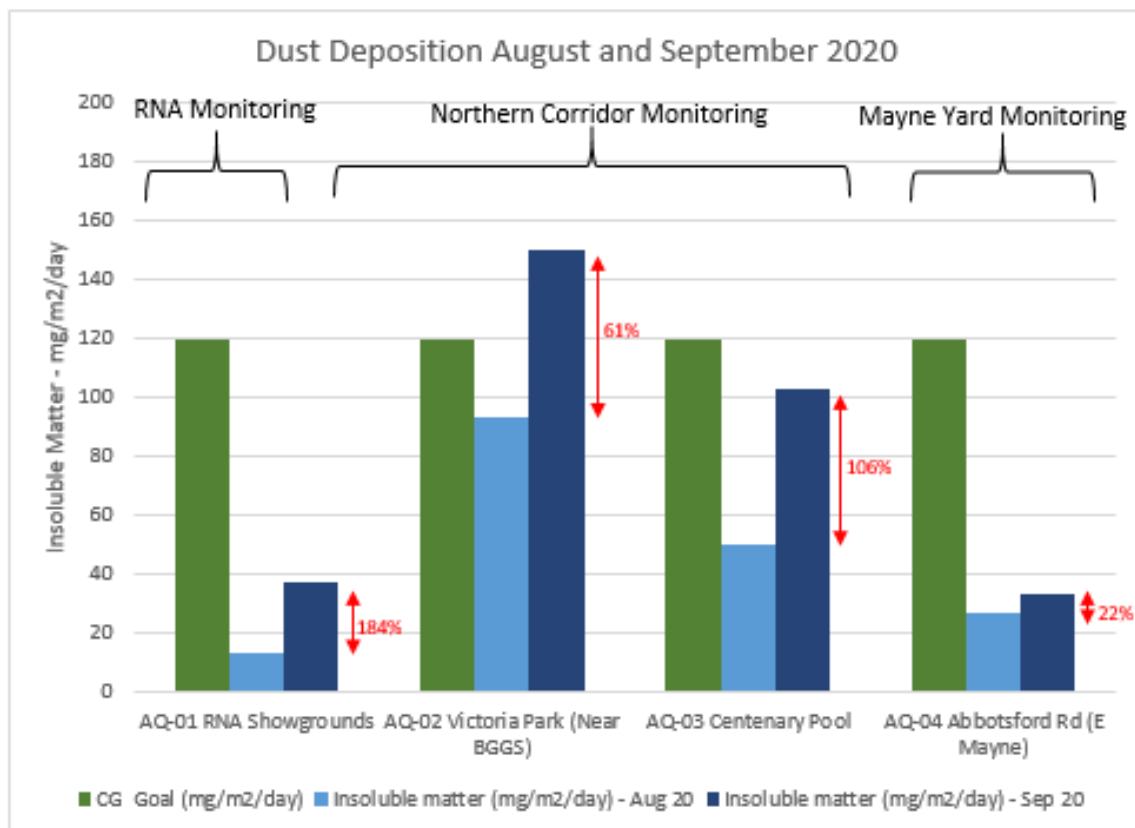
Figure 8: Project wide dust deposition gauges and increases during most recent DDG monitoring periods

- There was an increase (month to month) at the project Dust Deposition Gauges of 184% (24mg/m²/day) at RNA, 61% (47mg/m²/day) and 106% (53mg/m²/day) at the Northern corridor and 22% (6mg/m²/day) at Mayne Yard (Figure 8).

- Due to the limitations of the dust deposition methodology, it cannot be concluded but it is highly likely and assumed that the regional air quality event contributed to the consistent increases in deposited dust site-wide.

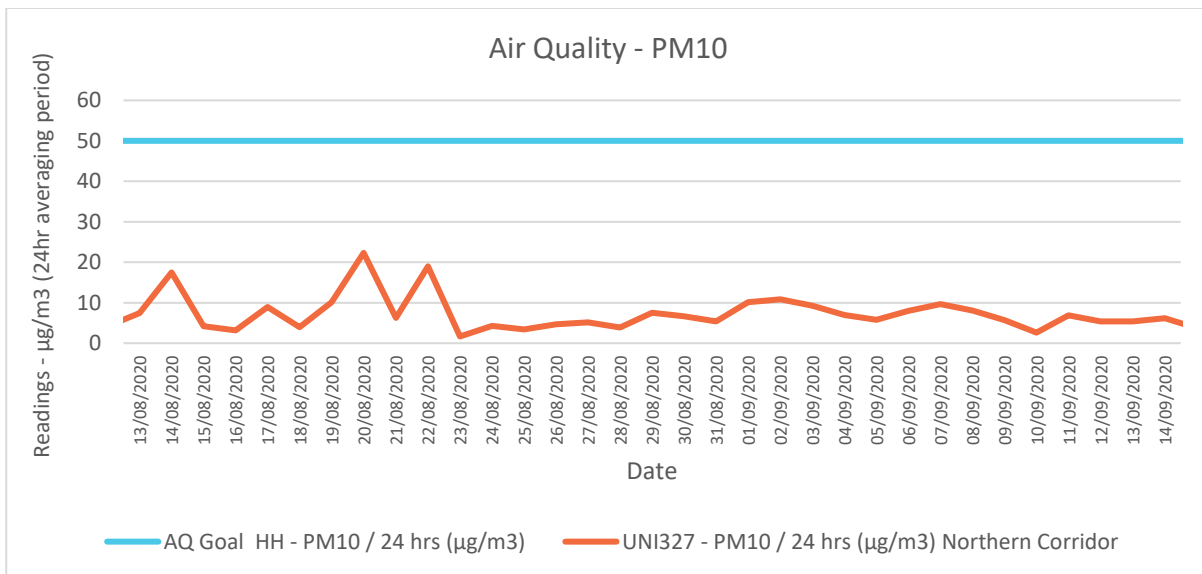
Figure 9: PM10 - Northern Corridor

- There were no recorded exceedances of the daily TSP or PM₁₀ Air Quality Goal at the Northern TSP/PM₁₀ monitoring station during the reporting period, (Figure 9 and Figure 10). There was an increase in both parameters during the regional air quality event (20-22 August 2020).

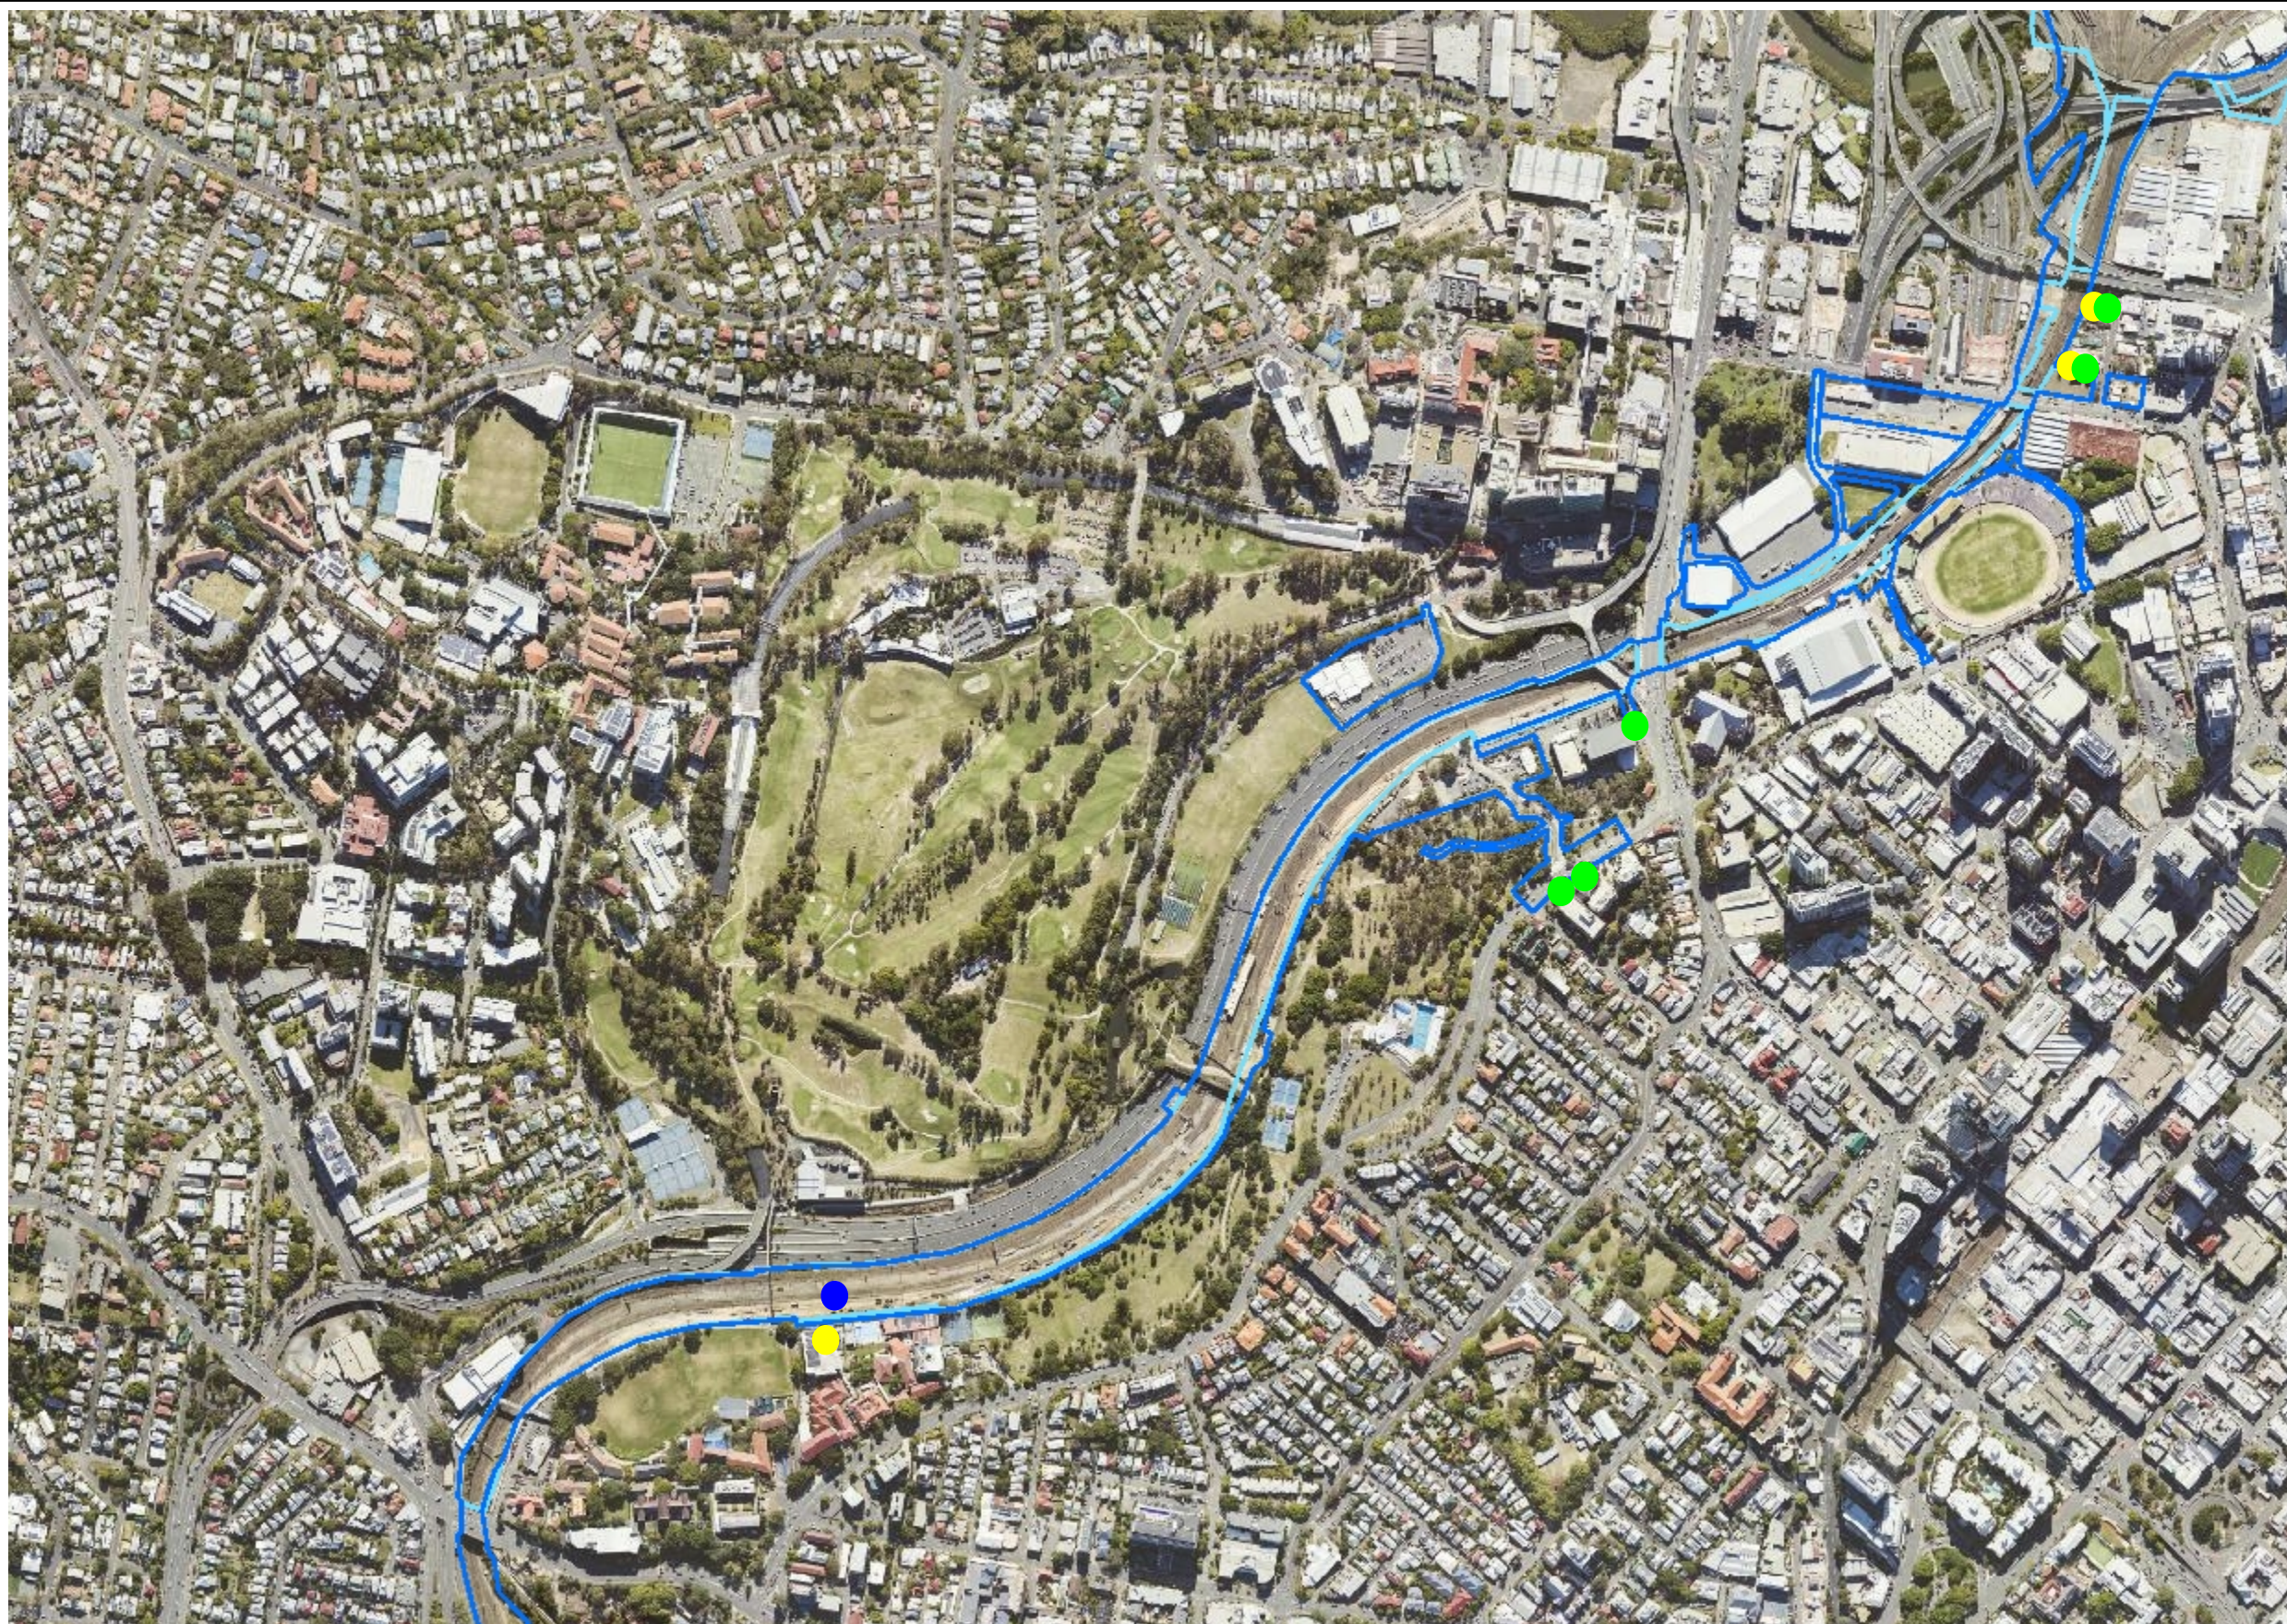
Attachment 2 Monitoring Locations – Noise

- Legend
- Project Boundary RFPC7
 - New Cadastral Boundary
 - Brisbane Imagery (25/06/2020)
 - Construction Monitoring at Sensitive places
 - Complaint Response
 - Plant Audit

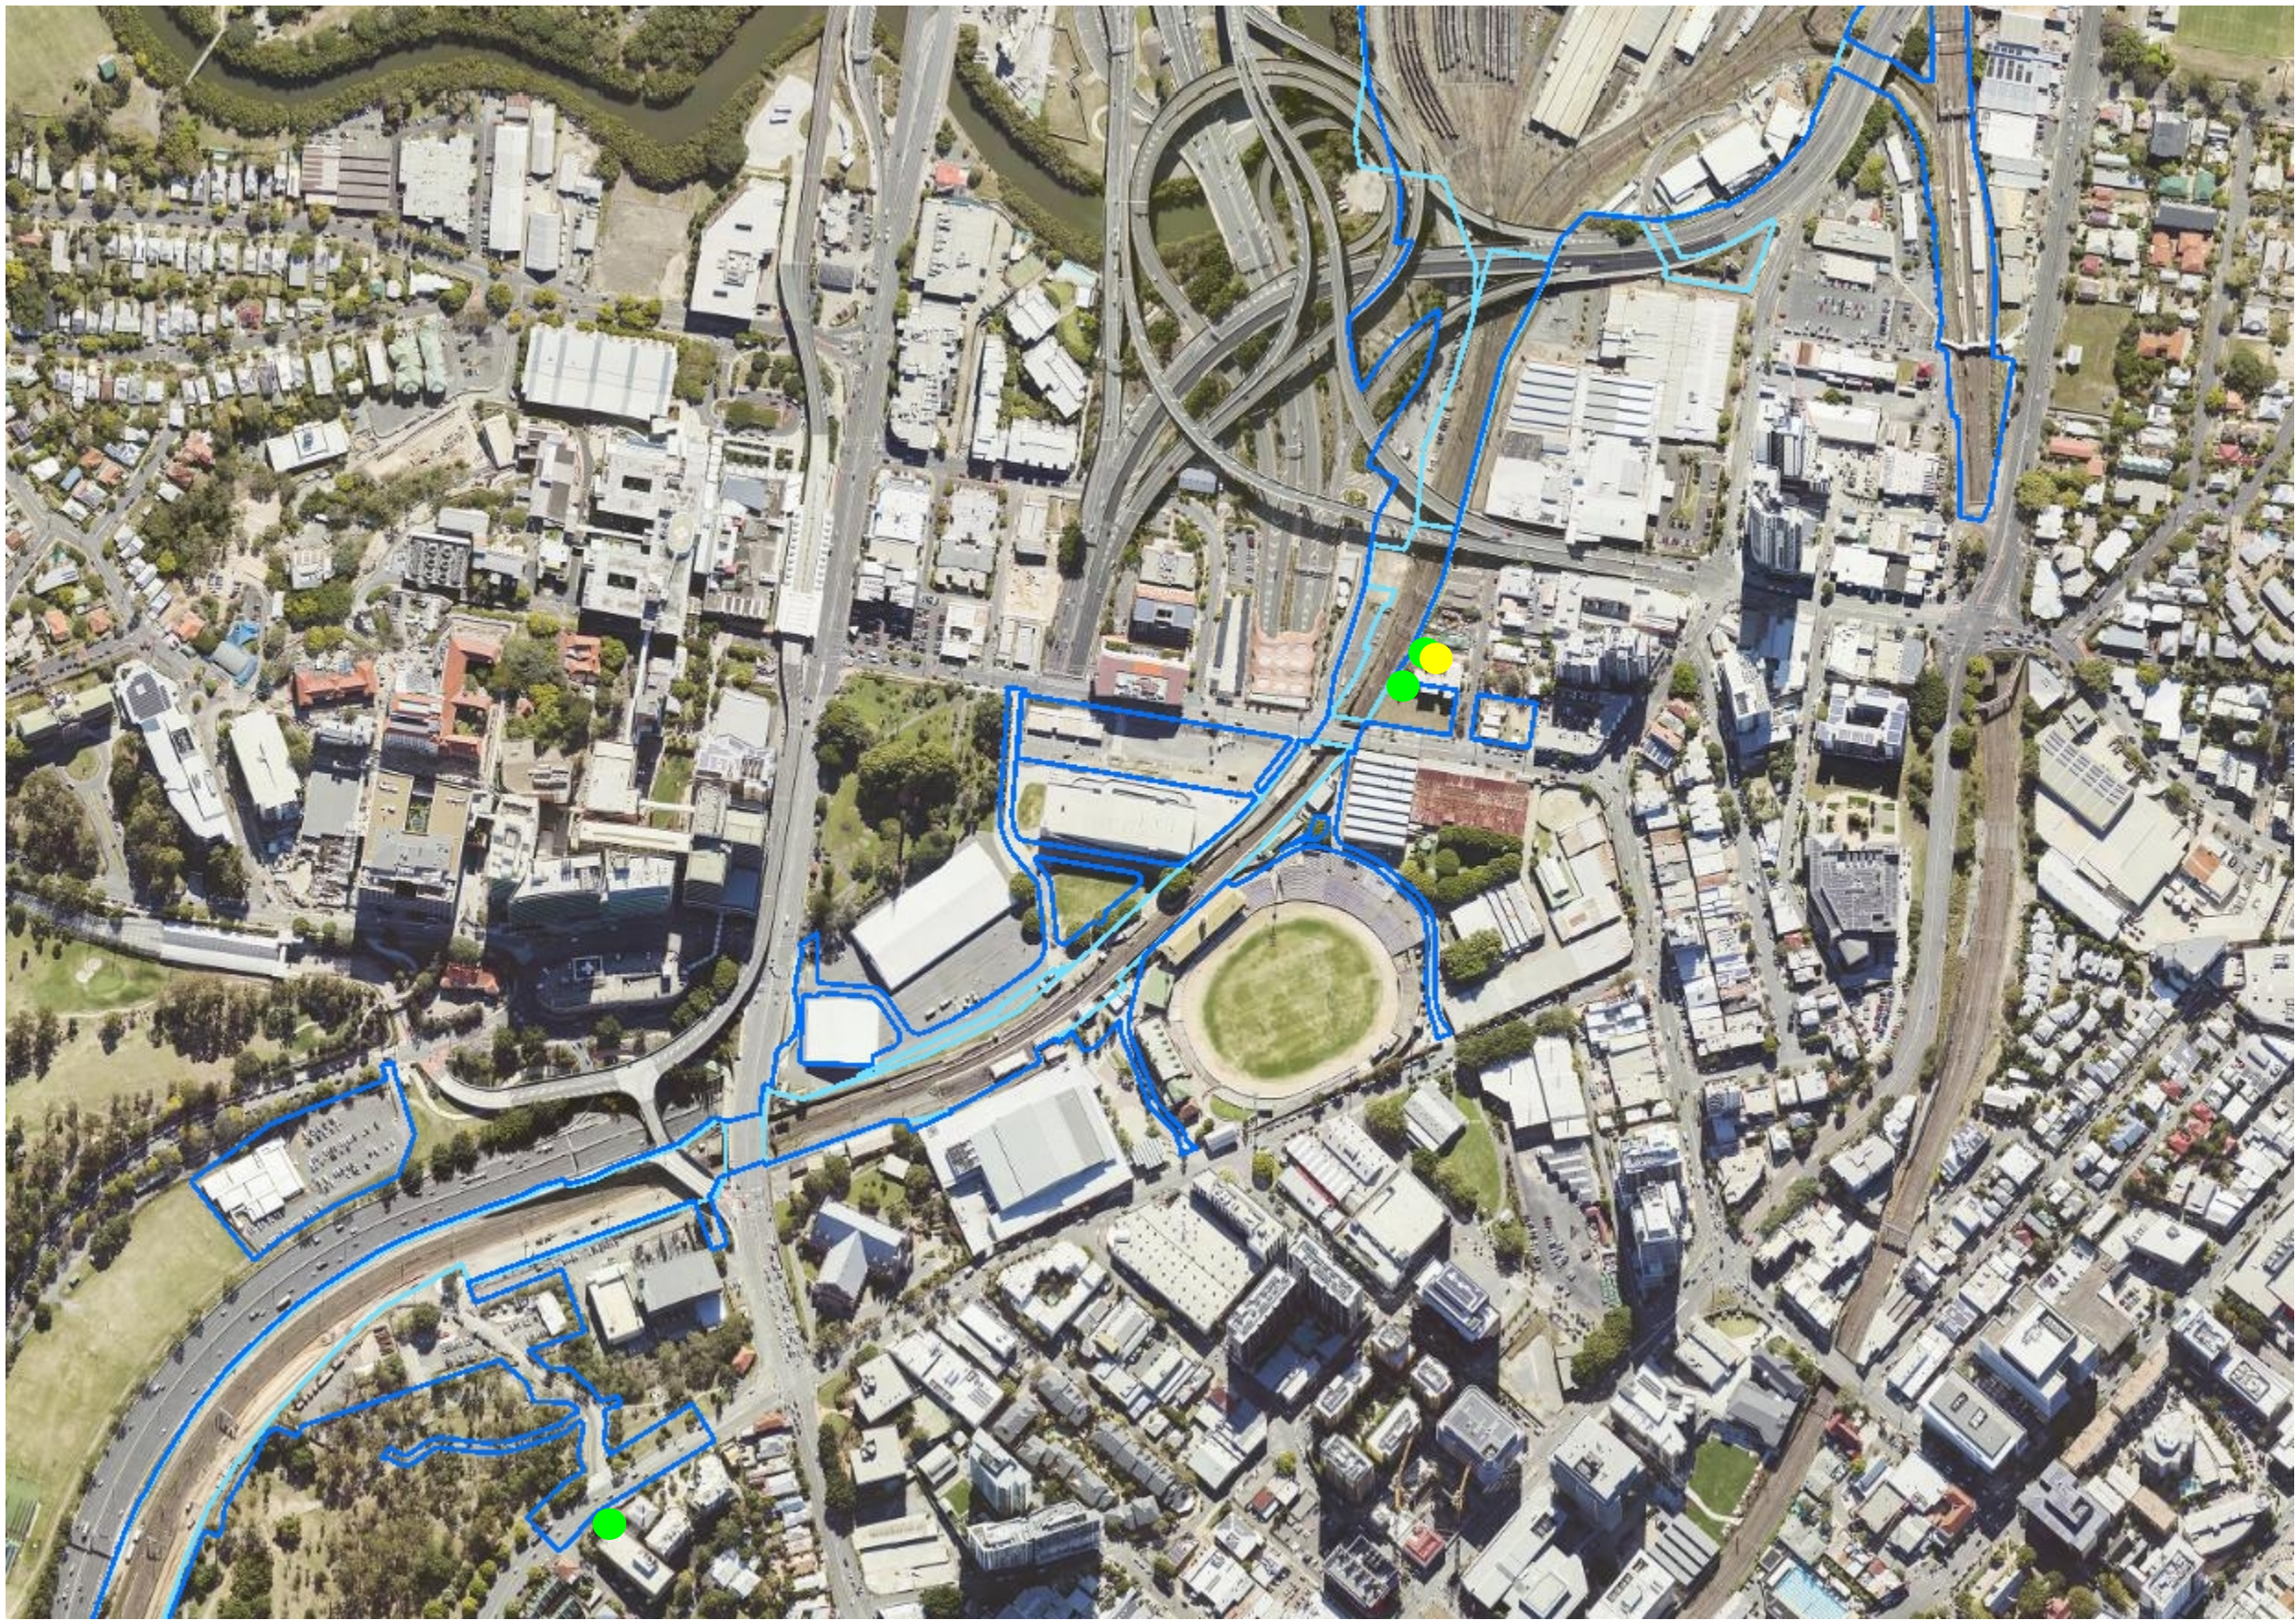
Attachment 3 Monitoring Locations – Vibration

- Legend
- Project Boundary RFPC7
 - New Cadastral Boundary
 - Brisbane Imagery (25/06/2020)
 - Construction Monitoring at Sensitive Places
 - Background Data

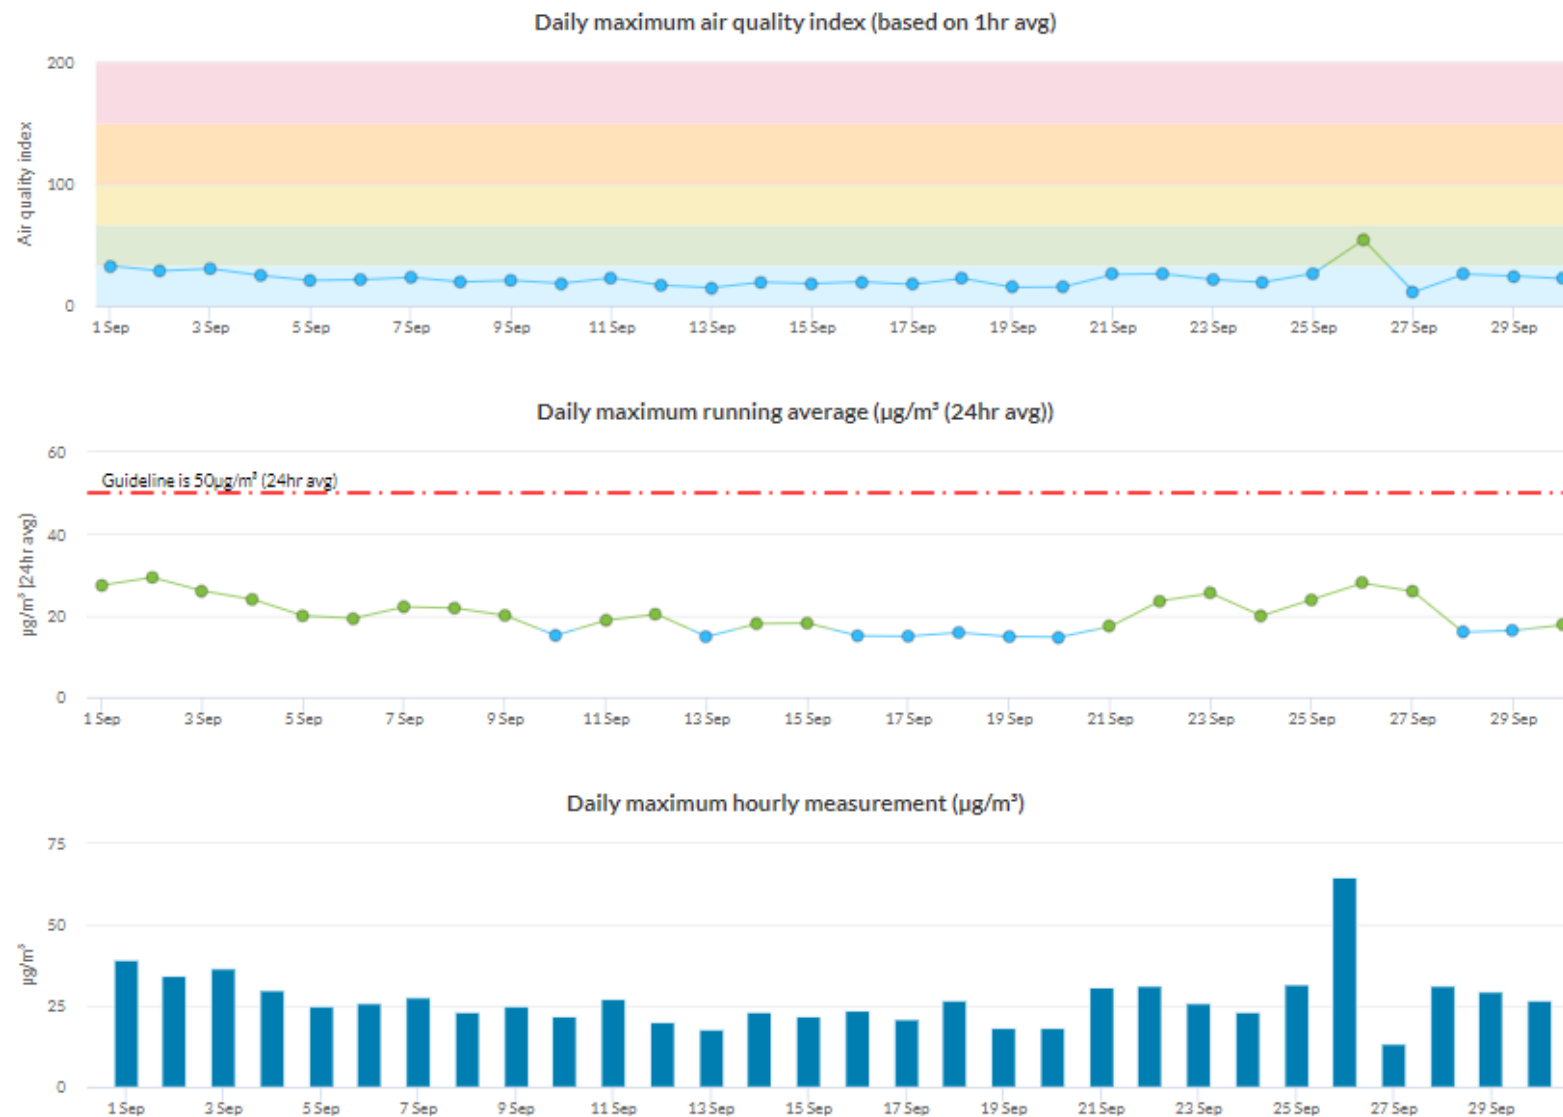
Figure 1: Brisbane CBD – DES Station - PM10 graph for August 2020 (reproduction from the DES website accessed October 2020)

Particle PM10 at South Brisbane, 1–30 September 2020

The graphical representation of the Government air quality data is presented in the below charts (refer to Figure 1-3).

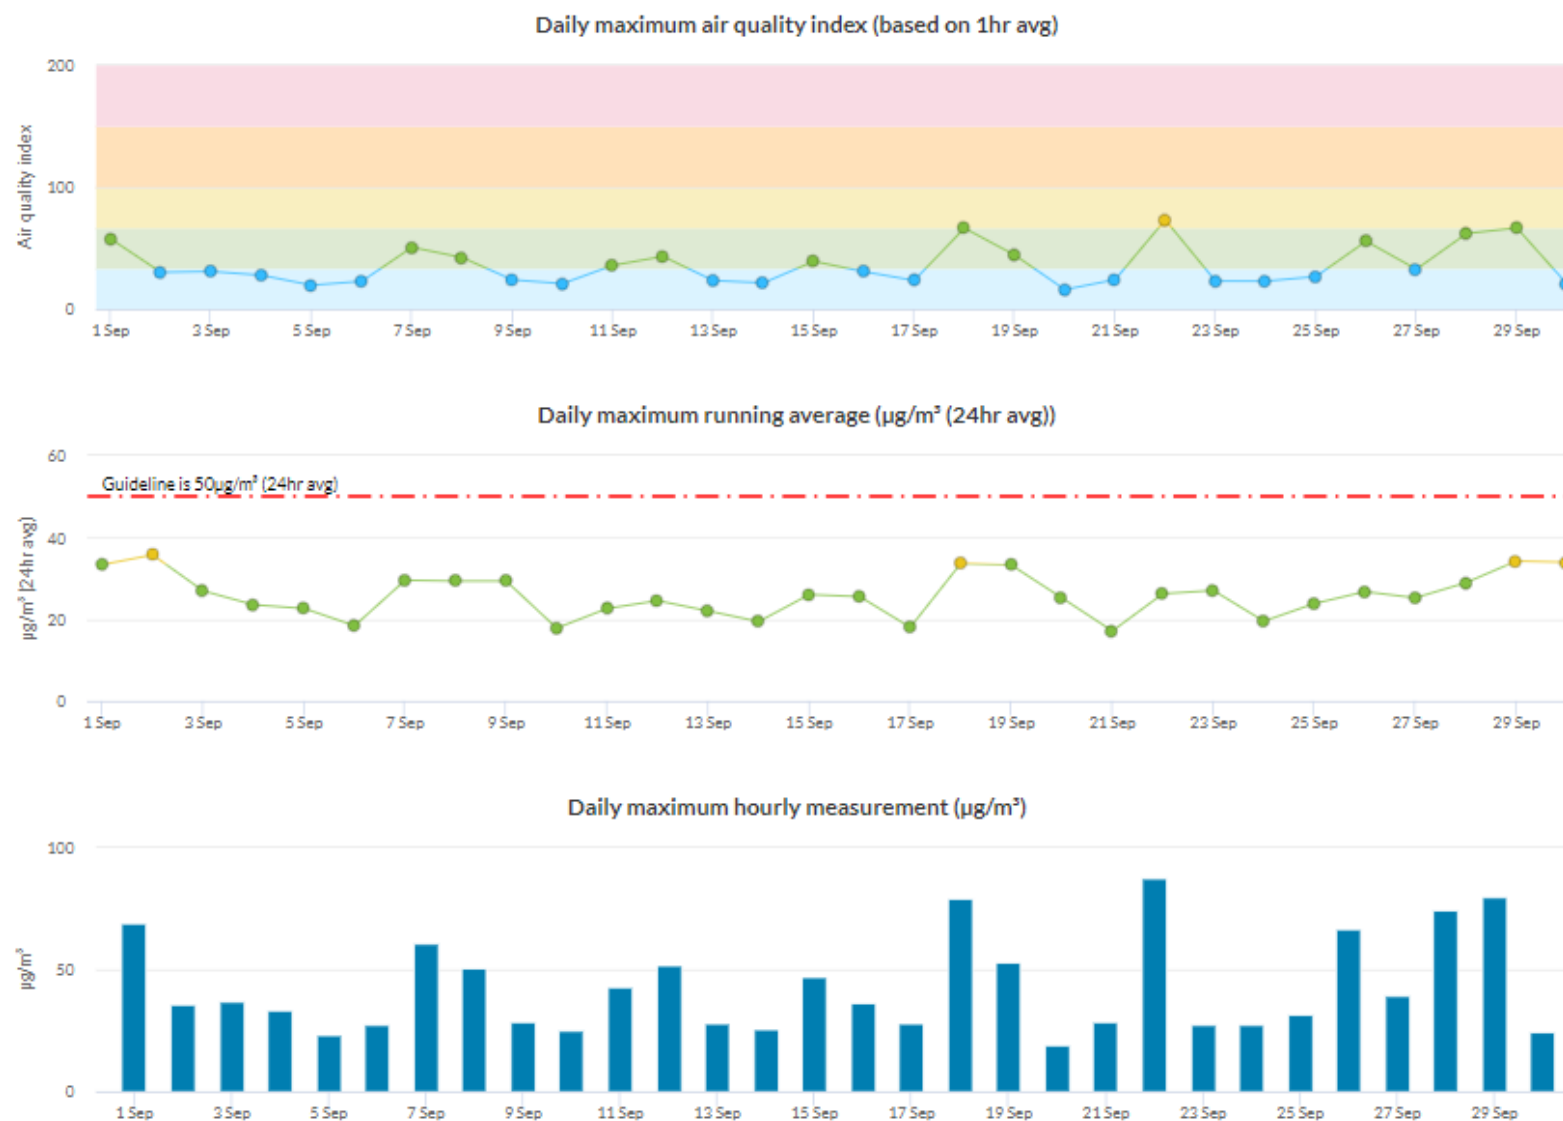
Figure 2: South Brisbane – DES Station - PM10 graph for August 2020 (reproduction from the DES website accessed October 2020)

Particle PM10 at South Brisbane, 1–30 September 2020

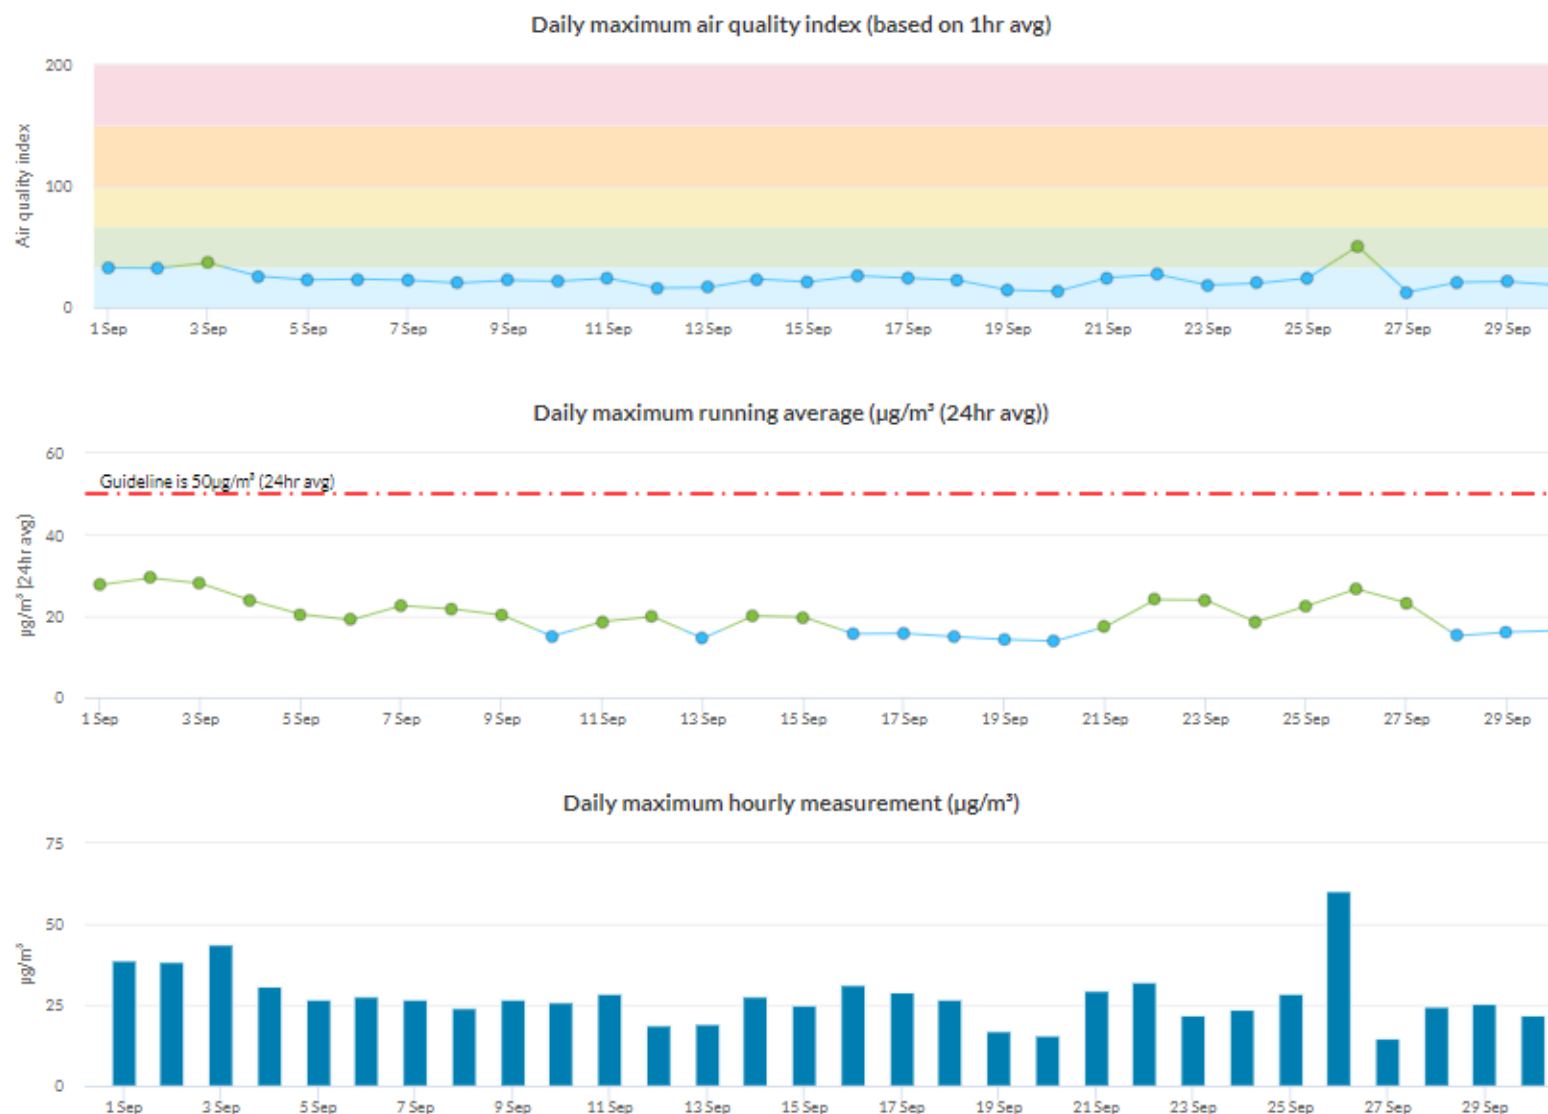
Figure 3: Woolloongabba – DES Station - PM10 graph for August 2020 (reproduction from the DES website accessed October 2020)

Particle PM10 at Woolloongabba, 1–30 September 2020
