Cross River Rail Project

Monthly Environmental Report

May 2022

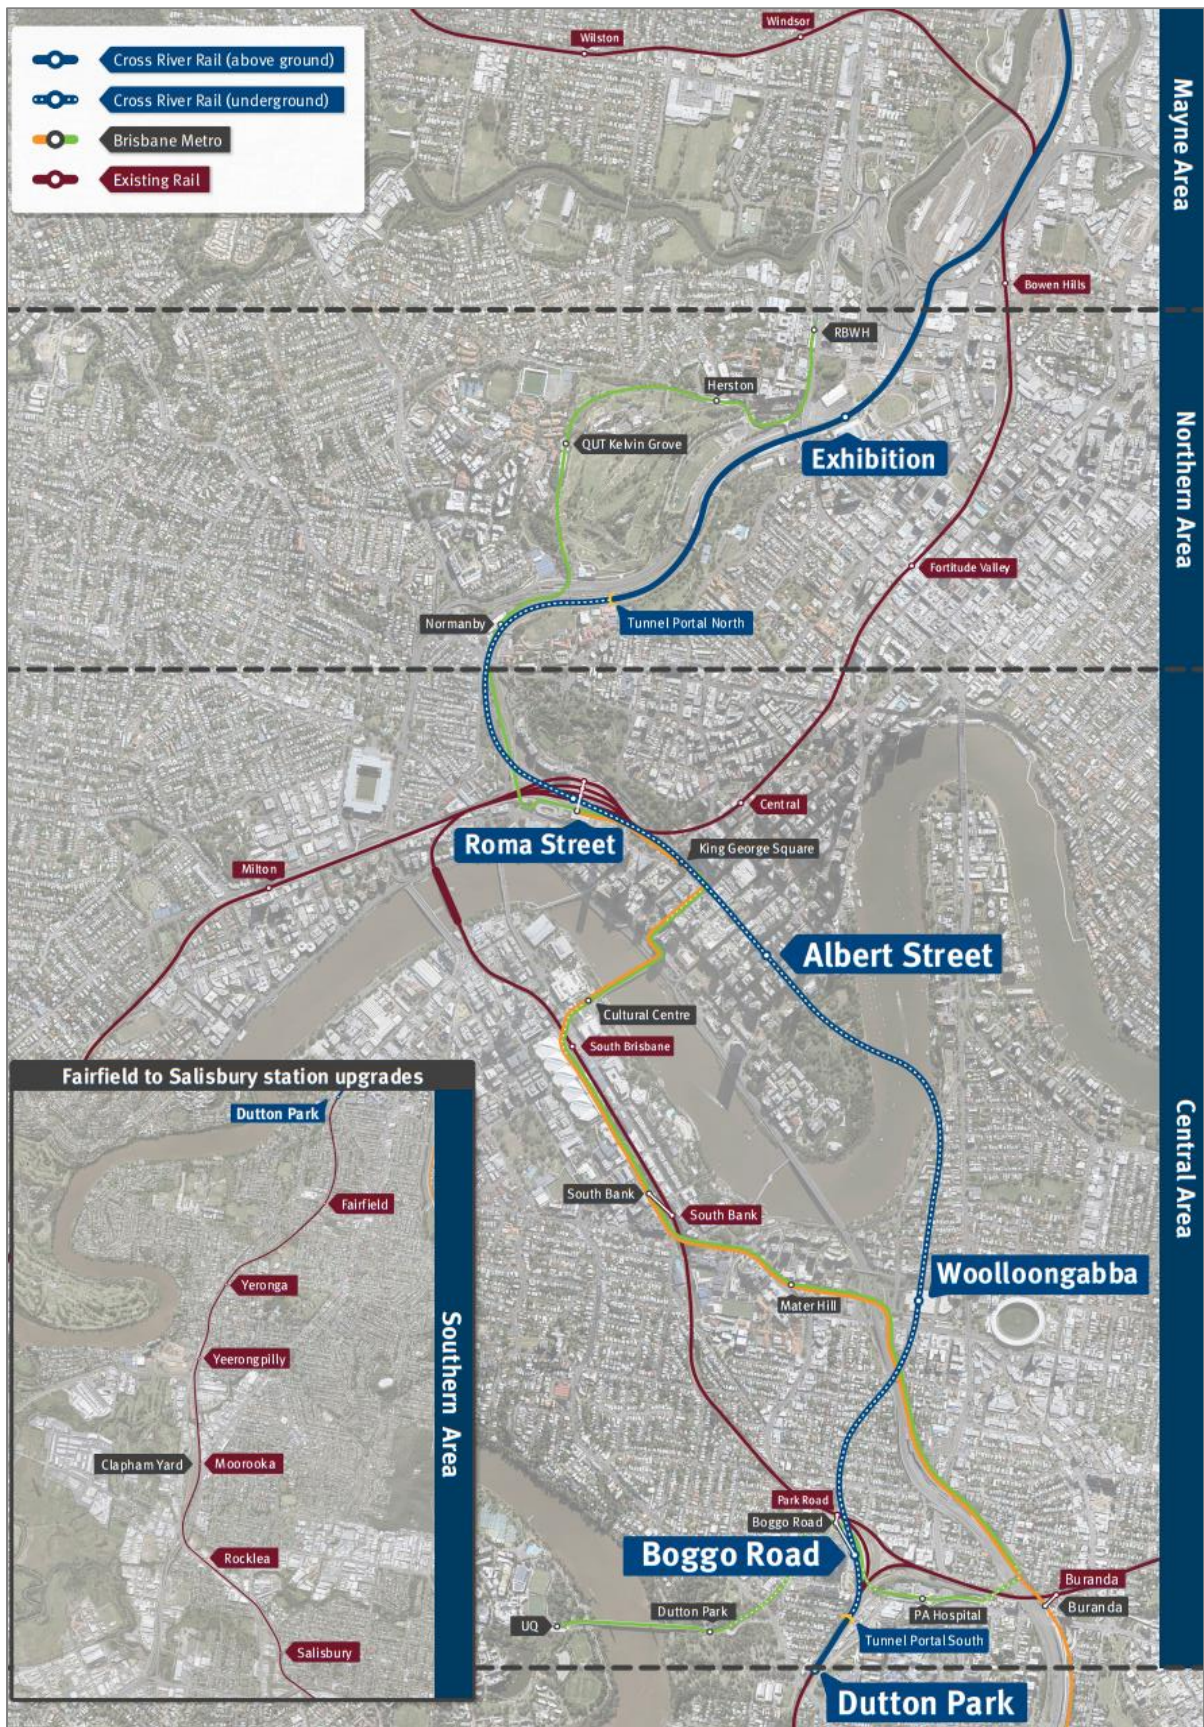
- Mayne Area;
- Northern Area;
- Central Area; and
- Southern Area.

These are shown in the figure over.

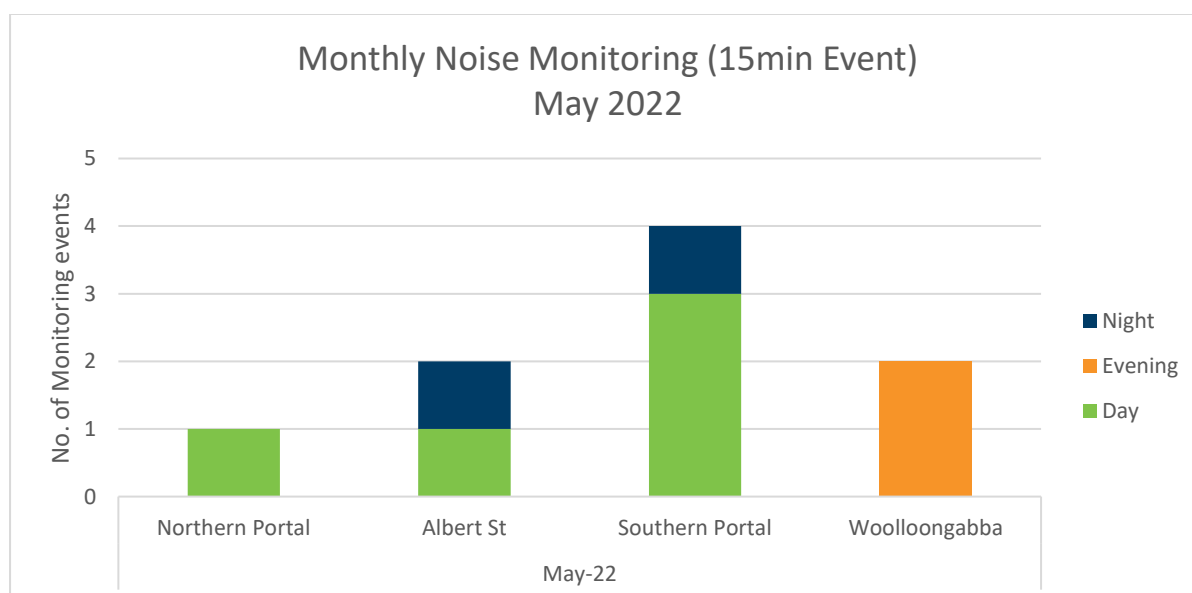
In the Central Area, noise monitoring was undertaken to validate predictive modelling at Sensitive Places close to the project worksites and in response to noise complaints. The TSD contractors reported that the project noise requirements have been met during this reporting month. Monitoring results for the Central Area are detailed in **Appendix B** (Table 3).

A summary of noise monitoring events for the month is provided in the chart below.

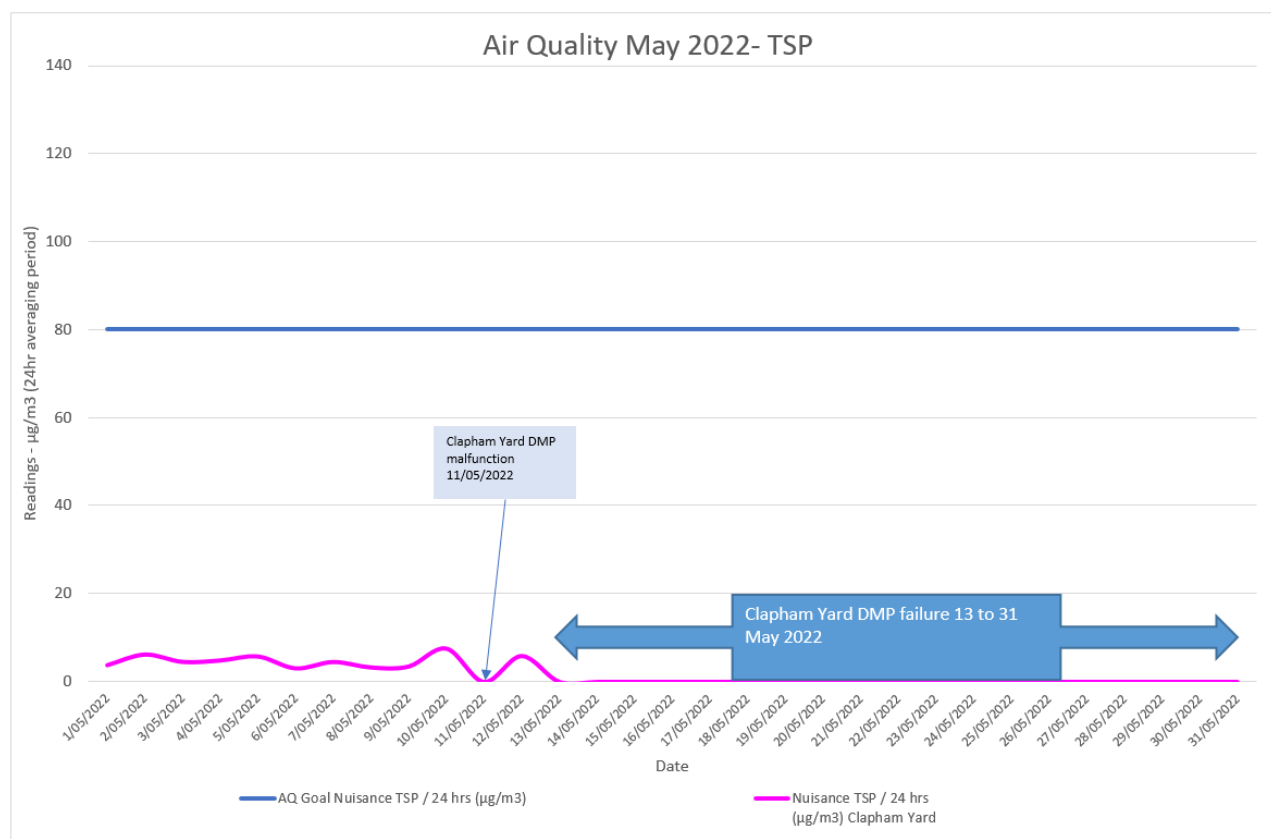
Figure 2 Air Quality Monitoring (TSP) Results

These stations have been installed on-site as per AS/NZS 3850 1.1 following consultation with UNITY air quality professionals.

As explained in the previous section, the results presented for the reporting period only cover the Clapham Yard records as the Mayne Yard and RNA data records are not reliant.

The Clapham Yard air quality monitor also experienced a malfunction preventing monitoring data on 11 and 13-31 May 2022. Only partial data was deemed reliable for the purpose of compliance assessment which did not exceed the relevant daily goals for PM₁₀ and TSP. The equipment manufacturer was also contacted in relation to these malfunctions for the Clapham Yard air quality. The manufacturer observed that similar damage to those observed at the Mayne Yard and RNA stations is likely to have caused these malfunctions. The Clapham Yard air quality monitor has also been removed from site and sent to the manufacturer in NSW for inspection.

Particulates results are detailed in **Appendix A** (Figure 2 and Figure 3) and **Appendix B** (Table 5)

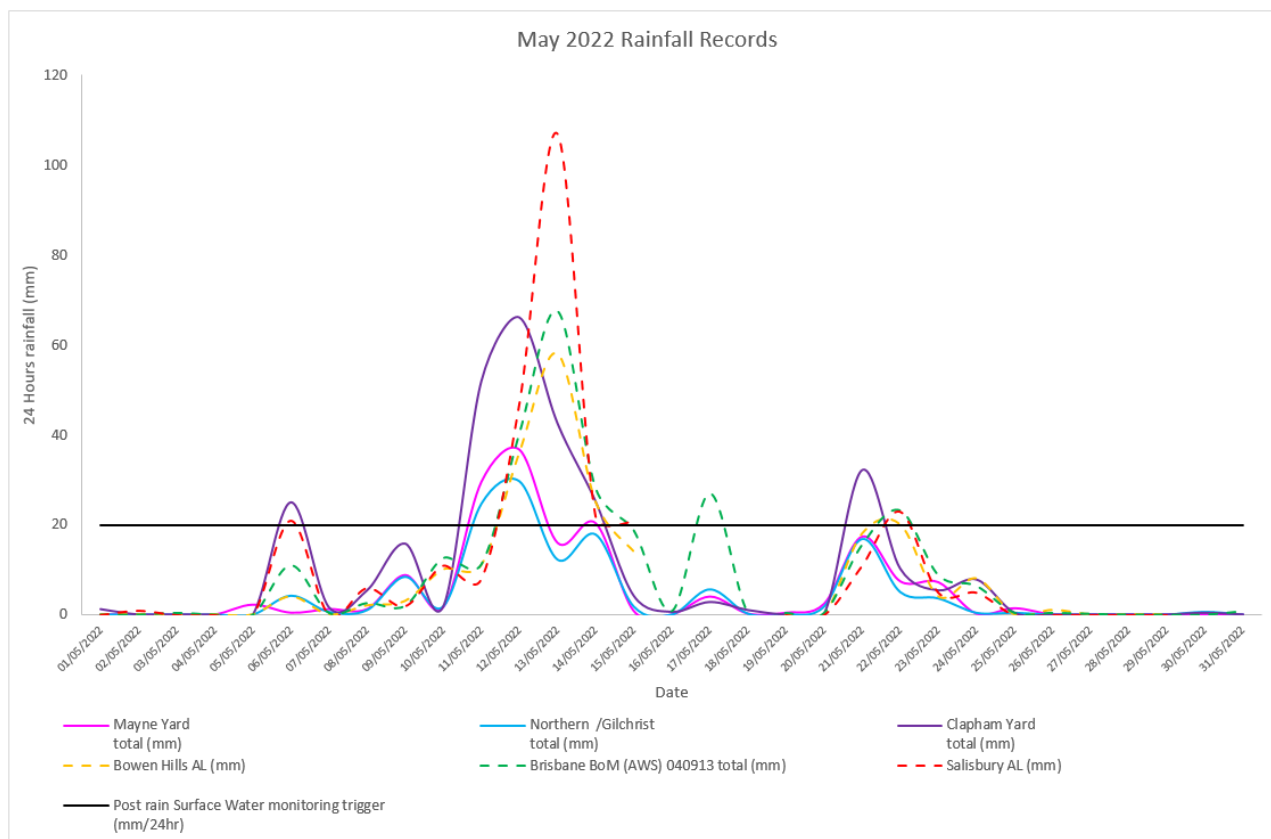
Figure 4: May 2022 Rainfall Records

3.3.1 Rainfall Records

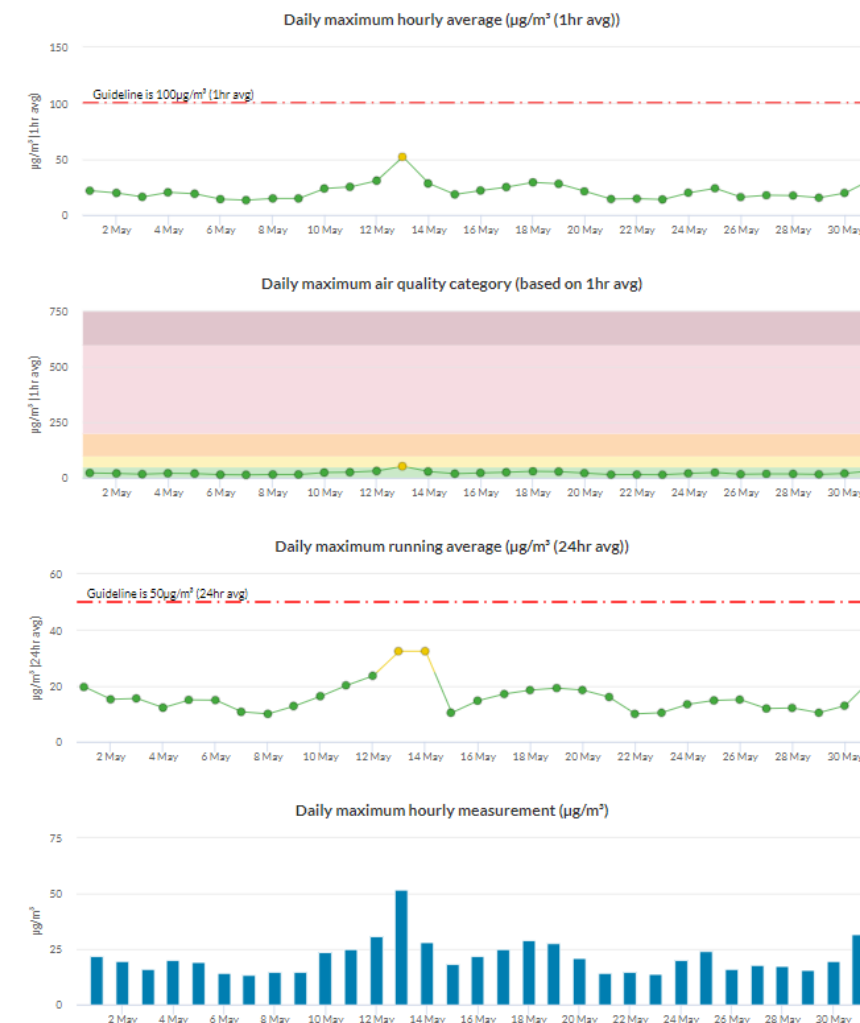
Figure 1: Brisbane CBD – DES Station - PM10 graph for May 2022 (reproduction from the DES website).

The guideline for Particle PM₁₀ is 100µg/m³ (1hr avg) and 50µg/m³ (24hr avg).

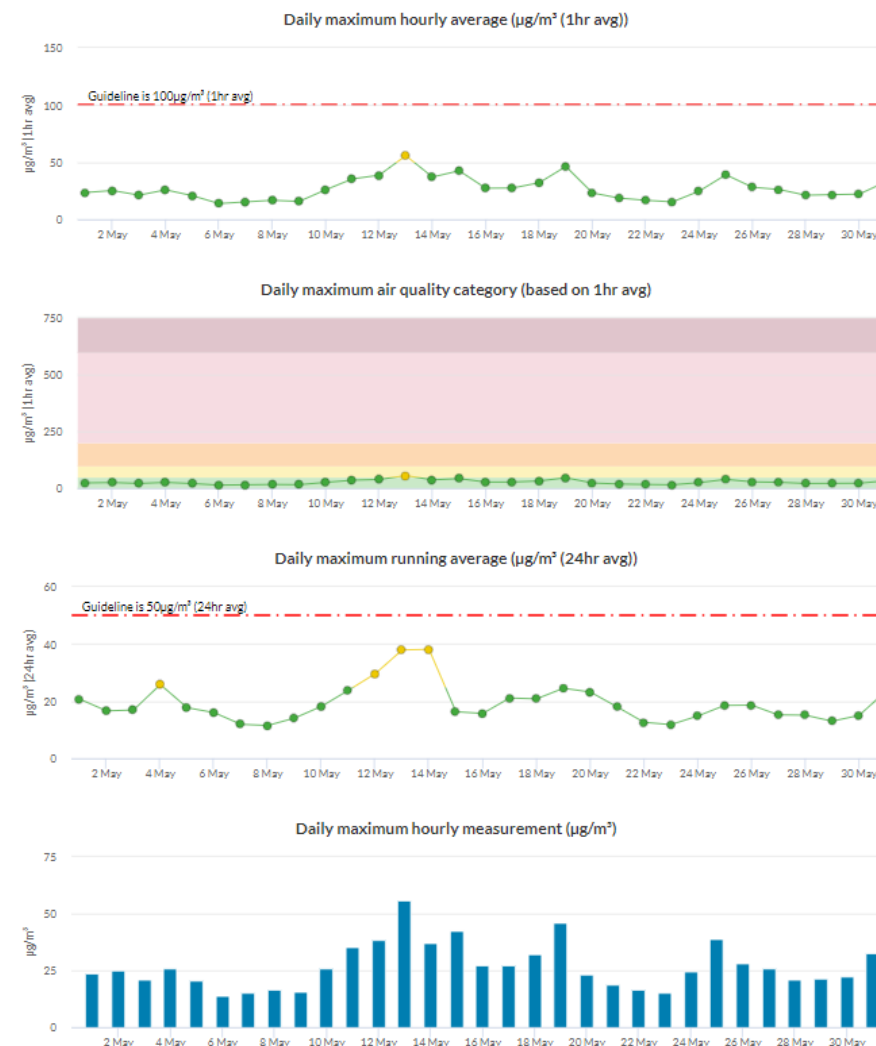
Figure 2: South Brisbane – DES Station - PM10 graph for May 2022 (reproduction from the DES website).

Particle PM₁₀ at South Brisbane, 1–31 May 2022 [about Particle PM₁₀](#)

The guideline for Particle PM₁₀ is 100µg/m³ (1hr avg) and 50µg/m³ (24hr avg).

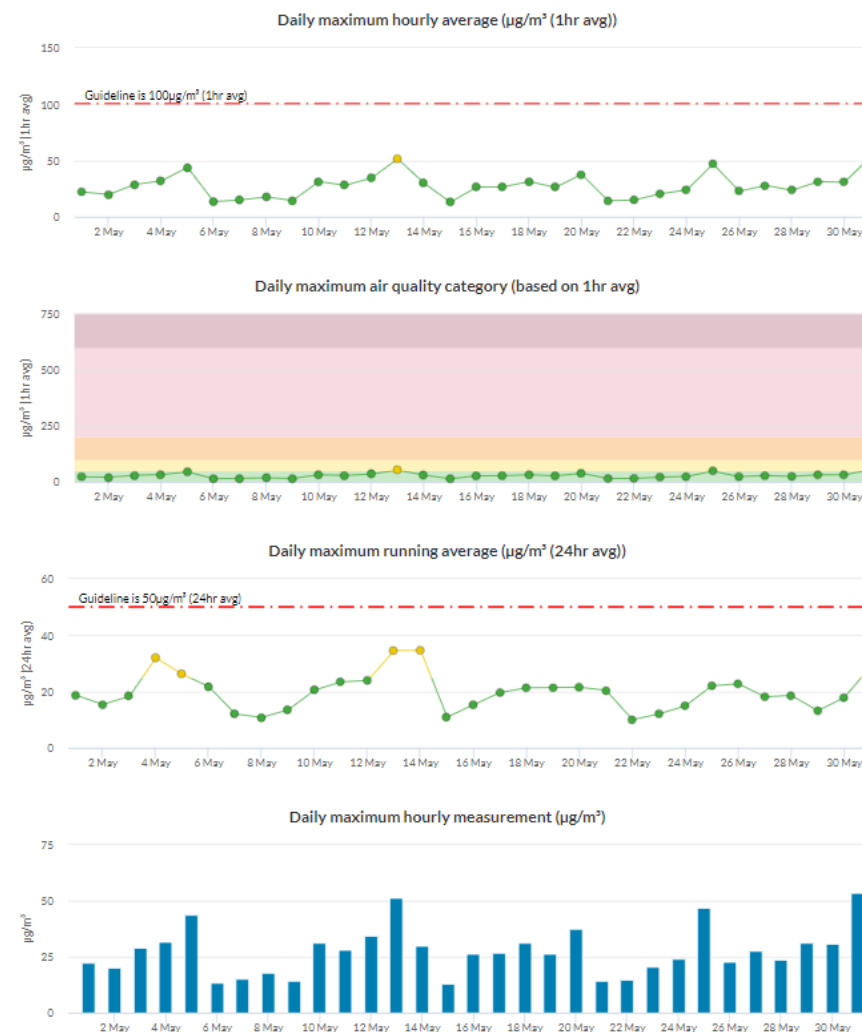
Figure 3: Woolloongabba – DES Station - PM10 graph for May 2022 (reproduction from the DES website).

Particle PM₁₀ at Woolloongabba, 1–31 May 2022 [about Particle PM₁₀](#)

The guideline for Particle PM₁₀ is 100µg/m³ (1hr avg) and 50µg/m³ (24hr avg).
