Cross River Rail Project

Monthly Environmental Report

October 2019

Monthly CGCR Report – October 2019

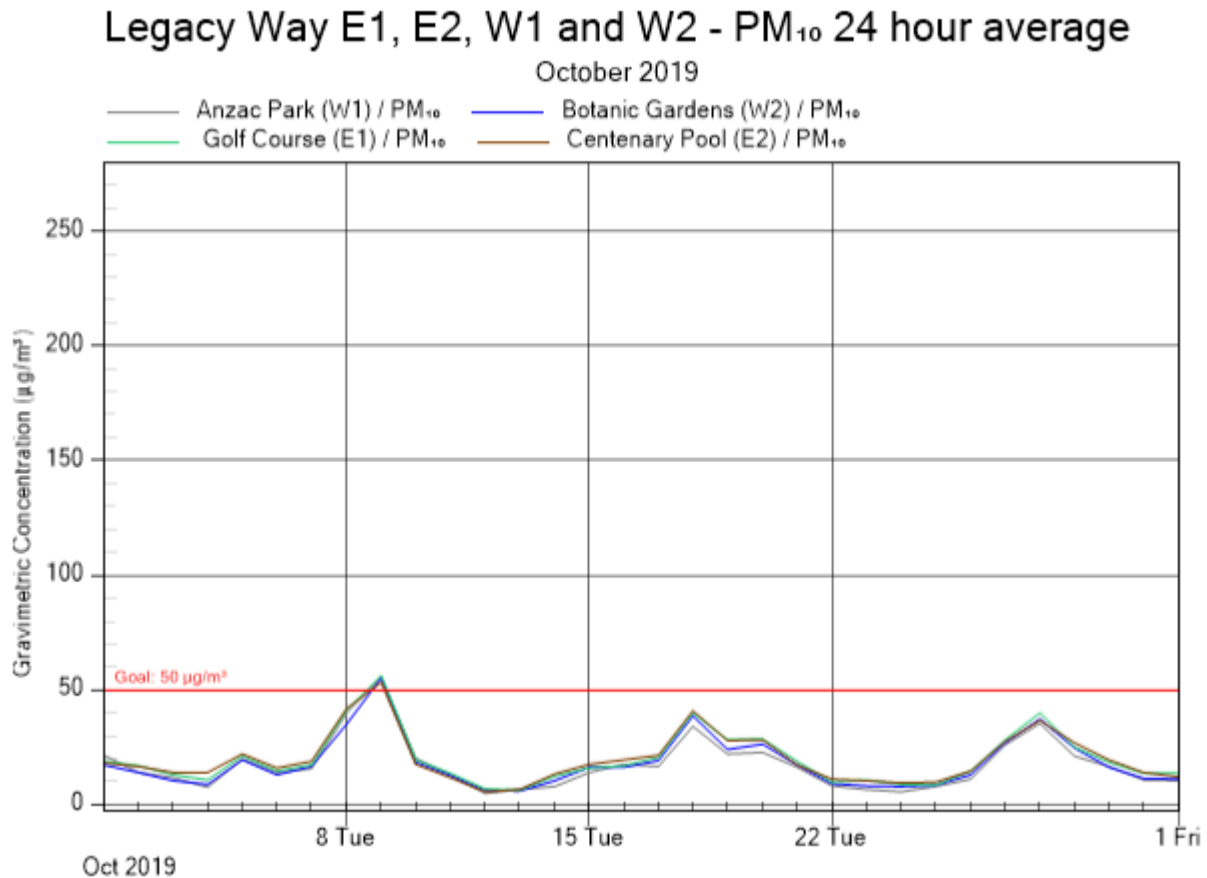
Figure 1: Transurban QLD Legacy Way (E1, E2, W1 and W2) - PM₁₀ graph for October 2019 (reproduction from the monthly report accessed 13 November 2019)

The following exceedance were recorded for the month of October for PM₁₀ near the northern corridor.

Parameter	Location	Time Period	Value of Exceedance	Date of Exceedance
PM ₁₀ (µg/m ³)	Victoria Park (E1)	24 hours	56	Wednesday 09 October 2019
PM ₁₀ (µg/m ³)	Centenary Pool (E2)	24 hours	53	Wednesday 09 October 2019

Similar exceedances were reported on the same day at the West Park Station (**56 µg/m³**) and the West Botanic Station (**55µg/m³**) for PM₁₀.

These two (2) stations are located 5 km south west from the Victoria Park and Centenary Pool stations, and therefore away from the direct influence of Unity's works.
